Defects in plumbing & drainage work / described by Francis Vacher.

Defects in Plumbing and Drainage Work

described by **Francis Vacher**
upwards of 100 illustrations

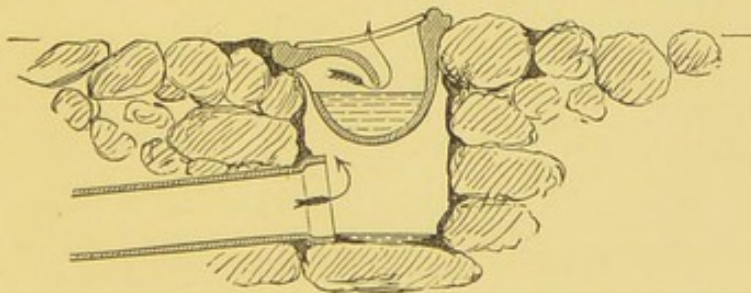
FIG. 16.

A defect less frequently met with is illustrated in Fig. 16. This trap, like all small D traps, holds too little trapping water to be secure, even had it been properly set. However, the workman who fixed it had done his work so negligently that, owing to uneven setting, the water seal was completely broken.

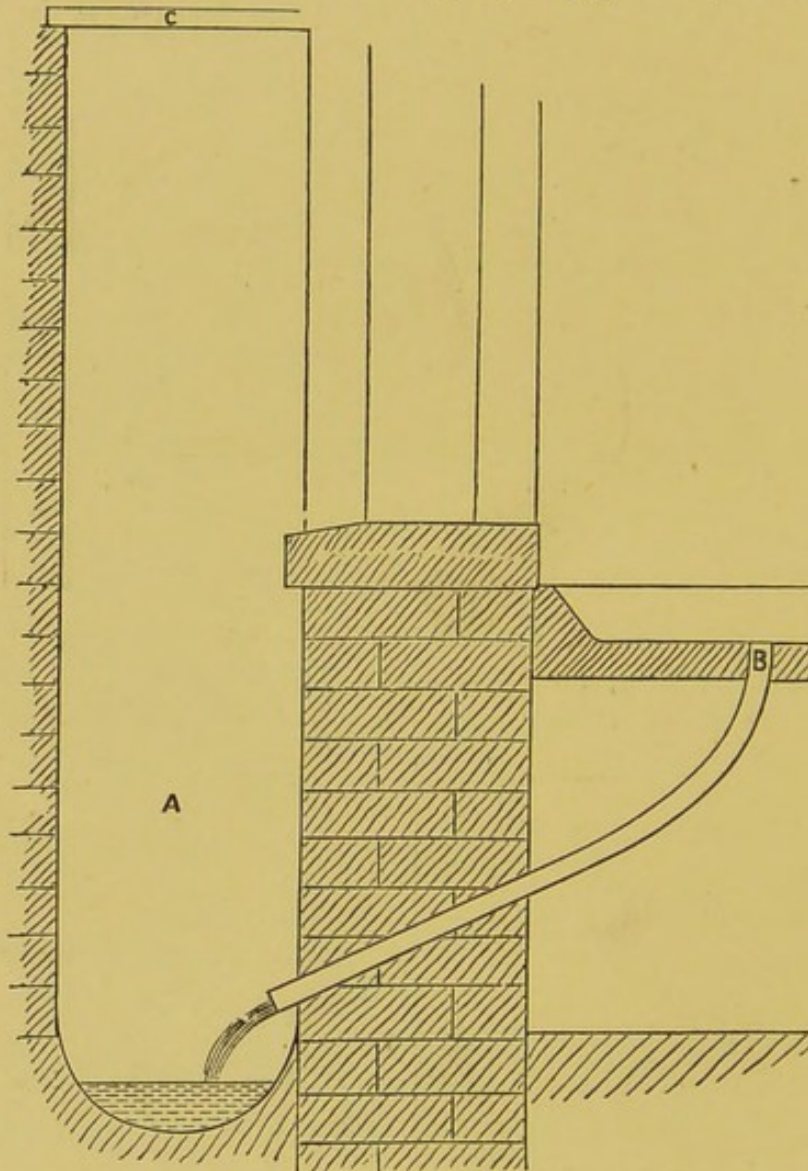
FIG. 27.

Fig. 27 shows a sink in the basement drained into an air drain. The house in which I noticed this defect was a hand-

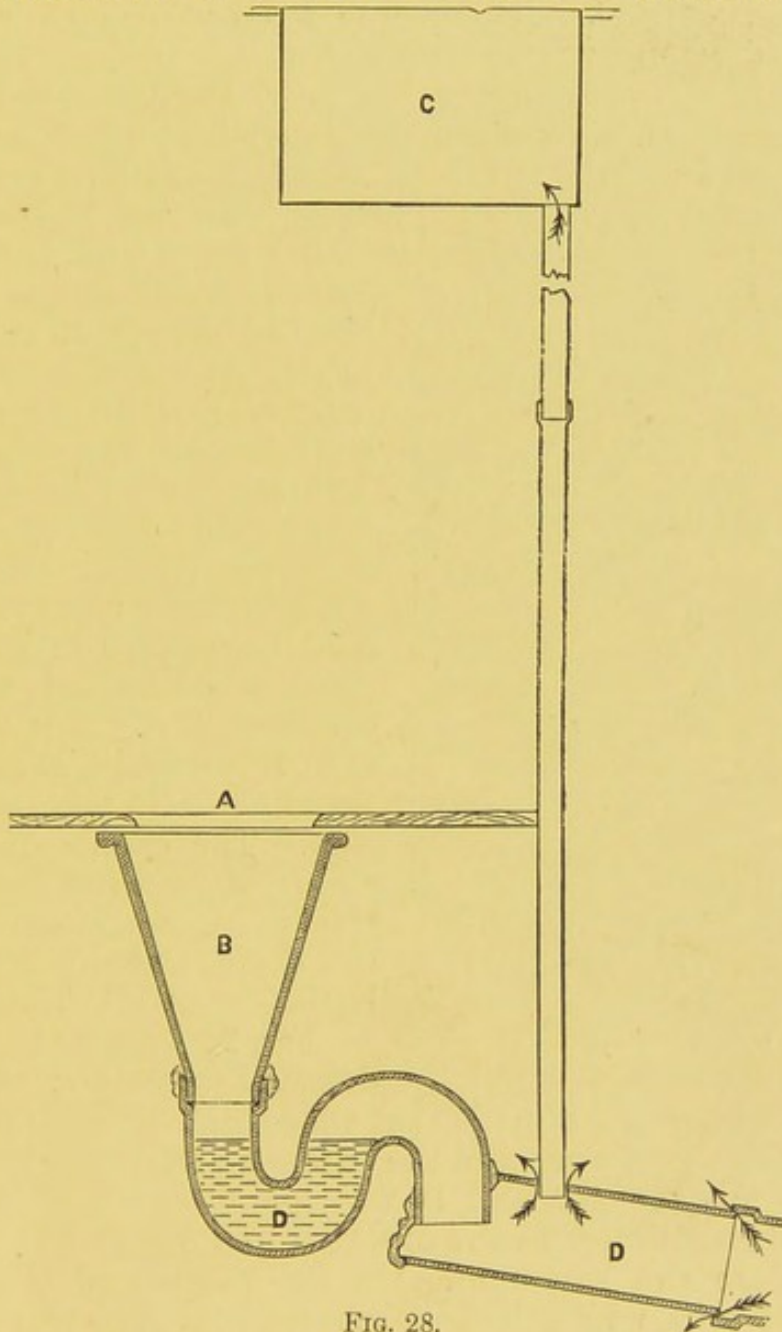
FIG. 28.

Fig. 28 shows what was discovered at a smaller suburban villa rented at £40. There was a complaint of effluvium nuisance, especially in the basement, and the examination of the premises was accordingly begun in the closet in the basement. Here was a basin of the usual pattern, properly connected to a 4in. glazed earthenware trap, and this again was connected to a 6in. glazed earthenware pipe, as indicated in the cut, the joint being not a workmanlike one, but made with cement, and apparently tight. The joint at the other end of the 6in. pipe

was bad all round, and in the upper part of this 6in. pipe a hole had been drilled to receive a 1½in. cast-iron waste pipe. The cast-iron pipe was quite loose, and could be moved freely from side to side. Above was a butler's pantry sink, the lead waste pipe of which was directly connected with the cast-iron pipe. A is the closet seat, B the basin, D and D the trap and drain pipe, and C the sink. The escape of foul air was from the defective joint in the drain, the hole drilled in the drain, and the sink in the butler's pantry.

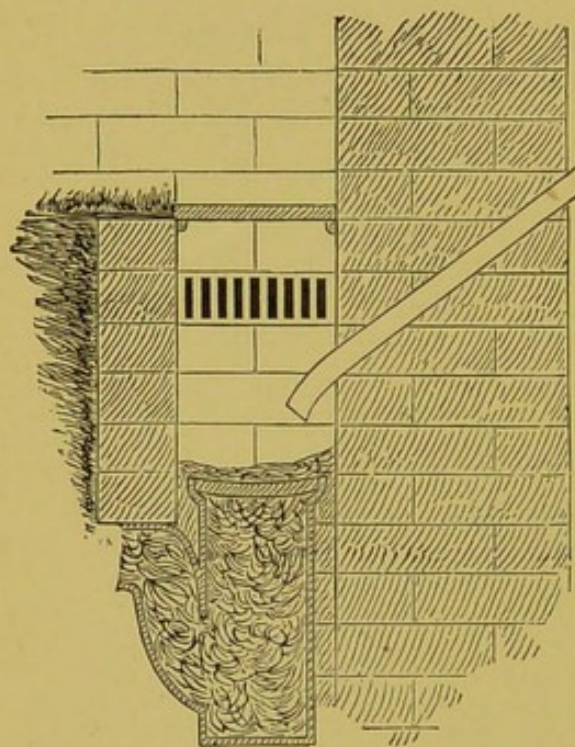
FIG. 29.

Fig. 29 illustrates a curious defect in another villa resi-

dence. Complaint was made that water was coming in through the external wall of a room in the basement used as a washhouse. A plumber was sent for, and it was found that the water came from an iron ventilator in the external wall, which had been put in to ventilate the basement. On the outside of the grating was a small area which had been made to receive the gulley trap on which the sink waste pipe delivered. As this area was covered by an iron grating, no attempt to cleanse it, or the trap it contained, had been made for a long time. The result was that the trap got filled to the brim with fat and other offensive matter; and then the foul water discharged by the sink waste pipe filled the area till it reached the level of the ventilator, and overflowed into the house.

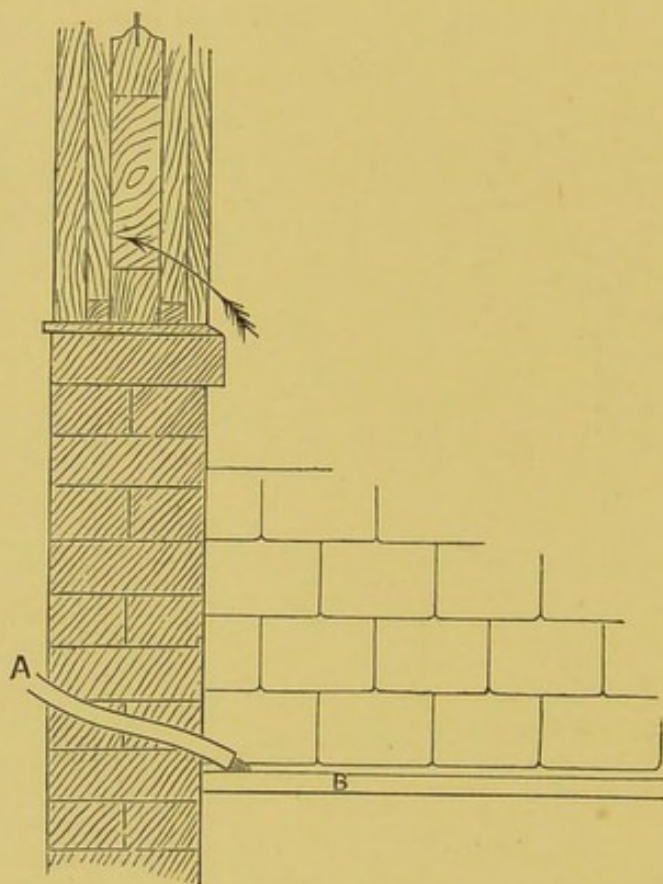
FIG. 31.

Fig. 31 shows a comparatively common defect. It is from a large building used as a hospital. A is a waste pipe from two hand-basins, discharging on a roof gutter B. The foul water from A runs along the open gutter for five feet before it reaches a downspout. Two feet above this gutter, which is ordinarily in a very foul state, is a window. Of course the proper practice

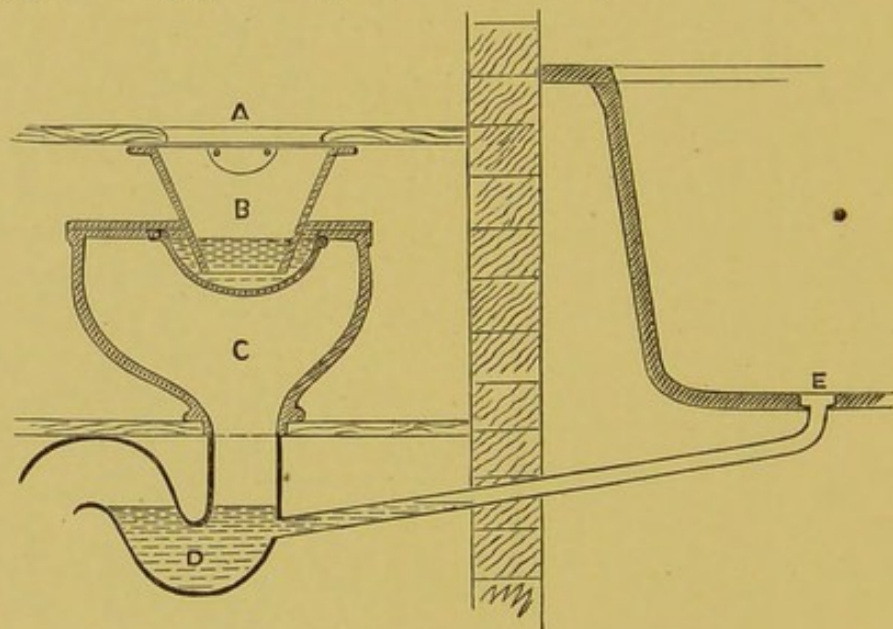
FIG. 35.

Fig. 35 is a section of a closet, showing also a portion of a bath in an adjoining room. As will be seen, the bath waste is taken into the closet trap. There was a complaint of an effluvium from the bath waste, and when the closet was used there were puffs of foul air from the waste pipe. In the cut A is the closet seat, B the basin, C the container, D the trap, and E the pipe wrongly brought into the trap.

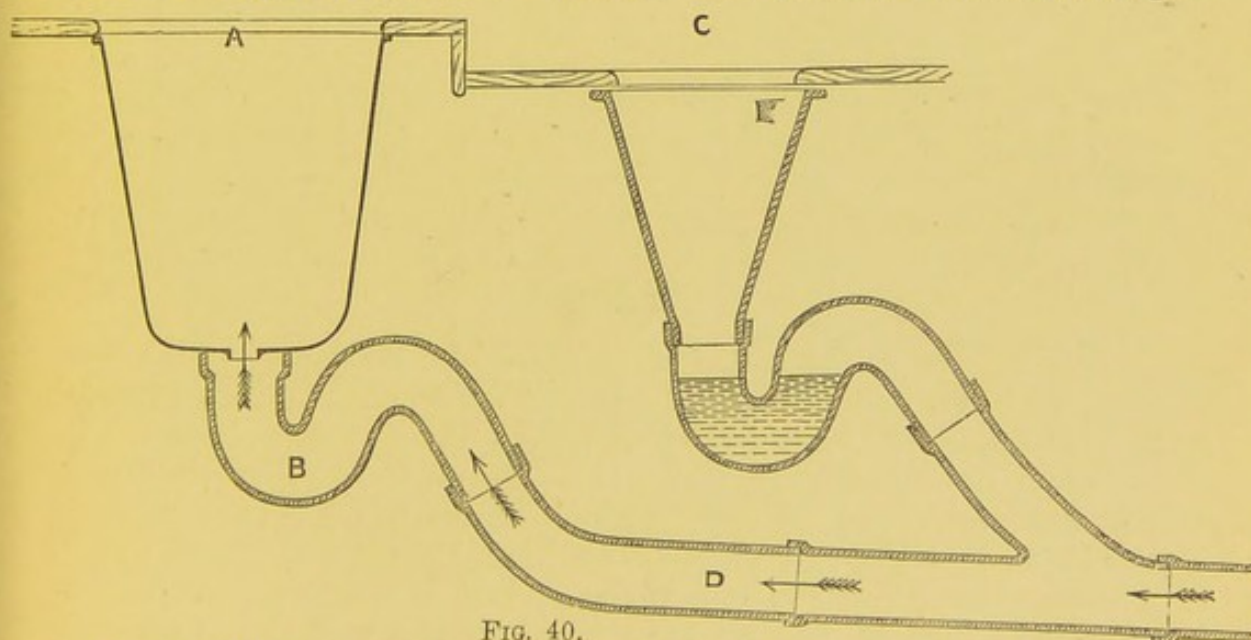
FIG. 40.

Fig. 40 shows in section a bath and closet situated in a small outbuilding erected as a "lean-to" in the rear of a dwelling-

house. There was no other bath or closet in the house, and complaint was made of a very great effluvium nuisance in the outbuilding. The nuisance was verified, and its cause was soon apparent. I found the bath full of lumber, and the taps

designed for the hot and cold supply twisted and immovable. The tenant said the bath had never been used. Of course, the 4in. earthenware pipe trap beneath was dry; and although the closet trap was acting, there was nothing to prevent the drain gases and effluvia having access to the room. A represents the bath, B the trap to the same, C the closet, and D the drain. In designing the house it was a mistake to put the bath in an outhouse, access to which could only be obtained by crossing a yard. Such a bath would almost certainly be neglected. However, it would have been quite easy to have made the bath waste deliver on the gully in the yard, and then, whether the bath were used or not, no nuisance could have arisen.

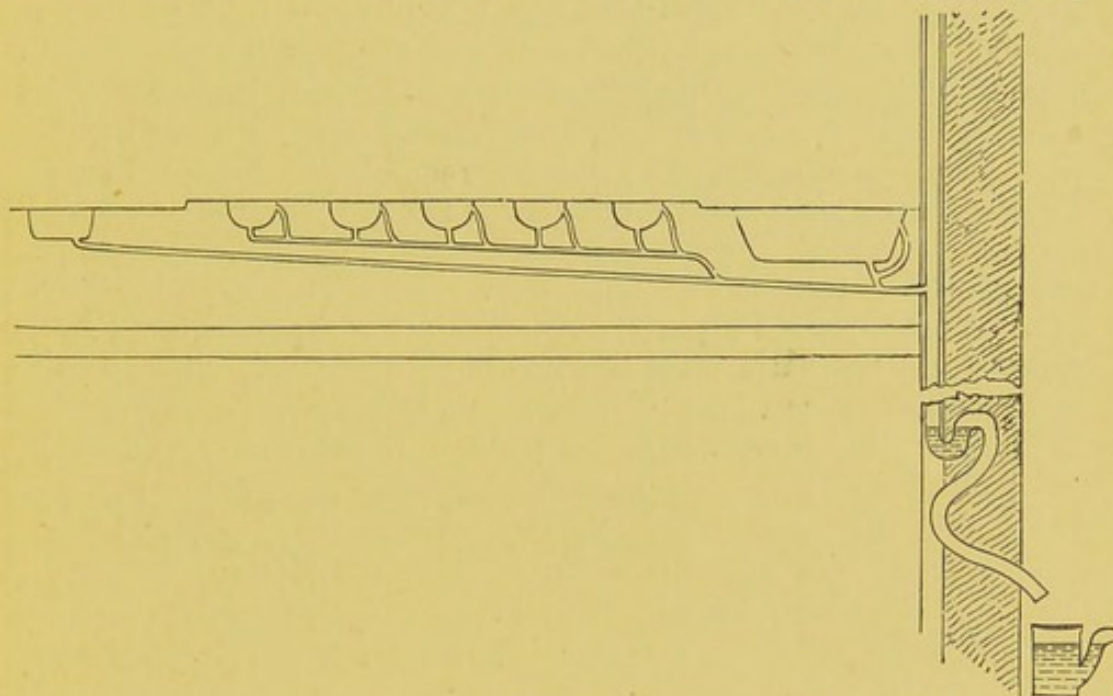
FIG. 42.

Fig. 42 represents a housemaid's sink, row of hand basins, and a bath, with waste pipes and overflow pipes discharging

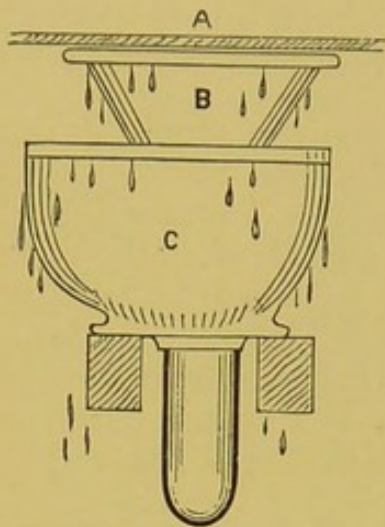
FIG. 46.

Fig. 46 represents an old pan closet as seen from the front. It was the only closet in a suburban villa rented at about £40. A nuisance was complained of, and on removing the wood which concealed the basin and container, both were found to be in a most filthy state, as well as the parts beneath. There was no

nected, &c.—but as unfortunately the local byelaws do not require safes to be placed beneath closets, a *saving* had been effected in this respect. This is not the only nuisance I have found due to this cause, but certainly the worst. In the cut, A is the seat, B the basin, and C the container.

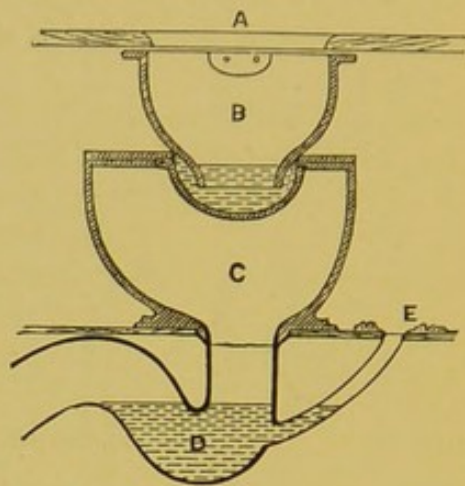
FIG. 47.

Fig. 47 shows a closet in which the lead tray just referred to was provided, but a nuisance had been caused through draining the tray into the closet trap. The surface of the safe around the drain was filthy, showing that foul matter had been pumped up from the trap each time the closet had been used. A is the

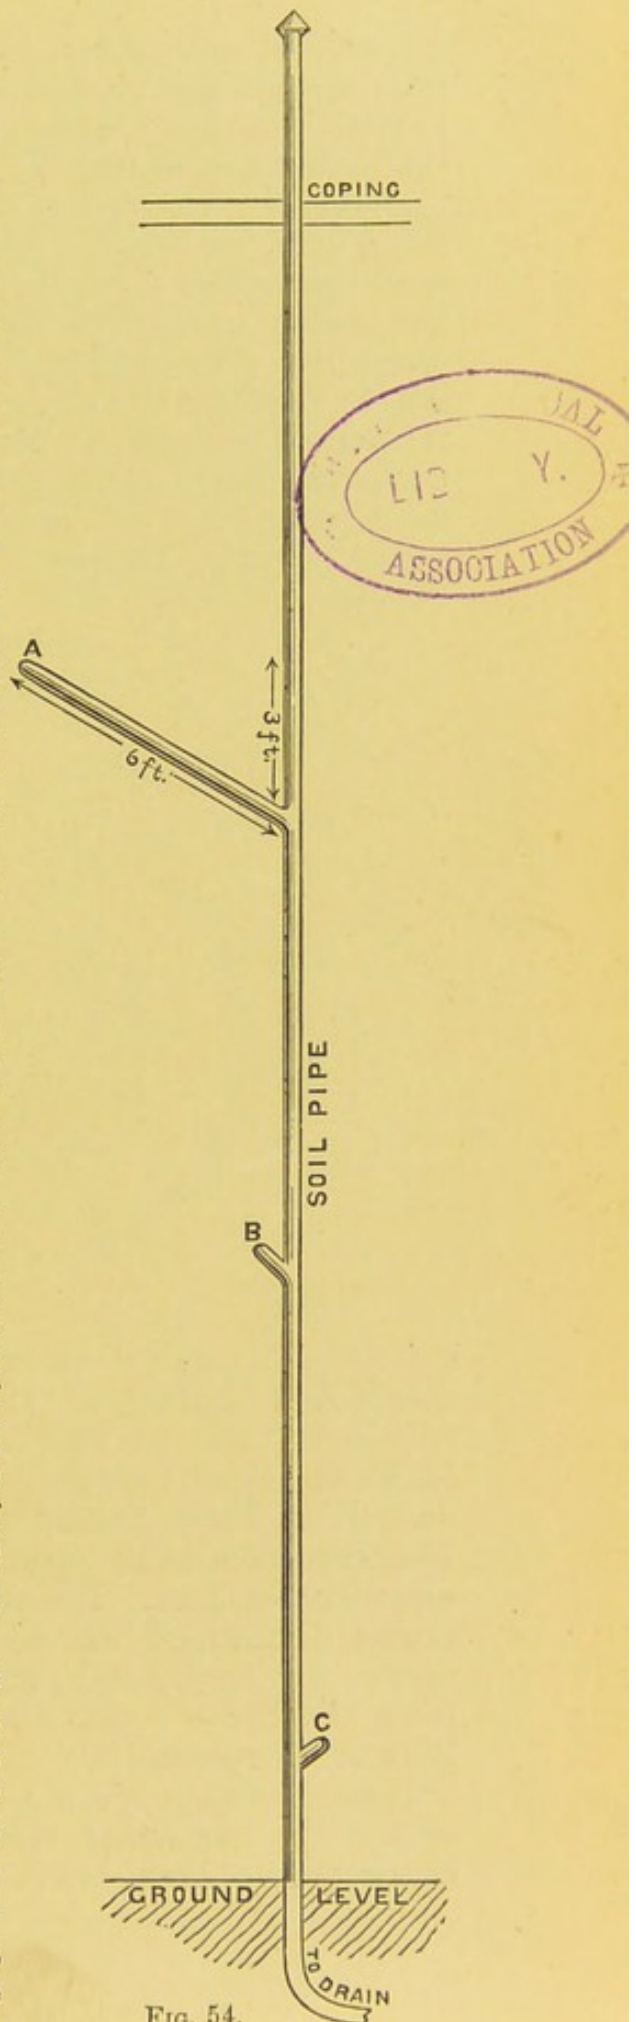
FIG. 54.

Fig. 54, with a description of the defect represented therein, was sent me by a correspondent. Complaint was received from a large boarding school, and my correspondent made a careful examination of the sanitary arrangements generally. On applying the smoke test it was found that smoke issued from the basin of the

watercloset at the top of the house, owing to the seal of the trap of this watercloset having been broken. How this had happened was not easy to discover. The trap was filled, and then the closet was flushed in the usual way. It was a powerful flush, but the water seal of the trap was only reduced from $1\frac{3}{4}$ in. to $1\frac{1}{2}$ in. Further inquiry, however, elicited the fact that the house slops (including water from sponge baths, &c.), amounting to about twelve pailfuls, were every morning emptied down the closet referred to, one pailful after another in quick succession. By way of experiment a pail of water was discharged into the basin of the closet quickly, and the normal depth of water in the trap was found to be reduced three-quarters of an inch. Another pail was discharged in like manner, and the depth of water in the trap was reduced half an inch more. A

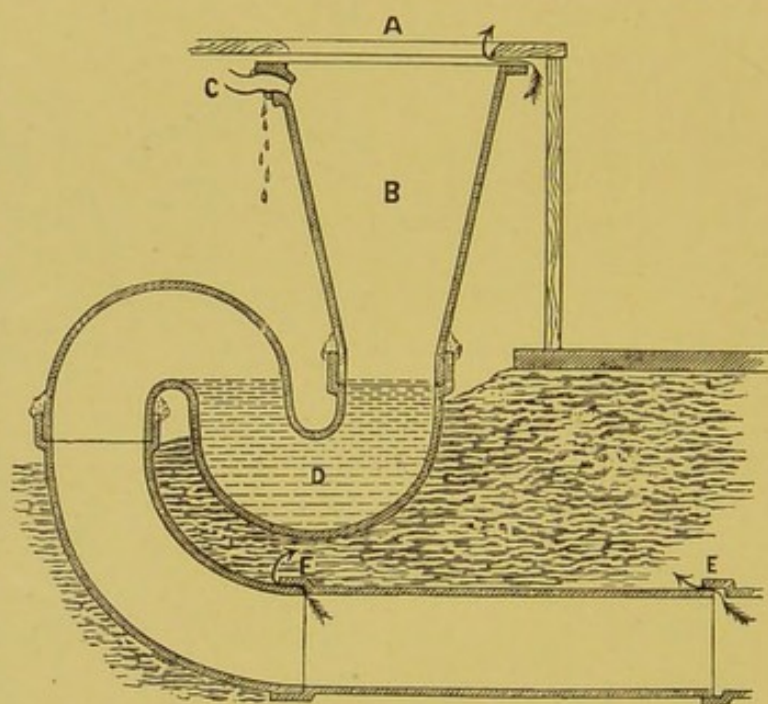
FIG. 55.

Fig. 55 shows in section a closet in the basement of a large semi-detached house in the suburbs. The closet was situated

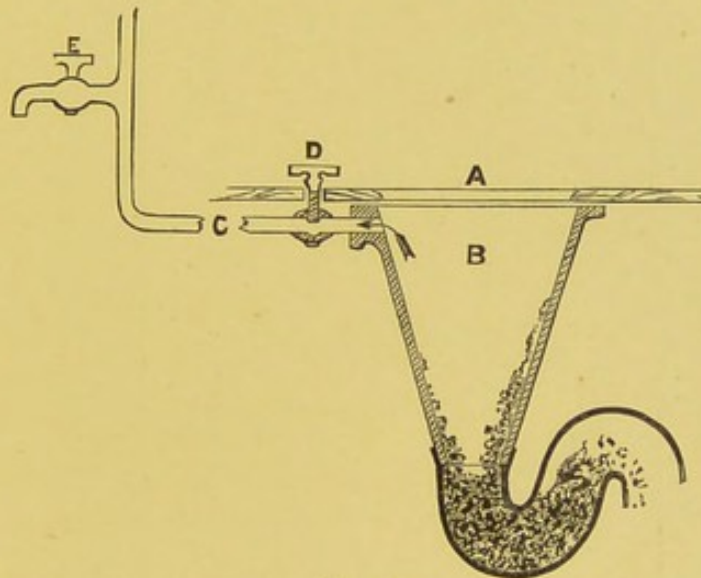
FIG. 56.

Fig. 56 is a section of a closet directly served from the main. A is the seat, B the basin, C the service pipe, D the screw-down tap on this pipe, and E the tap over the sink-stone, served from the same pipe. This arrangement was very common some years back, and though I have been long doing my utmost to get owners to provide closets with separate service cisterns, examples of the defect are brought to notice every month. When a single watercloset is flushed direct from the main the risk of fouling the town water (it may be with specific germs) is considerable, while

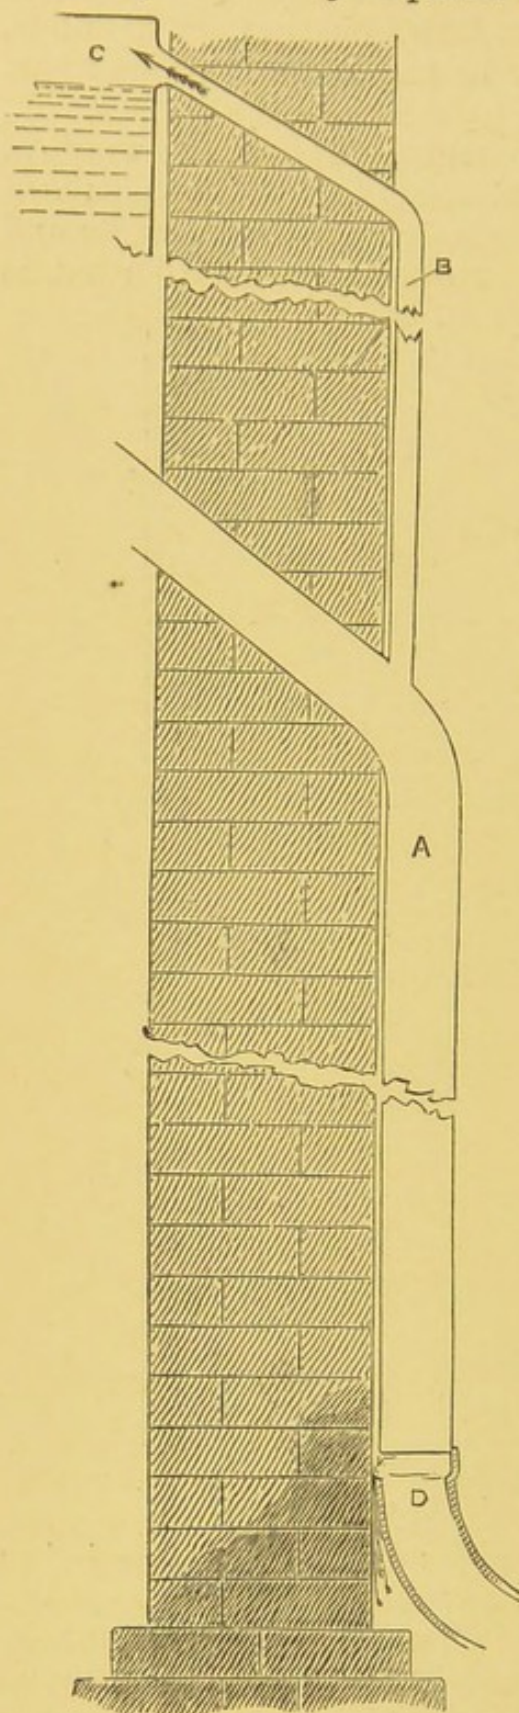
FIG. 69.

A correspondent sends me a sketch and description of a defect which he recently saw in an old house. (*Vide* Fig. 69.) Here is an unventilated soil pipe taken outside directly it leaves the watercloset, and as there is no proper connection between the soil pipe and house drain, filth is allowed to escape into the

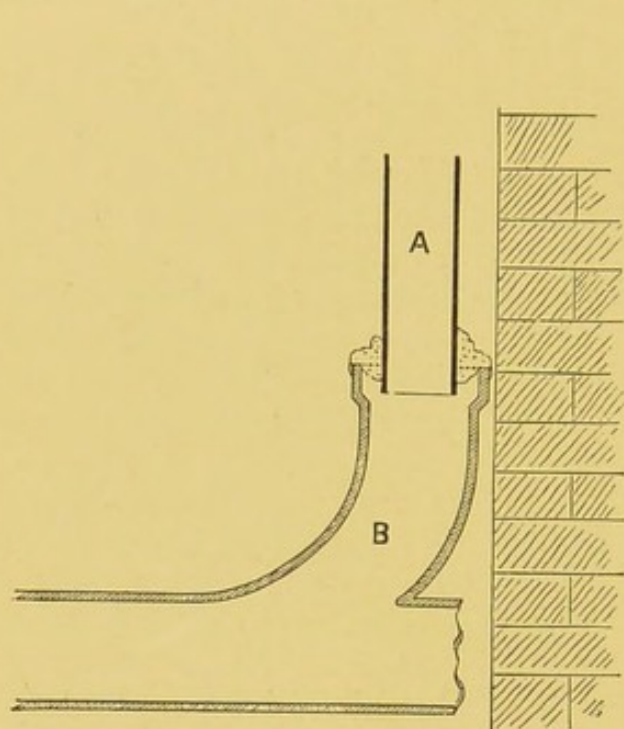
FIG. 71.

Fig. 71 represents a manner of connecting the soil pipe to the drain which I hope is exceptional in any town. To me it was certainly a new experience. Complaint was received of an effluvium nuisance in the front parlour of a small semi-detached villa, rented at about £20. On examination it was found that the soil pipe, which received also the bath waste, was carried into a 6in. earthenware junction pipe. The straight end of this pipe had been broken off in order to make it come close enough to the wall, and the broken end was *not stopped*. Of course, foul water penetrated through the wall just above the footings into the space beneath the parlour joists. A is the soil pipe and B the junction pipe.

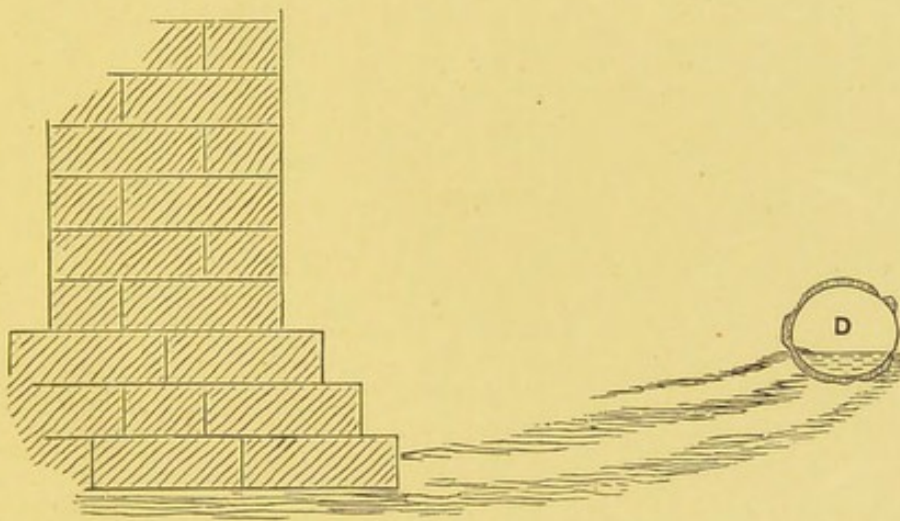
FIG. 76

Fig. 76 shows a defect in the drain of another suburban villa. Foul water was coming in through the wall and under the footings of the side of the house nearest the drain, and the drain was exposed and examined. Some of the 6in. glazed earthenware pipes D were found to be defective, the spigot ends having warped and got out of shape before being burnt, so that they would not slip into the flanges. Such pipes should, of course,

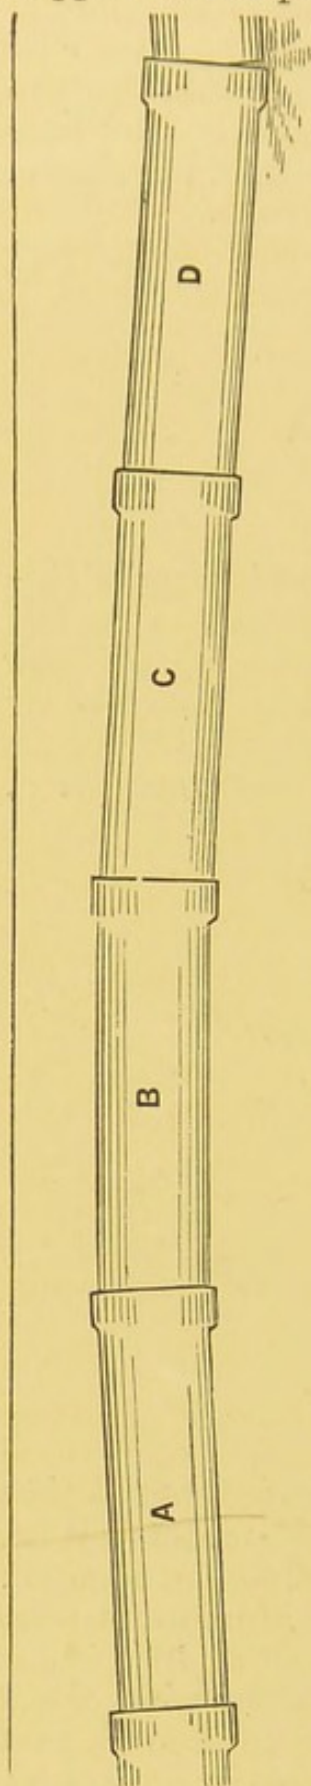
FIG. 77.

Fig. 77 shows a small portion in elevation. The horizontal line at the top indicates the level. Pipe A and the next to the left were about the fall intended, pipe B was dead level, pipes C and D were at different inclinations, the fall in both instances being the wrong way; beyond was a pipe with a slight inclination in the right direction. The joints were, almost without exception, imperfect, some allowing the contents to escape freely.

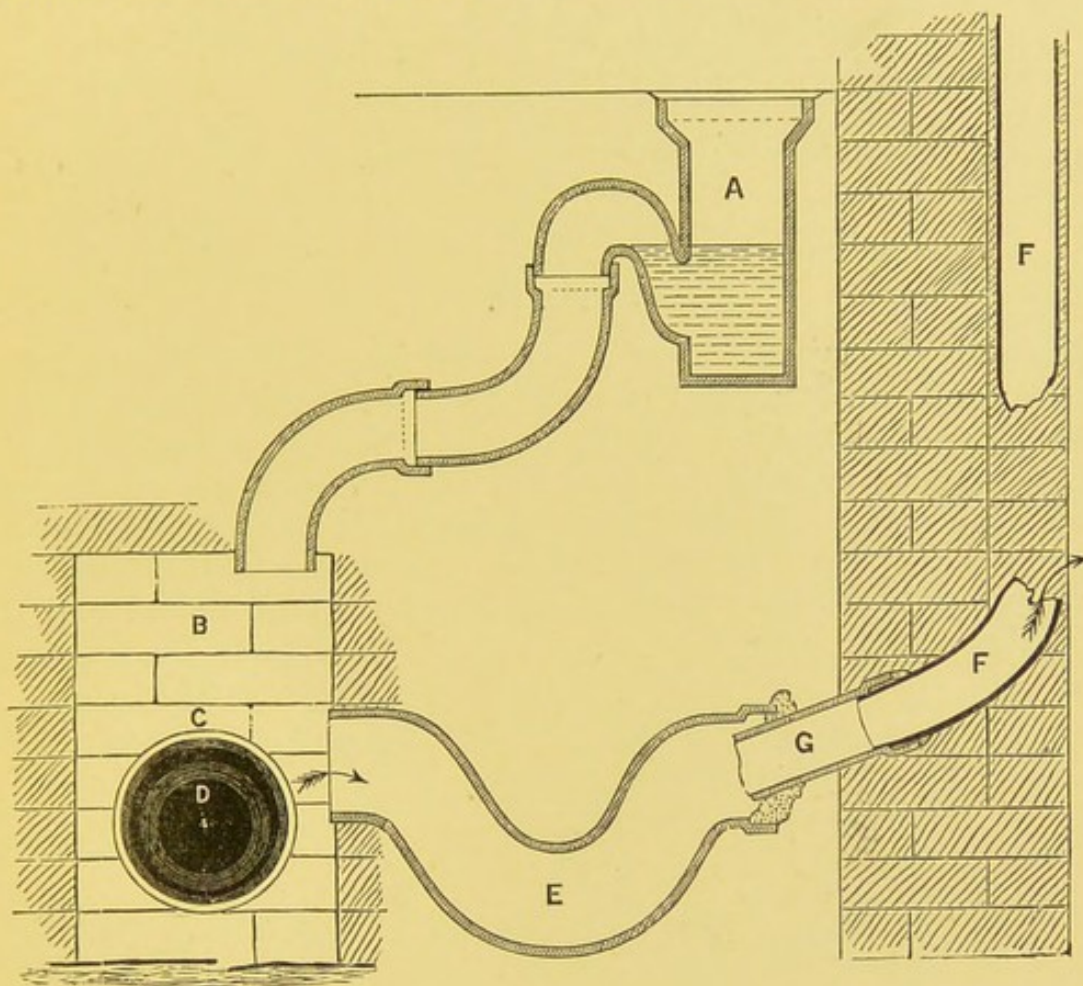
FIG. 80.

Fig. 80. A gully trap A, on which a waste pipe delivered, was brought into a cesspit B, loosely made with brick sides and a broken slate bottom; a 6in. earthenware pipe, as shown at E,

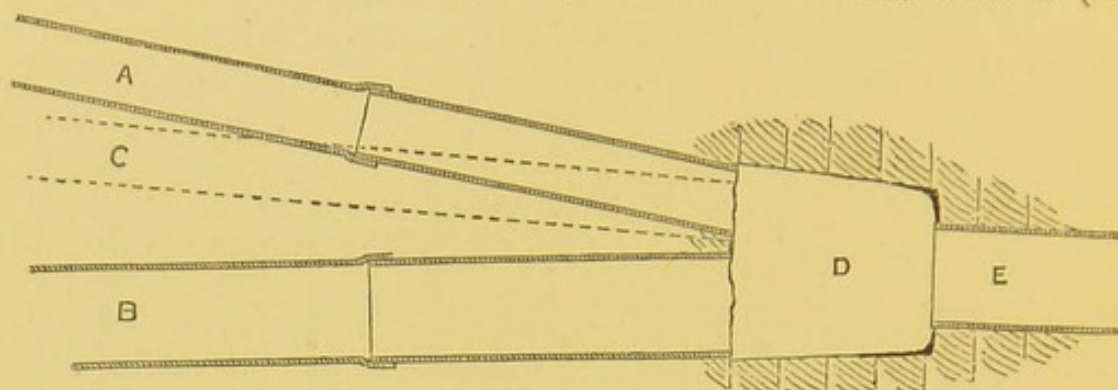
FIG. 81.

Fig. 81 represents defects in the drains in the basement of a large house I recently examined. A and B are glazed earthenware pipe drains, carrying slop water, and these, with C (an

old land drain just below A), are made to deliver into a small chamber D, and thence through the glazed earthenware pipe E. Drains should not be laid in the basement of a house, even if they only carry slop water. In this instance the joints were defective, and the flanged ends of the pipes all directed towards the outfall. However, the special defect to which attention is drawn by this illustration is connecting a land drain, roughly

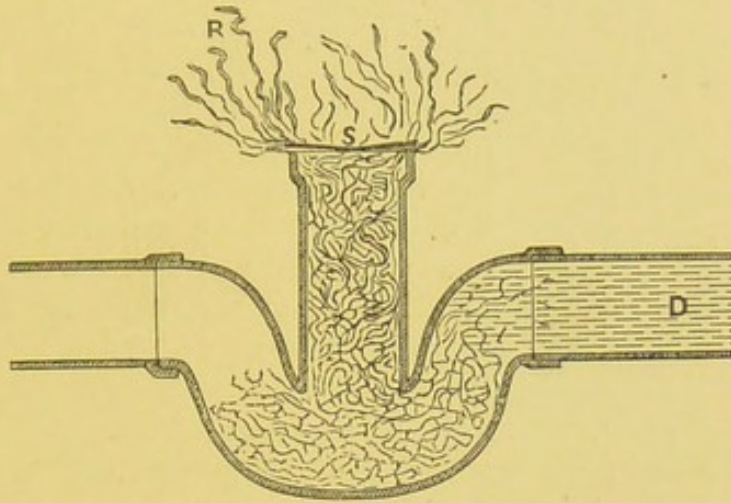
FIG. 83.

Fig. 83 represents the cause of a stoppage in a 6in. glazed earthenware pipe drain from a large house. The drain was laid

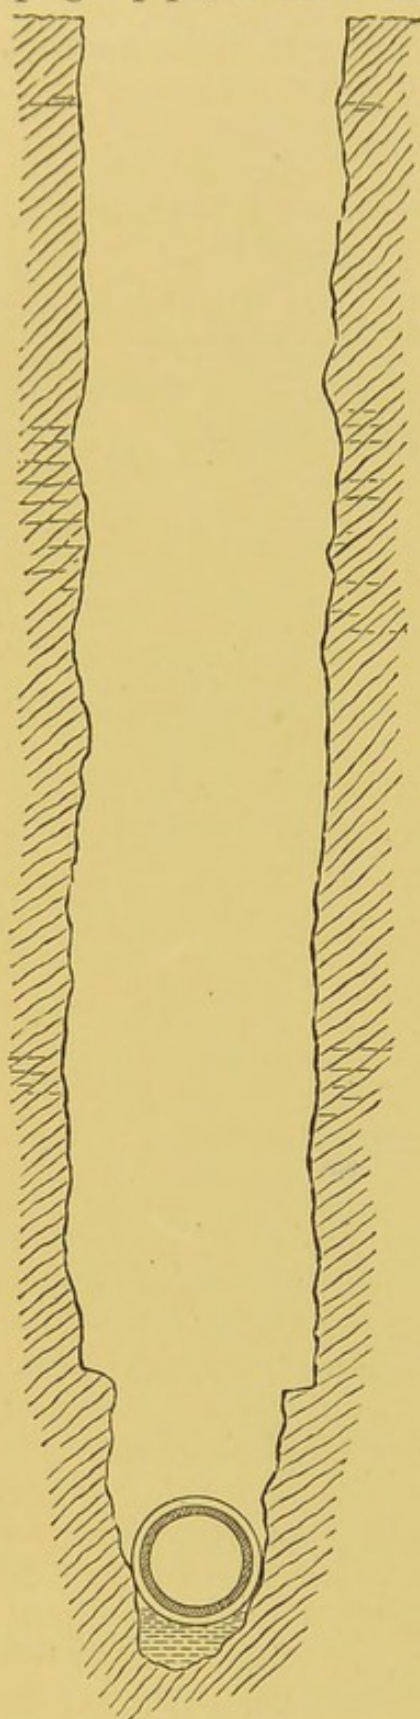
FIG. 86.

Fig. 86 indicates one of the causes of defective joints in drains. Defects were suspected in the drains of a good-class house built on the new red sandstone, and set back a little from the road. The main drain was exposed. It extended from the rear of the premises to the sewer, a distance of 75 feet, and was at the bottom of a very narrow cutting, as in the figure. It was a 6in. earthenware pipe drain; and considering the width of the cutting
