Defects in plumbing & drainage work... Illustrated by upwards of a hundred woodcuts. / described by Francis Vacher.

London : John Heywood, 1889.

Defects in Plumbing and Drainage Work

described by **Francis Vacher**
upwards of 100 illustrations

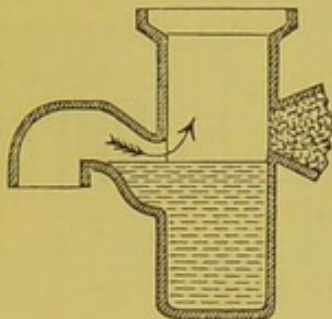
FIG. 13.

Fig. 13 is a section of another trap my attention was called to. It was fixed in the rear of a house bearing a rental of about £65, and was properly connected to the drain, and certain waste pipes delivering on it kept it well charged with water. However, on examining it, the trap was found to be a delusion, the water standing one inch too low to form a seal. Of course the gases and effluvia in the drains were thus brought close up to the dwelling-house, and delivered immediately under the scullery windows, &c. It may be said that as the workman

had set the trap quite square, and made good connections, he was not to blame. This is to take a very low view of a workman's duties. The primary defect was certainly in the casting, but surely no intelligent workman does his duty who fixes a trap without first testing it.

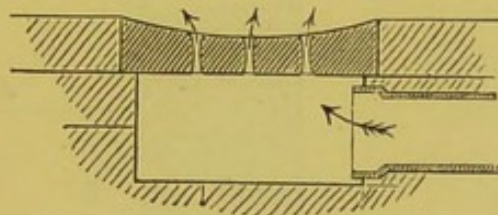
FIG. 15.

Fig. 15 shows another form of opening into a yard drain. The drain was of 4in. earthenware pipes, as in the last case, but

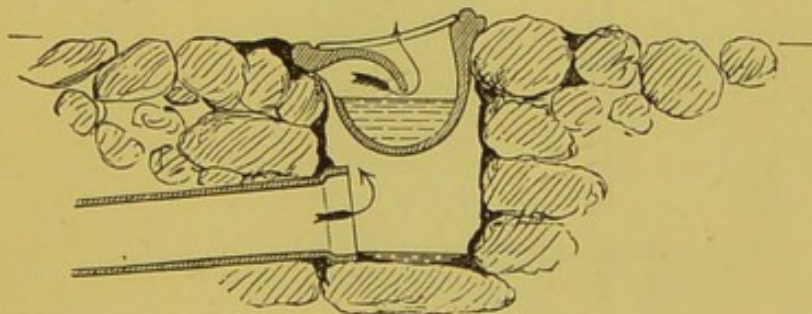
FIG. 16.

A defect less frequently met with is illustrated in Fig. 16. This trap, like all small D traps, holds too little trapping water to be secure, even had it been properly set. However, the workman who fixed it had done his work so negligently that, owing to uneven setting, the water seal was completely broken.

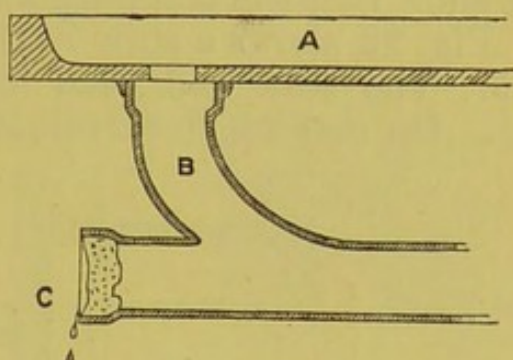
FIG. 22.

Fig. 22 shows a sink in the basement of a house rented at £45. The sink had been fitted with a bell trap, but this was lost. On making an examination beneath the stone it was found

that the sink waste was a 4in. earthenware junction pipe. A is the sink, B the pipe, and C the end which was imperfectly stopped, and through this stopping the foul water was leaking on the floor.

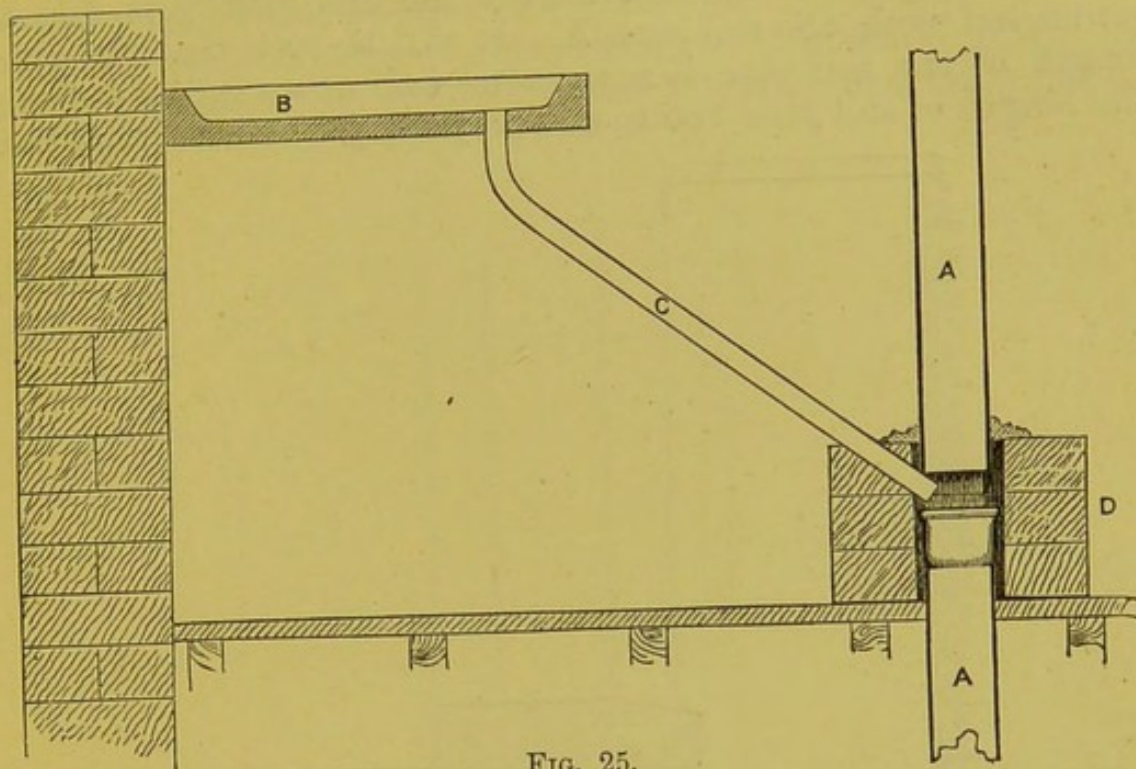
FIG. 25.

Fig. 25 represents an instance of badly-planned and badly-executed work. The defects will be obvious at a glance. A is an iron soil pipe from the closet above, running through the centre of the house to the drain in basement; B is a sink situated on an upstairs landing; and C is the sink waste pipe directly connected with the soil pipe A. It will be seen that the upper length of the soil pipe is not placed well down in the socket of the length of soil pipe below, and properly jointed, but that there

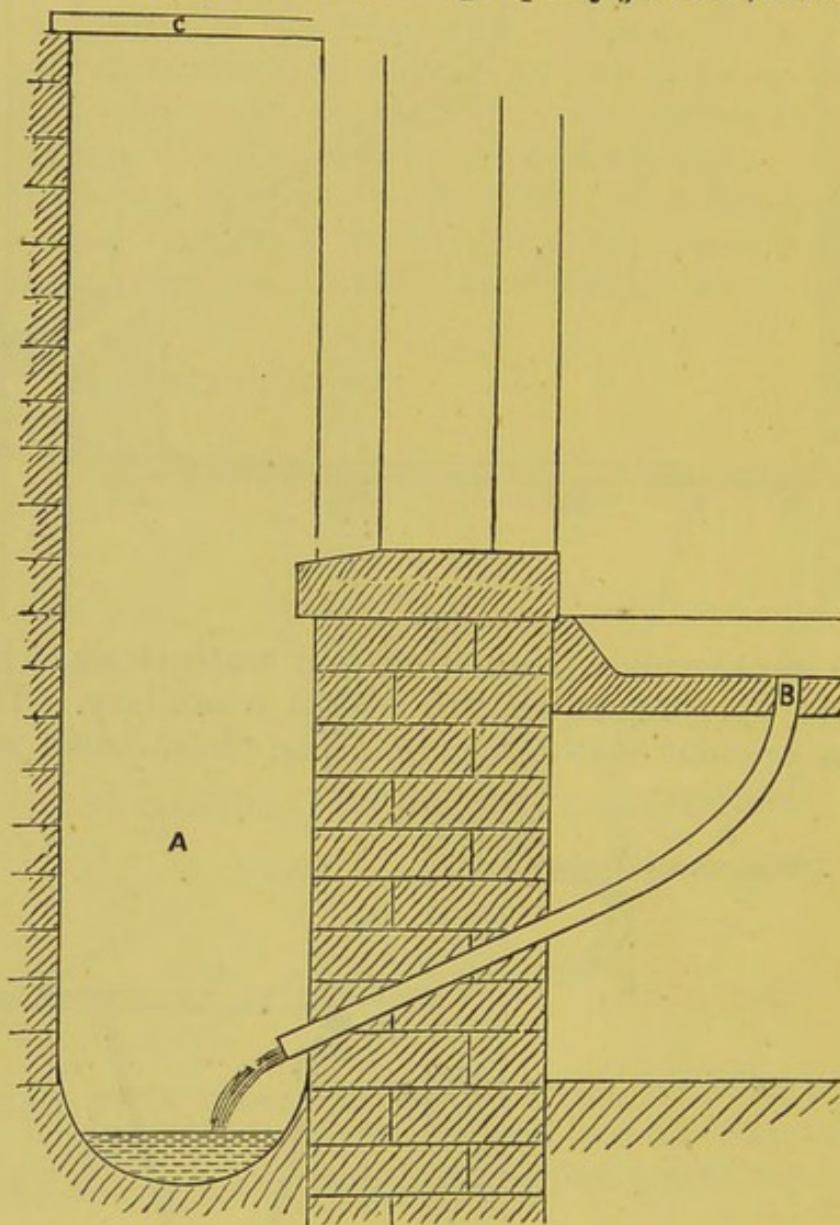
FIG. 27.

Fig. 27 shows a sink in the basement drained into an air drain. The house in which I noticed this defect was a hand-

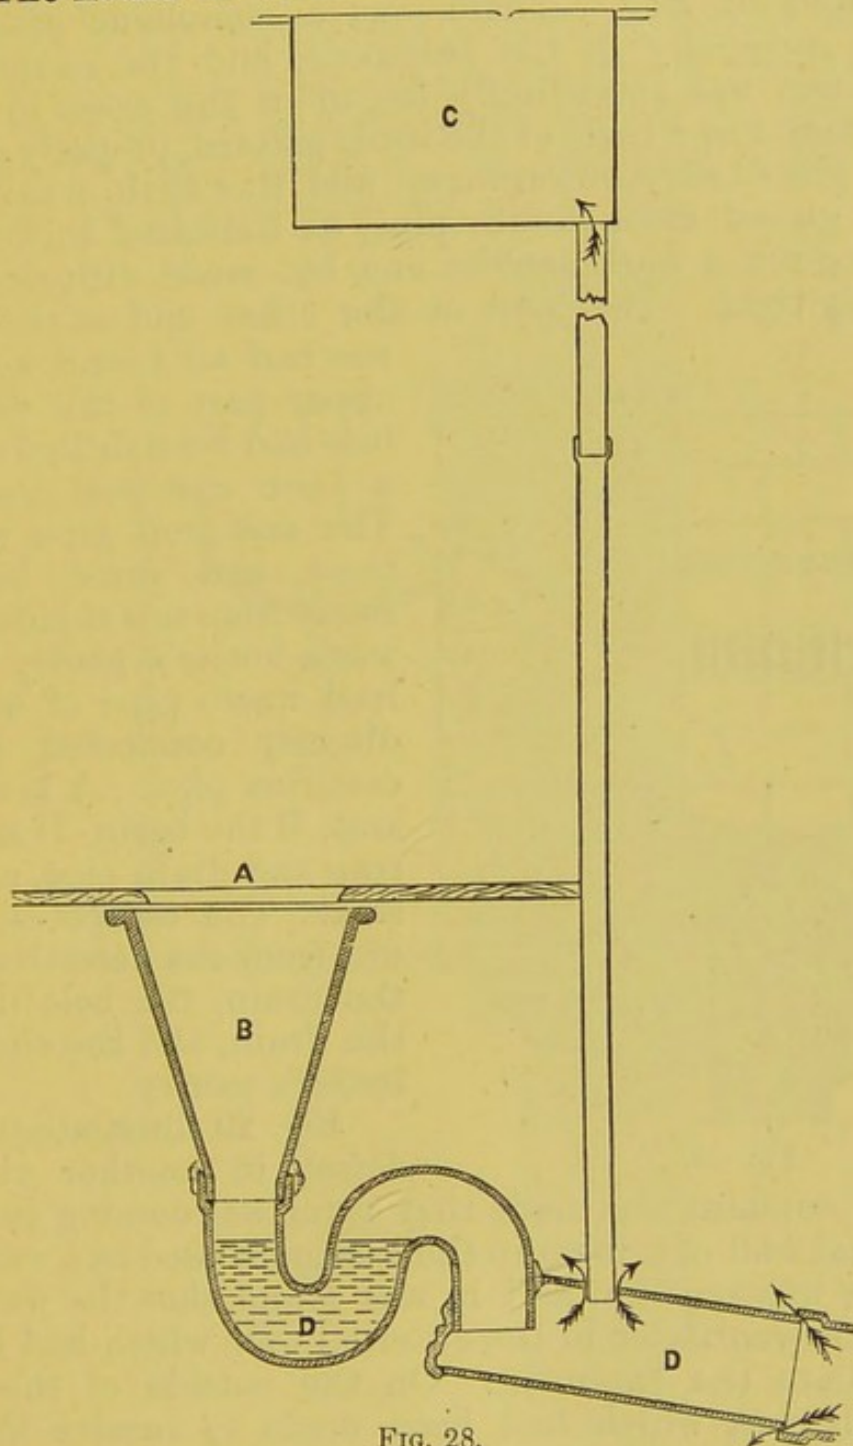
FIG. 28.

Fig. 28 shows what was discovered at a smaller suburban villa rented at £40. There was a complaint of effluvium nuisance, especially in the basement, and the examination of the premises was accordingly begun in the closet in the basement. Here was a basin of the usual pattern, properly connected to a 4in. glazed earthenware trap, and this again was connected to a 6in. glazed earthenware pipe, as indicated in the cut, the joint being not a workmanlike one, but made with cement, and apparently tight. The joint at the other end of the 6in. pipe

was bad all round, and in the upper part of this 6in. pipe a hole had been drilled to receive a 1½in. cast-iron waste pipe. The cast-iron pipe was quite loose, and could be moved freely from side to side. Above was a butler's pantry sink, the lead waste pipe of which was directly connected with the cast-iron pipe. A is the closet seat, B the basin, D and D the trap and drain pipe, and C the sink. The escape of foul air was from the defective joint in the drain, the hole drilled in the drain, and the sink in the butler's pantry.

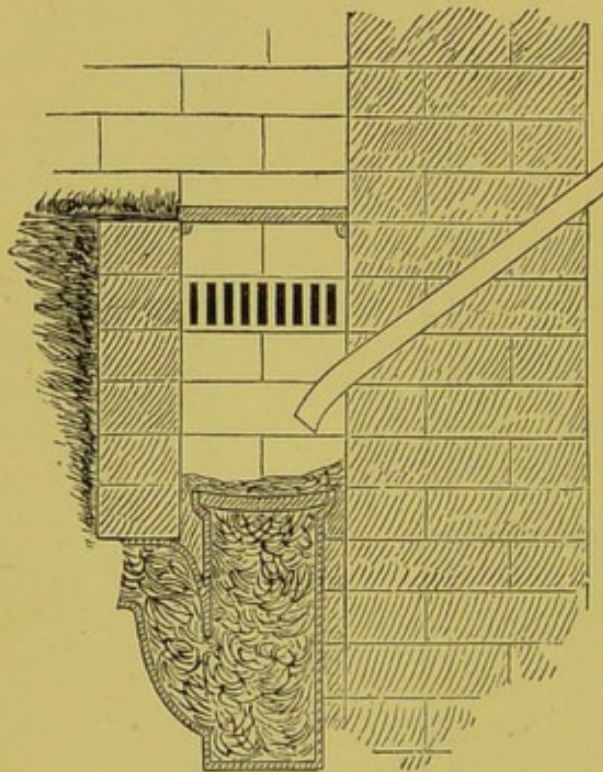
FIG. 29.

Fig. 29 illustrates a curious defect in another villa resi-

dence. Complaint was made that water was coming in through the external wall of a room in the basement used as a washhouse. A plumber was sent for, and it was found that the water came from an iron ventilator in the external wall, which had been put in to ventilate the basement. On the outside of the grating was a small area which had been made to receive the gulley trap on which the sink waste pipe delivered. As this area was covered by an iron grating, no attempt to cleanse it, or the trap it contained, had been made for a long time. The result was that the trap got filled to the brim with fat and other offensive matter; and then the foul water discharged by the sink waste pipe filled the area till it reached the level of the ventilator, and overflowed into the house.

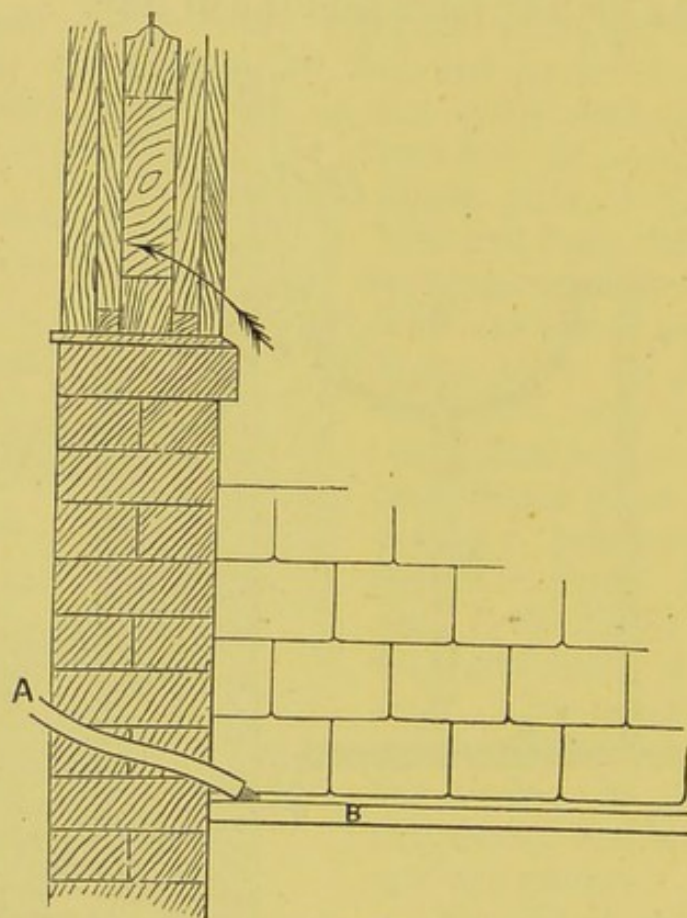
FIG. 31.

Fig. 31 shows a comparatively common defect. It is from a large building used as a hospital. A is a waste pipe from two hand-basins, discharging on a roof gutter B. The foul water from A runs along the open gutter for five feet before it reaches a downspout. Two feet above this gutter, which is ordinarily in a very foul state, is a window. Of course the proper practice

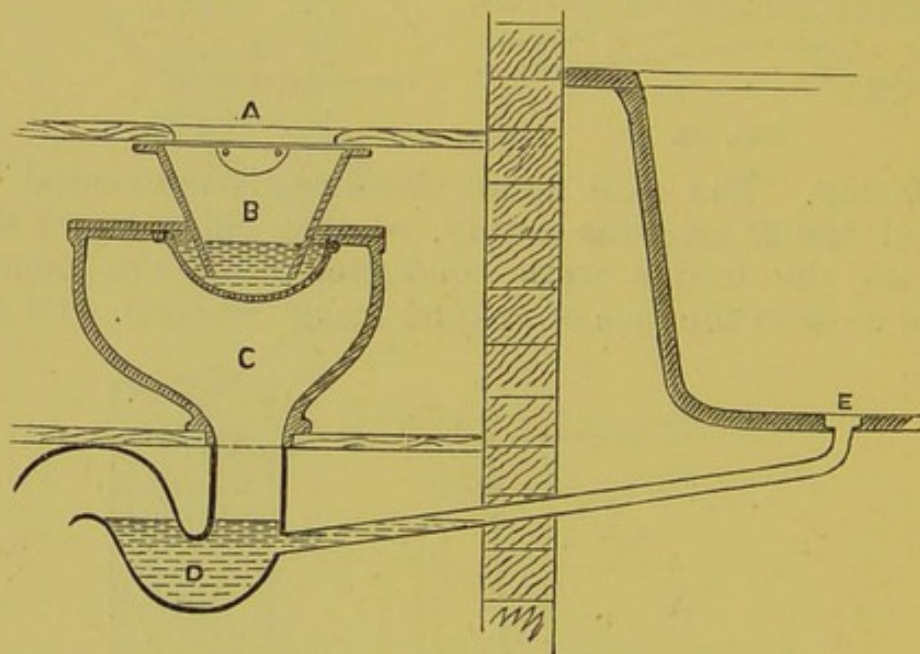
FIG. 35.

Fig. 35 is a section of a closet, showing also a portion of a bath in an adjoining room. As will be seen, the bath waste is taken into the closet trap. There was a complaint of an effluvium from the bath waste, and when the closet was used there were puffs of foul air from the waste pipe. In the cut A is the closet seat, B the basin, C the container, D the trap, and E the pipe wrongly brought into the trap.

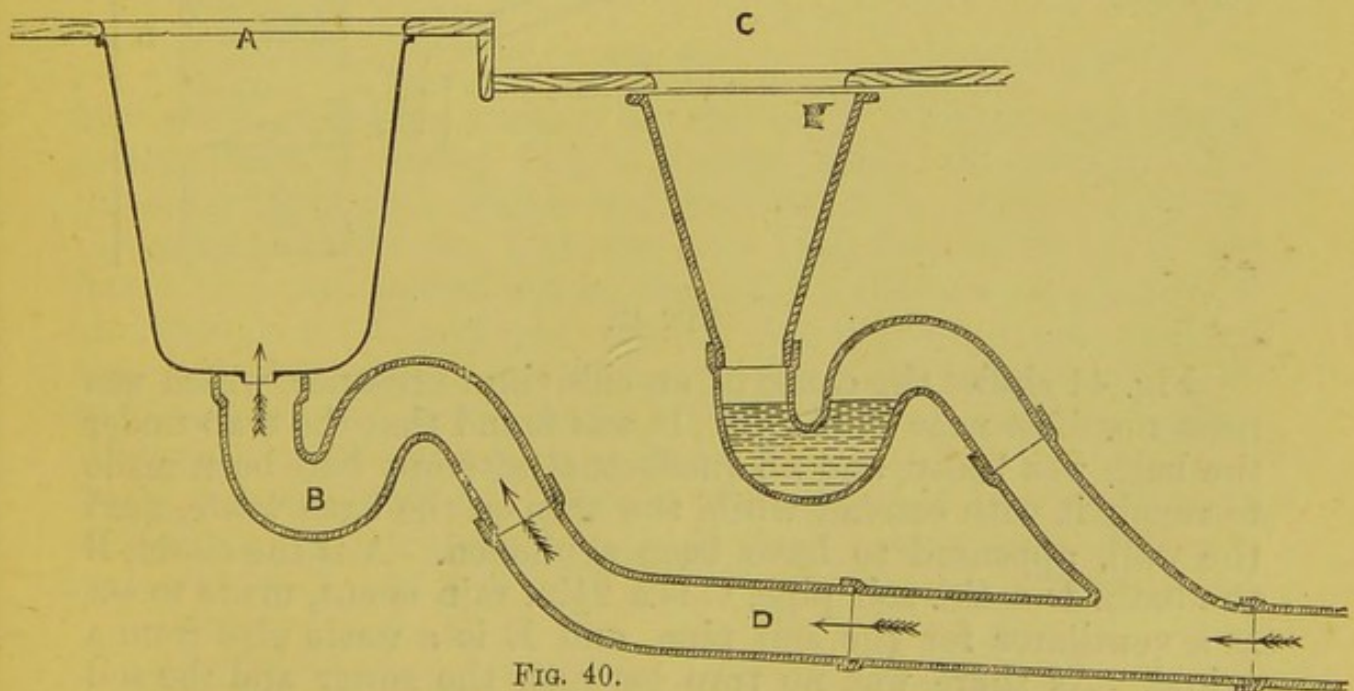
FIG. 40.

Fig. 40 shows in section a bath and closet situated in a small outbuilding erected as a "lean-to" in the rear of a dwelling-

house. There was no other bath or closet in the house, and complaint was made of a very great effluvium nuisance in the outbuilding. The nuisance was verified, and its cause was soon apparent. I found the bath full of lumber, and the taps

designed for the hot and cold supply twisted and immovable. The tenant said the bath had never been used. Of course, the 4in. earthenware pipe trap beneath was dry; and although the closet trap was acting, there was nothing to prevent the drain gases and effluvia having access to the room. A represents the bath, B the trap to the same, C the closet, and D the drain. In designing the house it was a mistake to put the bath in an outhouse, access to which could only be obtained by crossing a yard. Such a bath would almost certainly be neglected. However, it would have been quite easy to have made the bath waste deliver on the gully in the yard, and then, whether the bath were used or not, no nuisance could have arisen.

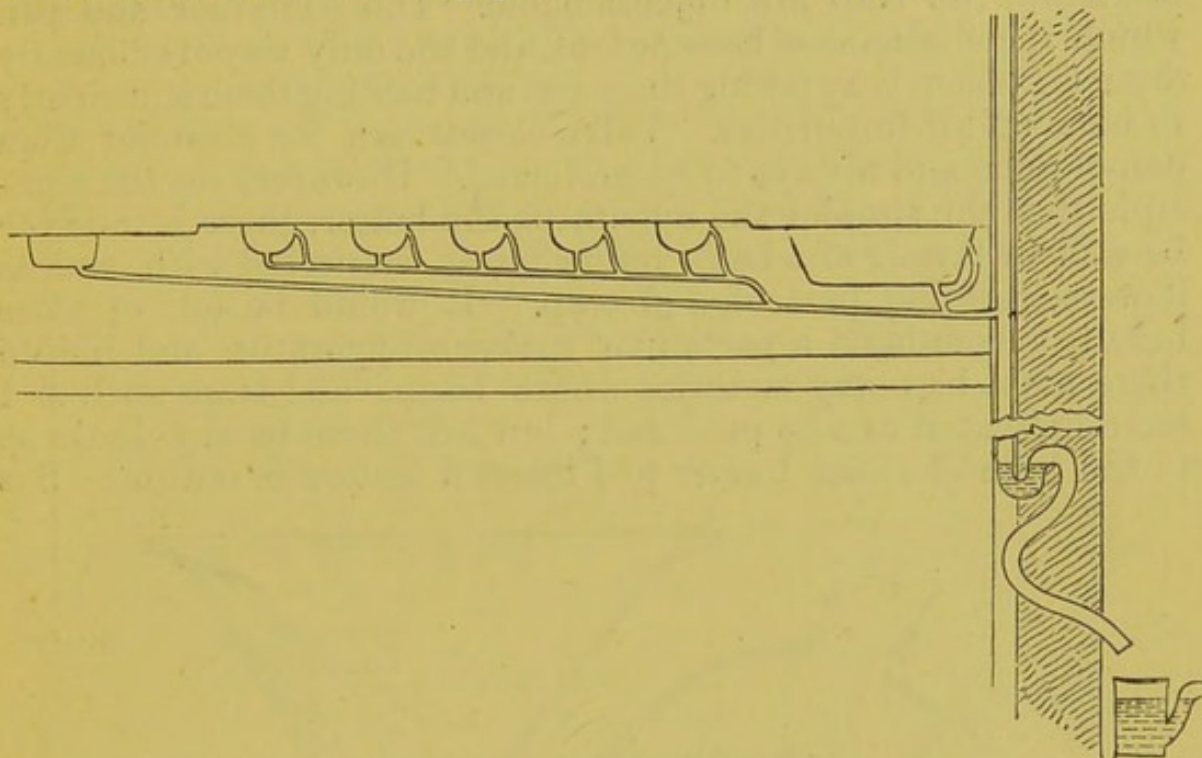
FIG. 42.

Fig. 42 represents a housemaid's sink, row of hand basins, and a bath, with waste pipes and overflow pipes discharging

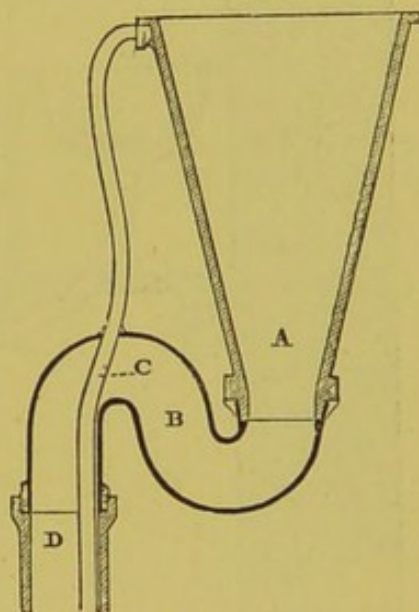
FIG. 43.

Fig. 43 shows the arrangement. A represents the basin, B the lead trap, C the lead service pipe, and D the earthenware soil pipe. Where the service pipe came through the trap it was carefully soldered round, but where it entered the earthenware

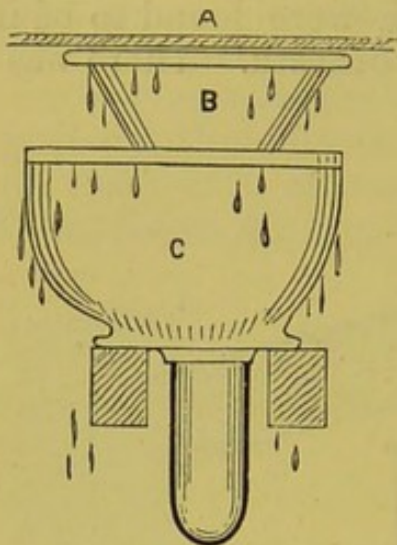
FIG. 46.

Fig. 46 represents an old pan closet as seen from the front. It was the only closet in a suburban villa rented at about £40. A nuisance was complained of, and on removing the wood which concealed the basin and container, both were found to be in a most filthy state, as well as the parts beneath. There was no

nected, &c.—but as unfortunately the local byelaws do not require safes to be placed beneath closets, a *saving* had been effected in this respect. This is not the only nuisance I have found due to this cause, but certainly the worst. In the cut, A is the seat, B the basin, and C the container.

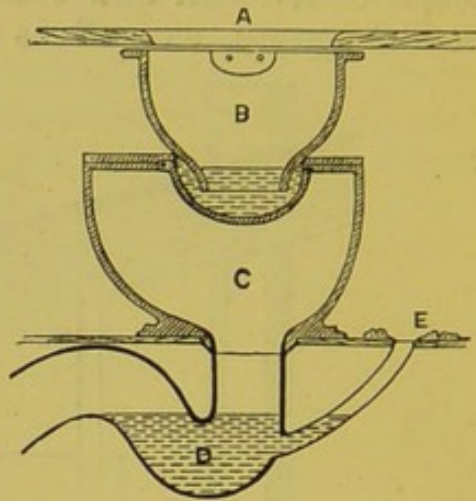
FIG. 47.

Fig. 47 shows a closet in which the lead tray just referred to was provided, but a nuisance had been caused through draining the tray into the closet trap. The surface of the safe around the drain was filthy, showing that foul matter had been pumped up from the trap each time the closet had been used. A is the

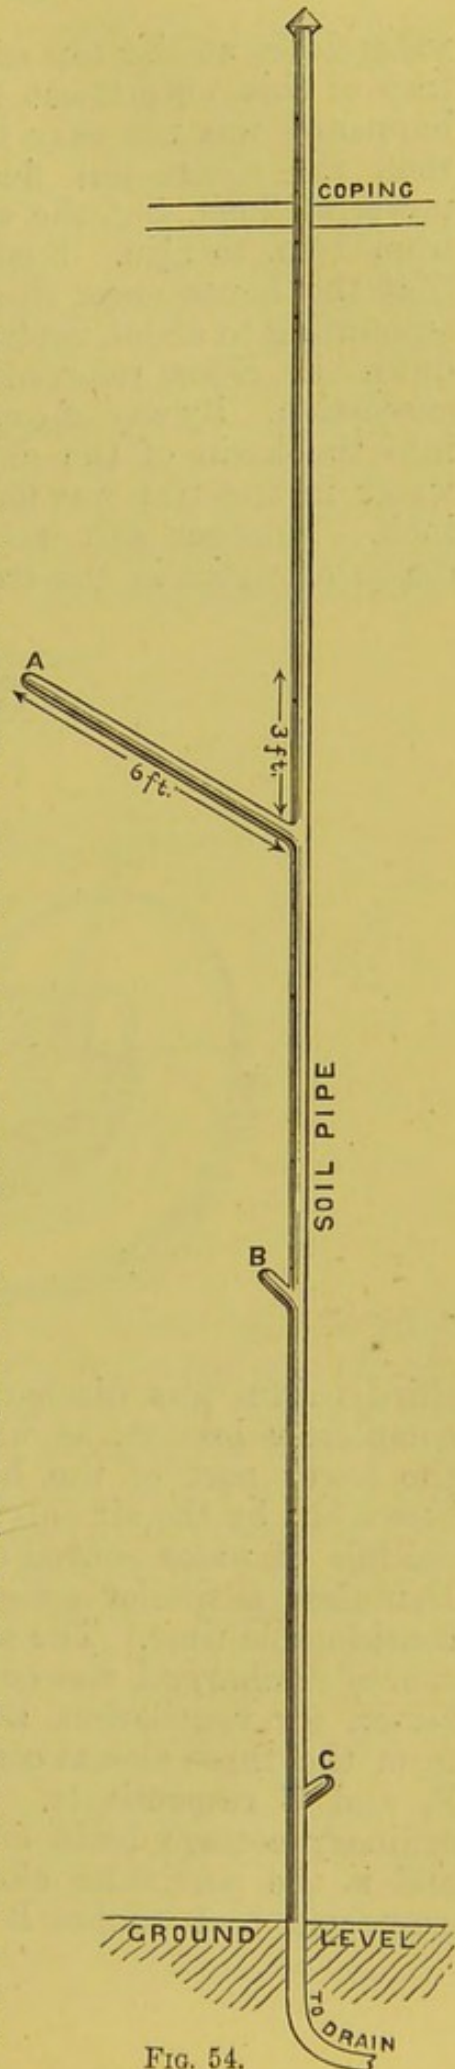
FIG. 54.

Fig. 54, with a description of the defect represented therein, was sent me by a correspondent. Complaint was received from a large boarding school, and my correspondent made a careful examination of the sanitary arrangements generally. On applying the smoke test it was found that smoke issued from the basin of the

watercloset at the top of the house, owing to the seal of the trap of this watercloset having been broken. How this had happened was not easy to discover. The trap was filled, and then the closet was flushed in the usual way. It was a powerful flush, but the water seal of the trap was only reduced from $1\frac{3}{4}$ in. to $1\frac{1}{2}$ in. Further inquiry, however, elicited the fact that the house slops (including water from sponge baths, &c.), amounting to about twelve pailfuls, were every morning emptied down the closet referred to, one pailful after another in quick succession. By way of experiment a pail of water was discharged into the basin of the closet quickly, and the normal depth of water in the trap was found to be reduced three-quarters of an inch. Another pail was discharged in like manner, and the depth of water in the trap was reduced half an inch more. A

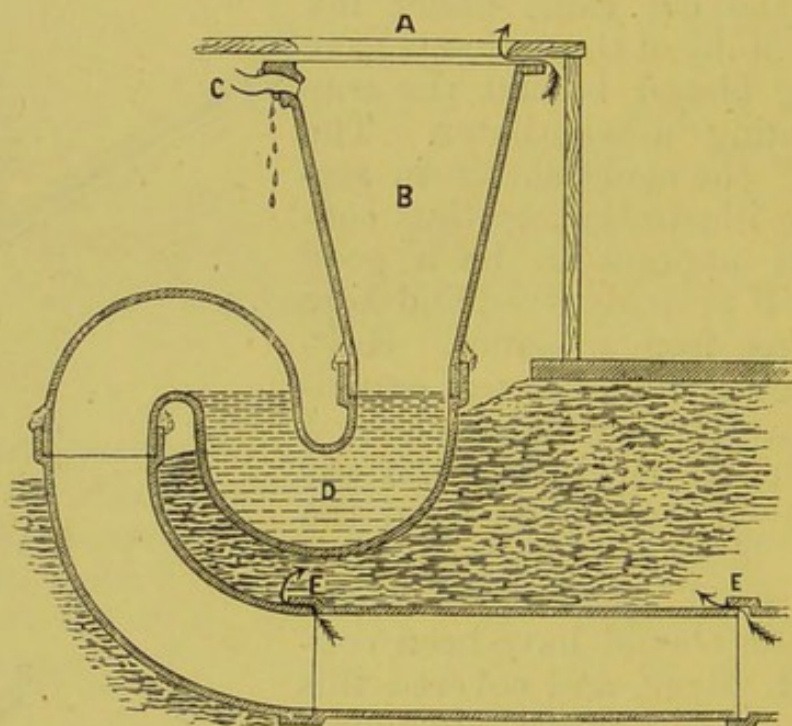
FIG. 55.

Fig. 55 shows in section a closet in the basement of a large semi-detached house in the suburbs. The closet was situated

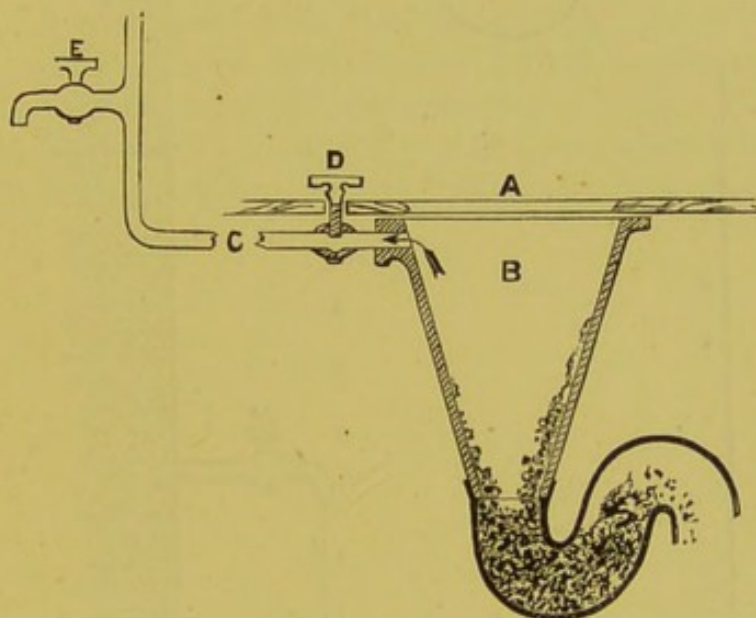
FIG. 56.

Fig. 56 is a section of a closet directly served from the main. A is the seat, B the basin, C the service pipe, D the screw-down tap on this pipe, and E the tap over the sink-stone, served from the same pipe. This arrangement was very common some years back, and though I have been long doing my utmost to get owners to provide closets with separate service cisterns, examples of the defect are brought to notice every month. When a single watercloset is flushed direct from the main the risk of fouling the town water (it may be with specific germs) is considerable, while

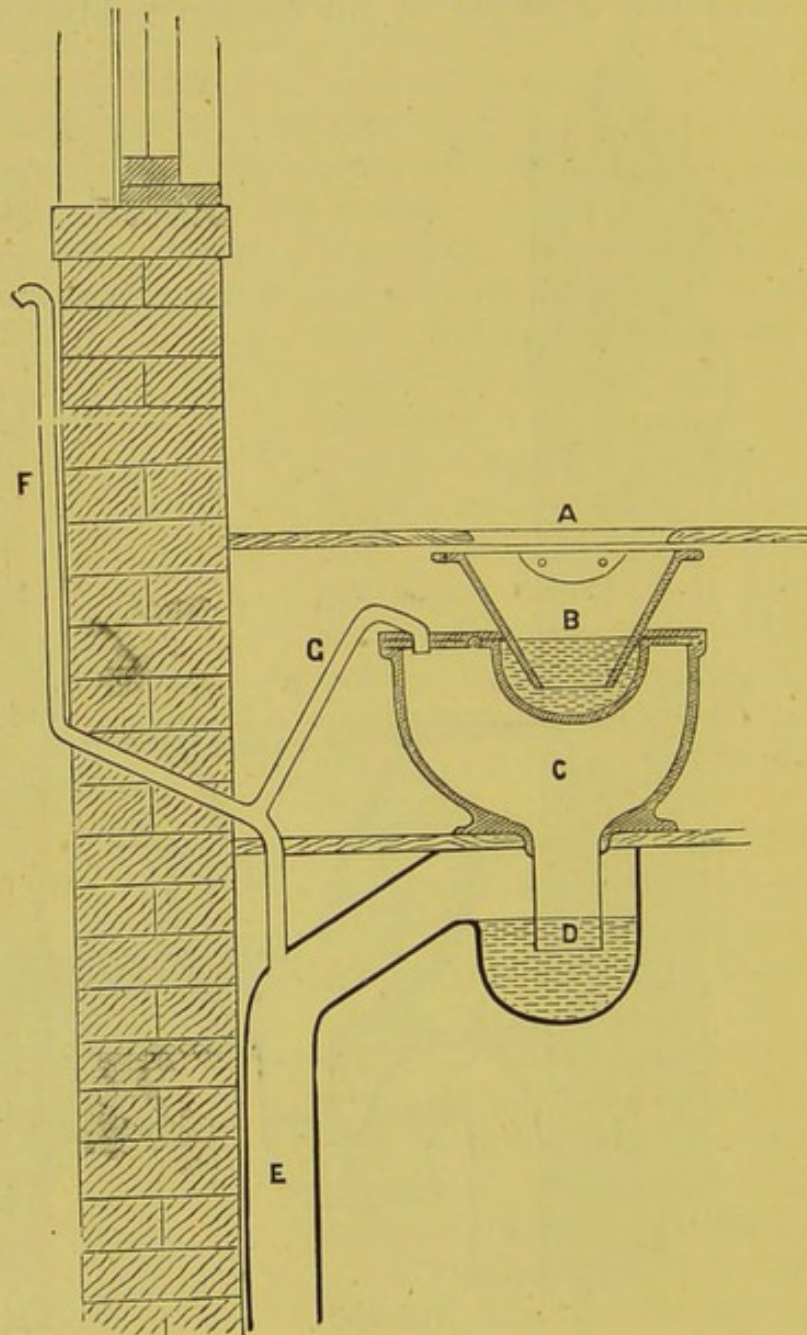
FIG. 60.

Fig. 60 explains itself. It gives a section of the closet fittings found in a large ecclesiastical residence, where what were alleged

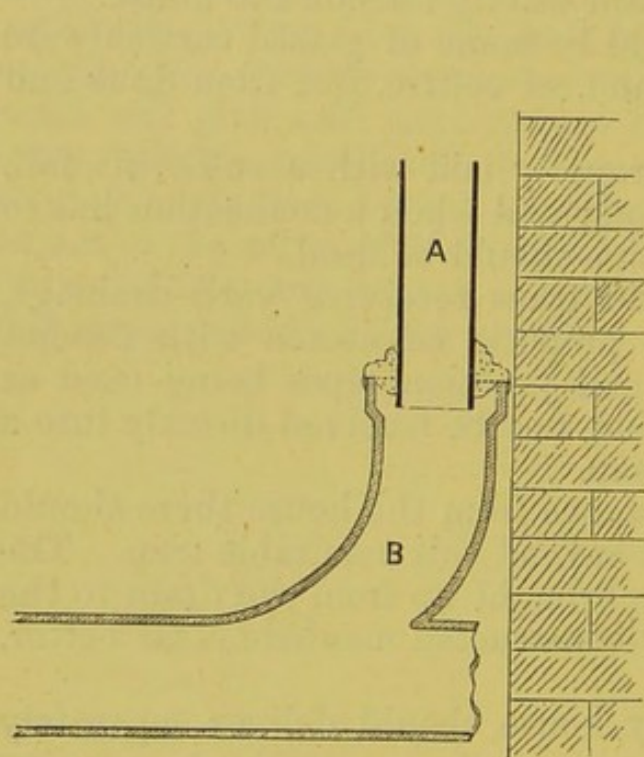
FIG. 71.

Fig. 71 represents a manner of connecting the soil pipe to the drain which I hope is exceptional in any town. To me it was certainly a new experience. Complaint was received of an effluvium nuisance in the front parlour of a small semi-detached villa, rented at about £20. On examination it was found that the soil pipe, which received also the bath waste, was carried into a 6in. earthenware junction pipe. The straight end of this pipe had been broken off in order to make it come close enough to the wall, and the broken end was *not stopped*. Of course, foul water penetrated through the wall just above the footings into the space beneath the parlour joists. A is the soil pipe and B the junction pipe.

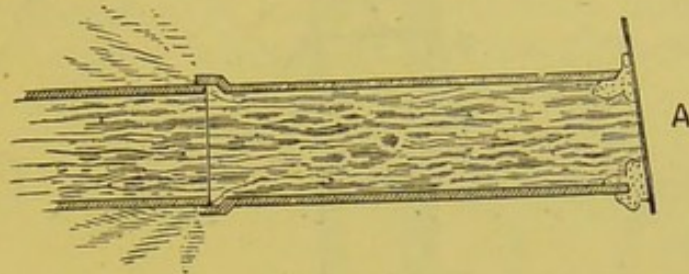
FIG. 75.

Fig. 75 illustrates the cause of a nuisance in a suburban villa. On inspection it was found that the 6 in. drain from the closet came to an abrupt termination close to the garden wall dividing this property from the next. The end of it had been deliberately closed up as shown at A, and the drain was full and leaking at some of the joints. A reference showed that two villas were built at the same time, and were allowed to drain together to the same sewer in front. Subsequently the villa in which the nuisance occurred was sold, and the other remained the property of the builder. It seems probable that about the date of the sale the vendor must have severed the drain from the villa he was selling, and reserved the drain running down his garden for the exclusive use of his own villa. A similar case was brought under my attention some time since. A drain serving two adjoining houses became frequently choked, and the tenants quarrelled about the payment of the charges made for cleansing it. Eventually the tenant of the garden in which the drain was situated cut off his neighbour's drain. Here, however, the disconnection was done openly and avowedly, and no attempt was made to close the end of the pipe, so that the resulting nuisance was manifest, and a separate drain was provided without delay.

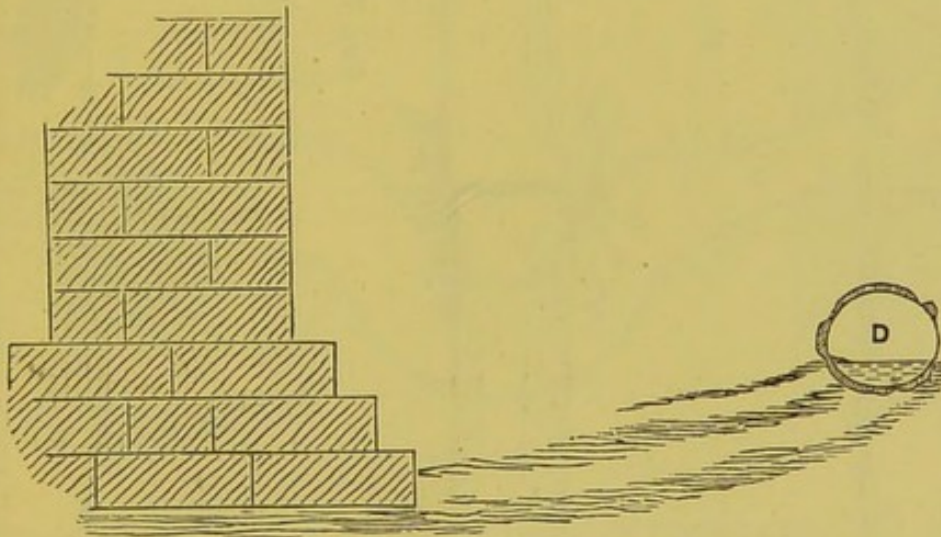
FIG. 76

Fig. 76 shows a defect in the drain of another suburban villa. Foul water was coming in through the wall and under the footings of the side of the house nearest the drain, and the drain was exposed and examined. Some of the 6in. glazed earthenware pipes D were found to be defective, the spigot ends having warped and got out of shape before being burnt, so that they would not slip into the flanges. Such pipes should, of course,

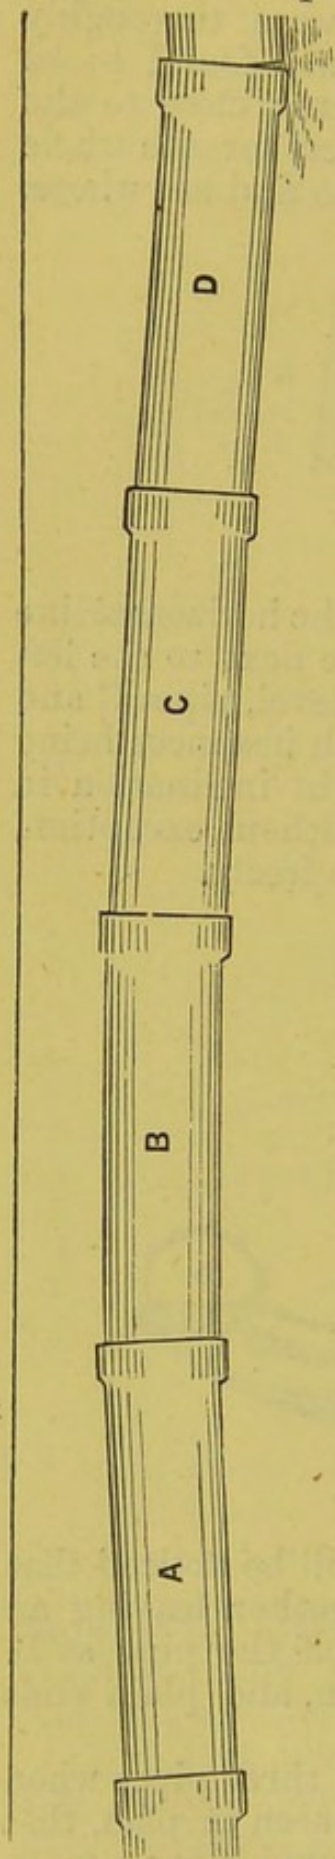
FIG. 77.

Fig. 77 shows a small portion in elevation. The horizontal line at the top indicates the level. Pipe A and the next to the left were about the fall intended, pipe B was dead level, pipes C and D were at different inclinations, the fall in both instances being the wrong way; beyond was a pipe with a slight inclination in the right direction. The joints were, almost without exception, imperfect, some allowing the contents to escape freely.

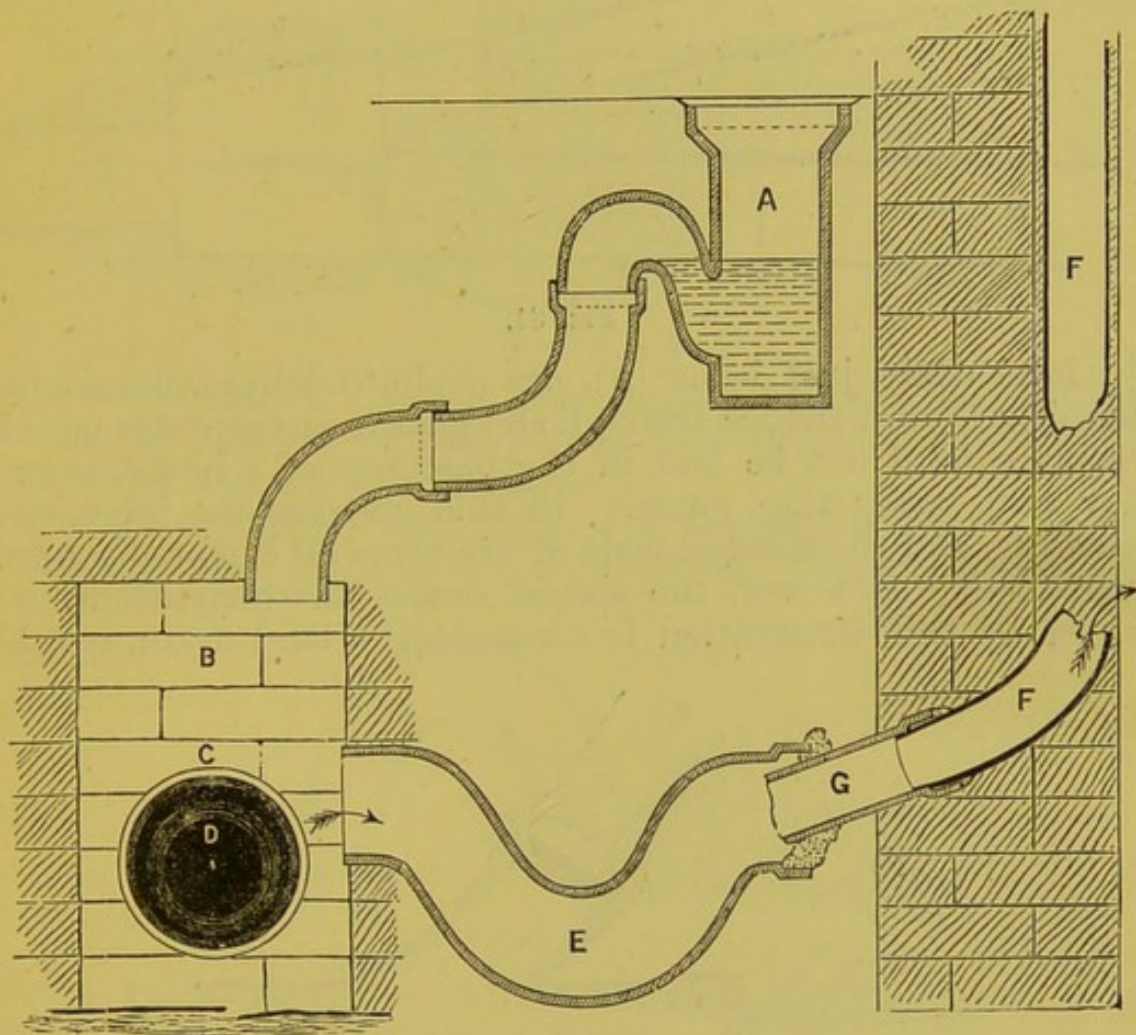
FIG. 80.

Fig. 80. A gully trap A, on which a waste pipe delivered, was brought into a cesspit B, loosely made with brick sides and a broken slate bottom; a 6in. earthenware pipe, as shown at E,

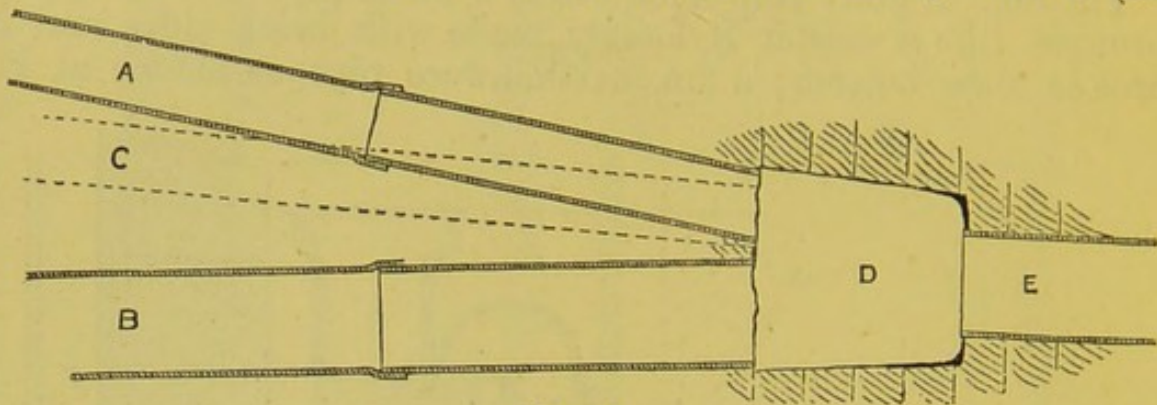
FIG. 81.

Fig. 81 represents defects in the drains in the basement of a large house I recently examined. A and B are glazed earthenware pipe drains, carrying slop water, and these, with C (an

old land drain just below A), are made to deliver into a small chamber D, and thence through the glazed earthenware pipe E. Drains should not be laid in the basement of a house, even if they only carry slop water. In this instance the joints were defective, and the flanged ends of the pipes all directed towards the outfall. However, the special defect to which attention is drawn by this illustration is connecting a land drain, roughly

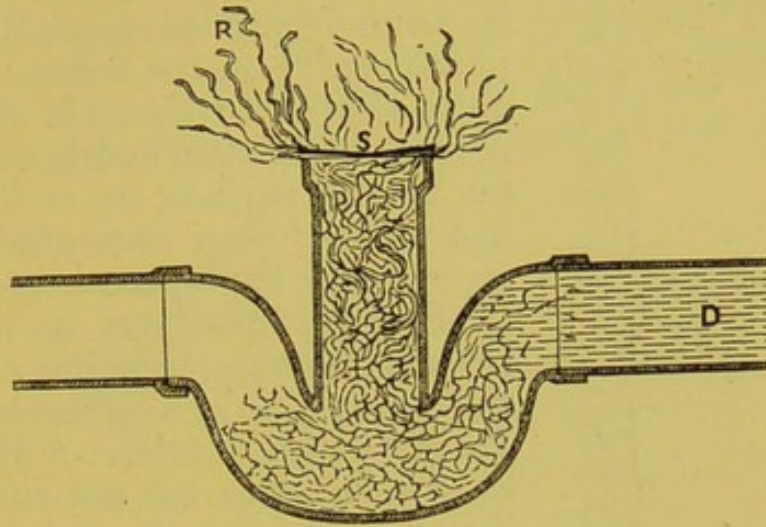
FIG. 83.

Fig. 83 represents the cause of a stoppage in a 6in. glazed earthenware pipe drain from a large house. The drain was laid
