Defects in plumbing & drainage work / described by Francis Vacher.

Defects in Plumbing and Drainage Work

described by **Francis Vacher**
upwards of 100 illustrations

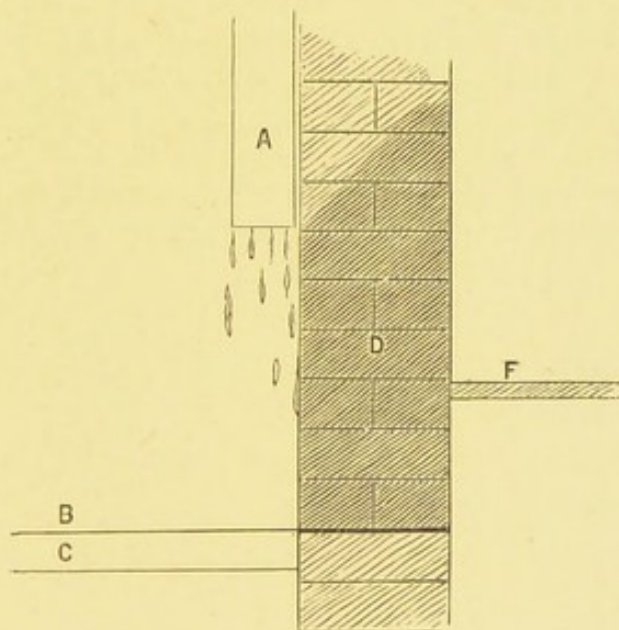
FIG. 1.

Figs. 1 and 2 illustrate the negligent way in which rain spouts are fixed, and the resulting nuisance from damp. The examples are taken from two new houses in a new street.

Fig. 1 shows the rain spout terminating 18in. above the surface of the pavement, and consequently discharging large quantities of rain directly on the wall of the front parlour.

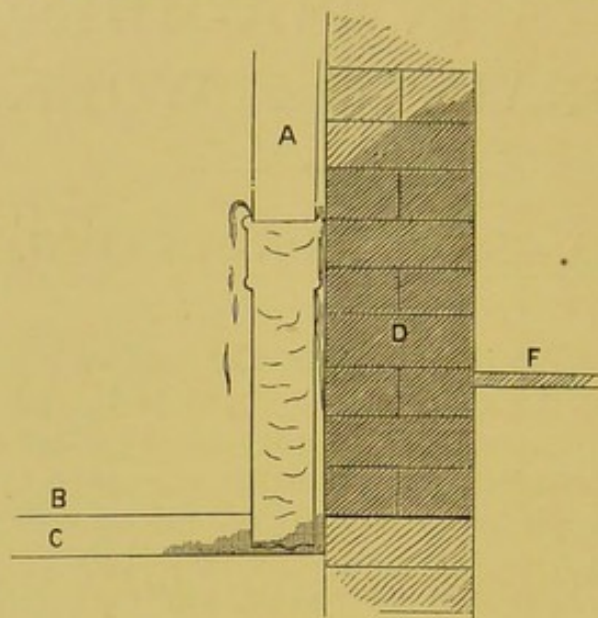
FIG. 2.

Fig. 2 shows the spouting continued by a length which has been broken off too short, and fastened too low. The end being

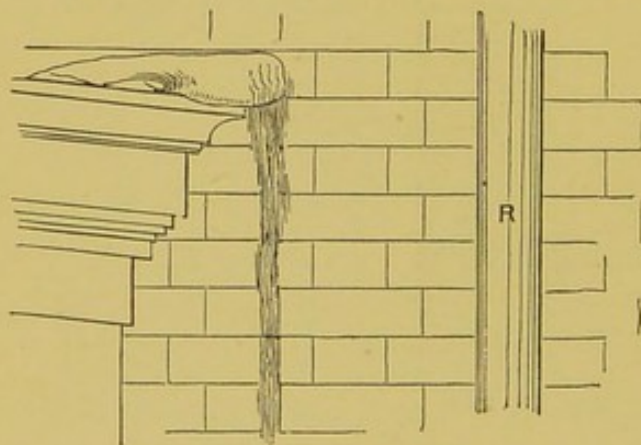
FIG. 3.

Figs. 3 and 4 represent defects lately brought to my notice in a row of new buildings. The bay windows in the front of four small houses have the rain conducted from the roofs, as shown in Fig. 3. In each house a piece of lead, cut too large for the window, is rolled up one side, and conducts the rain on the front wall, where it has already left a large stain. A rain spout R, terminating in a channel in the pavement, passes close by. The bay windows in front of the remaining six houses in the same row have the rain conducted from the roofs as shown in Fig. 4. The lead-covered roof of each window is provided with a short lead pipe, which pierces the coping stone, and delivers, as shown, like a watering pipe.

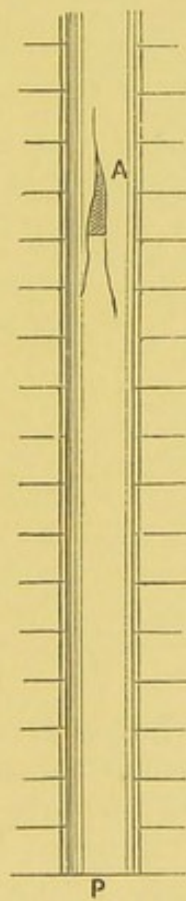
FIG. 6.

Fig. 6 indicates a defect I noticed lately. In the wall of a new building, flush with the street line, is a chase containing a 4 in. iron rain spout. In this is a double crack, 13 in. long, and this crack has lately been converted into a hole 1 in. across at

the bottom and 5in. long, as shown at A. The hole, being $3\frac{1}{2}$ ft. from the pavement P, causes a nuisance to foot passengers. The flaw was in the pipe originally, and could hardly have escaped the notice of the builder and his employés, and yet the pipe was accepted and used.

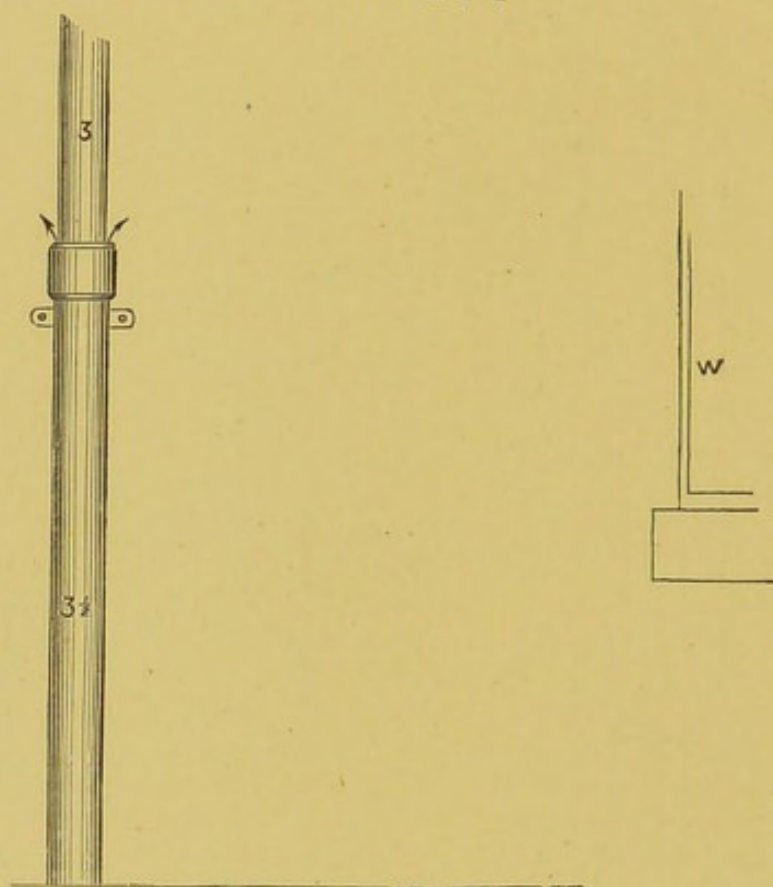
FIG. 8.

Fig. 8 shows an arrangement for conducting rain from an artificer's cottage which I took a note of. The lower length of the rain pipe, which was directly connected with the drain, was $3\frac{1}{2}$ in. in diameter, and the lengths above 3in. in diameter, the joints being unmade. It will be seen that when foul air ascended from the drain, part of it was delivered in front of the cottage, but three feet from a window often open. It seems strange that pipes of different sizes should be used, as in this instance. The explanation suggested is that the petty tradesman employed on the job had not enough pipes of one size, and, to avoid the trouble of sending for what he required, used what he had in stock.

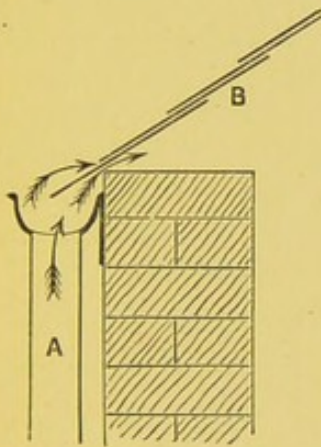
FIG. 9.

Fig. 9 is the section of the top of a wall, the slates, and rain gutter, and shows how a rain spout, carried straight into the drain, delivers gases from the drain into the house. To simplify the illustration, the framework of the roof is not indicated. B is where this framework would be; A is the 3in. rain spout made of sheet iron, and well jointed and connected to the gutter; and the arrows show how the gases find their way under the slates into the house.

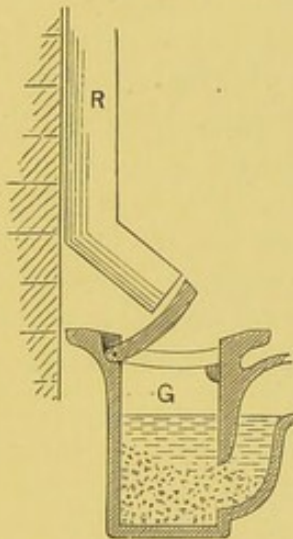
FIG. 10.

Fig. 10 illustrates a defect I saw recently, and I have frequently seen similar defects in sink-waste disconnections. In a detached villa in the suburbs the rain spouts are brought down to deliver on gully traps, in the manner shown. The grating of the trap is hinged, and made to open to a right-angle with the mouth of the trap, in order to allow of the trap being systematically cleansed. The end of the rain spout is fixed so close to the trap that the grid cannot be opened except to an angle of about 35 degrees, and the result is that it is almost impossible to cleanse the trap efficiently. As the rain spout is cast iron, the outflow of the trap is almost choked with rust. R is the rain pipe, and G the gully trap.

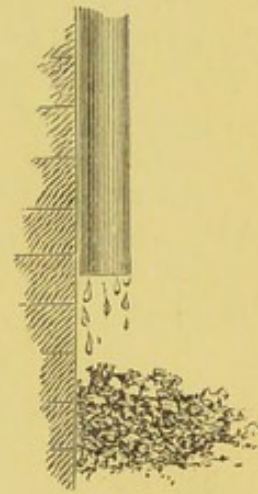
FIG. 11.

Fig. 11 shows a 3in. iron rain spout delivering into an ashpit. The spout receives from the back portion of the roof: thus about half the rainfall is directly conducted into the ashpit. The result is that after wet weather there is an effluvium nuisance from the ashpit, and the contents are usually saturated.

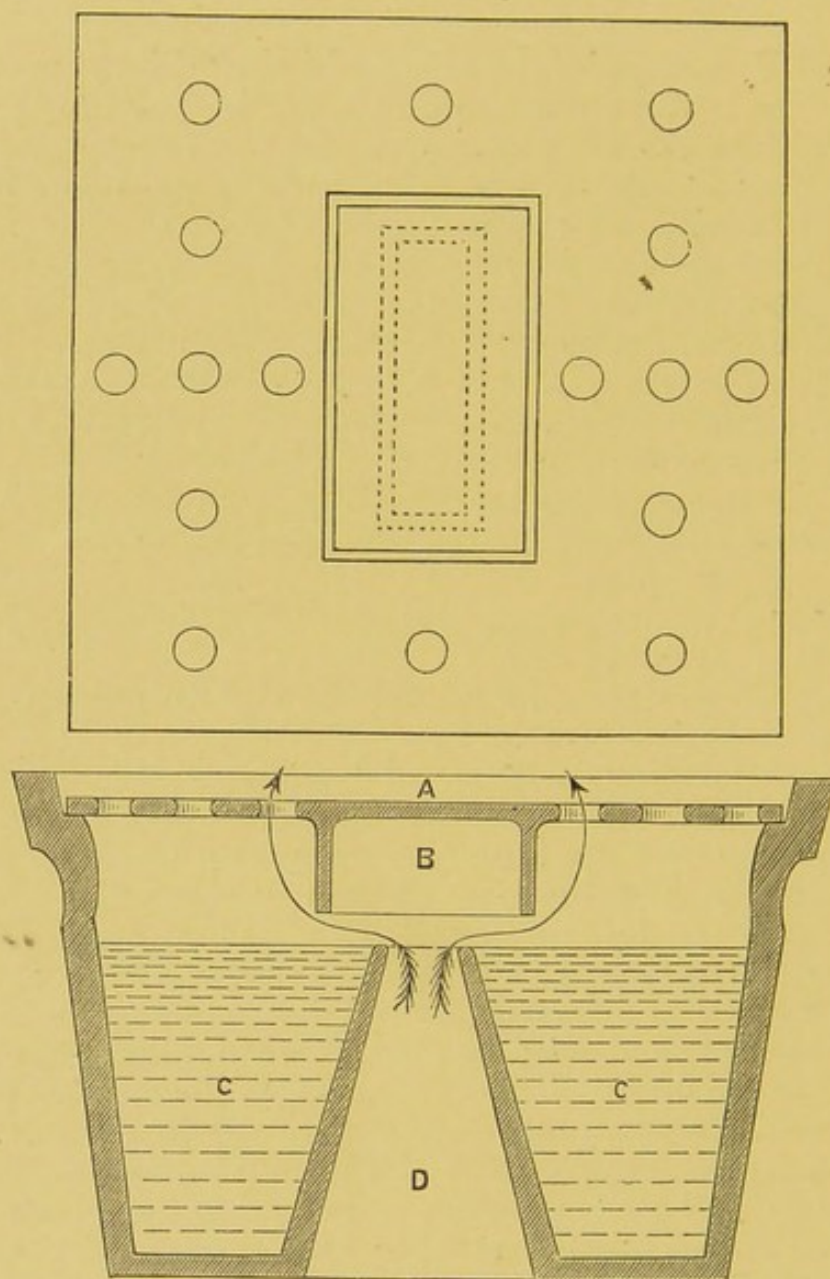
FIG. 12.

Fig. 12 represents a so-called box trap. When discovered, it was supposed to be trapping the yard drain belonging to a house in an important thoroughfare in the centre of the town. The sketch is half the size (linear) of the original. In the section, A is the lid, perforated with sixteen small holes, and carrying the useless box B on the under surface; C is the reservoir of water $2\frac{1}{4}$ in. deep, into which the box should dip, but which it does not touch; and D is the outflow from the trap leading to the drain. The upper part of the cut represents the lid turned upside down, the inner dotted line being a plan of the mouth of the trap outflow. The trap is of cast iron, and in all probability hundreds of the same casting have been sold.

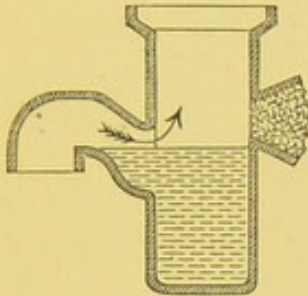
FIG. 13.

Fig. 13 is a section of another trap my attention was called to. It was fixed in the rear of a house bearing a rental of about £65, and was properly connected to the drain, and certain waste pipes delivering on it kept it well charged with water. However, on examining it, the trap was found to be a delusion, the water standing one inch too low to form a seal. Of course the gases and effluvia in the drains were thus brought close up to the dwelling-house, and delivered immediately under the scullery windows, &c. It may be said that as the workman

had set the trap quite square, and made good connections, he was not to blame. This is to take a very low view of a workman's duties. The primary defect was certainly in the casting, but surely no intelligent workman does his duty who fixes a trap without first testing it.

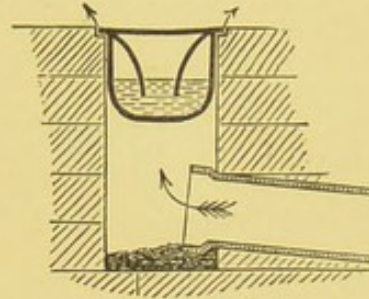
FIG. 14.

Fig. 14 shows the uselessness of trapping a yard drain with a loose trap of any pattern. The trap shown is a so-called dish

trap made of cast iron. It very easily gets choked, and for this reason it is commonly inserted without any setting, so that it may be taken up and cleansed. Any gases or vapours in the drain are not, of course, kept back, but find their way out external to the trap on all sides, as indicated in the illustration. The trap shown was found on premises owned by well-to-do

people, who would hardly have objected to the cost of providing and fixing an efficient gully trap, if the defects of the loose trap had been pointed out to them.

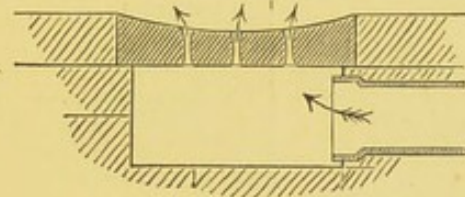
FIG. 15.

Fig. 15 shows another form of opening into a yard drain. The drain was of 4in. earthenware pipes, as in the last case, but

the mouth was not protected by any trap at all but only by a perforated stone.

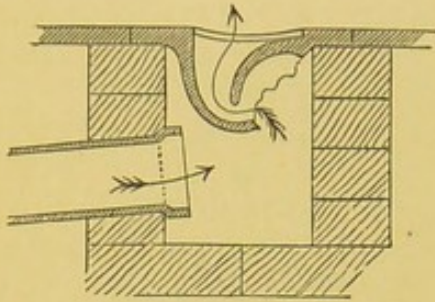
FIG. 17.

Fig. 17 represents the trapping of a yard drain as done by a local tradesman. A notice had been served on the owner of a small cottage dwelling to provide a properly trapped yard drain

and I called to see if the work had been done. The tenant said the workmen had finished the job a day or two ago, and took me into the yard. Here was the new glazed earthenware trap, but as it did not hold water, even when freshly poured in, I had

it removed. There was a large hole in the back, as shown in the cut. I questioned the tenant as to whether anyone belonging to the house had removed the trap and broken it, and he said the trap had not been touched since the workmen left. The only course open to me, therefore, was to believe that

a tradesman had been guilty of the fraud of selling and fixing a broken trap.

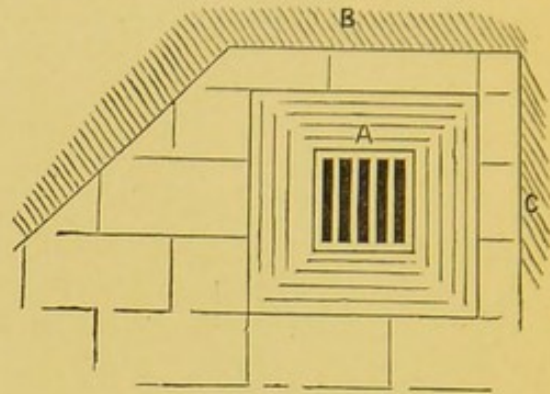
FIG. 18.

Fig. 18 shows a dummy area drain. Damp was complained of in the front wall of a kitchen. The area was paved with brick, and in the corner where the damp was noticed was a

stone collar and iron D trap. On the trap being taken up it was found to deliver its contents on the earth beneath the bricks, and the water had soaked through an 18in. wall into the kitchen. A represents the trap, B the kitchen wall, C the area wall. The workman who inserted this trap was guilty of a deliberate piece of wrongdoing; for the house was one of many in a terrace, an area drain was provided, and the corresponding traps in the houses on either side were connected.

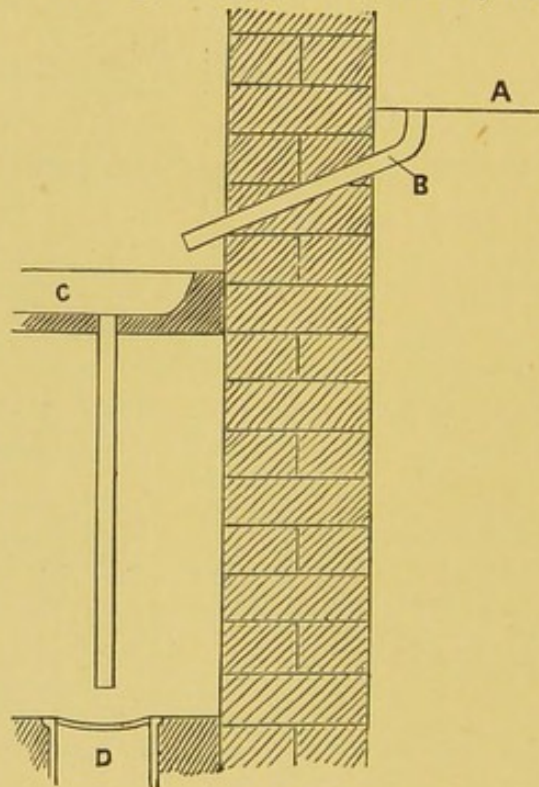
FIG. 19.

Fig. 19 is the section of the wall of a back kitchen. A represents the bottom of an area, C a sink-stone, and D a trap for the back kitchen drain on which the sink waste pipe discharged. Instead of draining this area in a proper way it was drained to the sink-stone by a short lead pipe B. What first led to this part of the house being examined was an effluvium nuisance in the back kitchen, which was traced to the trap D. The trap was obviously sealed with a decomposing animal liquid, and the readiest explanation of this seemed to be that the area had been used after dark for a purpose for which it was certainly not intended.

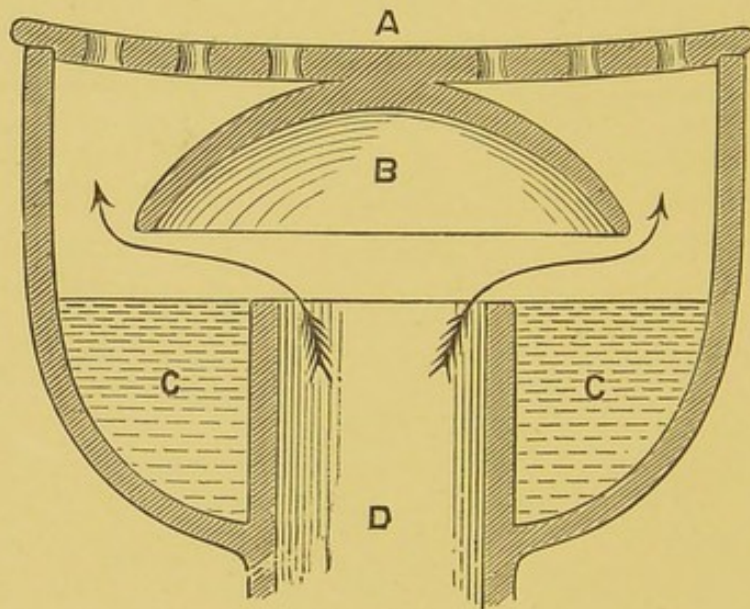
FIG. 20.

Fig. 20 shows a typically bad bell trap I discovered in the scullery of a house rented at £30. I examined it with great care, and then drew the section given, the exact size of the original. A represents the perforated grating, B the bell, CC the water reservoir—which the bottom of the bell never could have reached—and D the portion of the trap which was continuous with the sink waste that went straight into the drain. It will be seen that the whole apparatus is simply a pretence,

the depth of the bell at the centre being barely half an inch, and the distance between the bell rim and the surface of the water being just a quarter of an inch. On the same day, in the same street, I examined a sink bell trap in another house, and found the

depth of the bell at the centre three-eighths of an inch. These were not traps the bells of which had partly corroded away by means of the action of water on iron, but nearly new traps, absolutely useless when fixed.

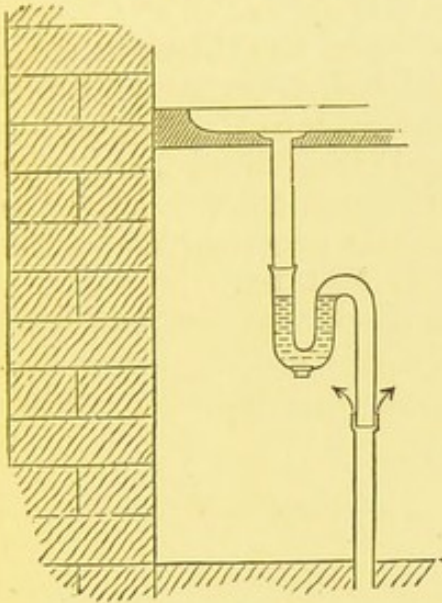
FIG. 21.

Fig. 21 indicates a sink waste pipe and its trap to which my attention was called. Being in a dark corner, it at first appeared to be a satisfactory fixing, but when closely examined it was

found the sink had a *movable trap*. The pipe to receive the lower end of the trap had been bulged out for barely an inch, and in this the lower end was placed, there being no trace of a joint of any kind having been made. The upper part of the trap had been widened out for a quarter of an inch, just enough to retain the trap in position. I have no doubt the trap had been fixed in this way to allow the tenant to clean it out at pleasure, but this was quite uncalled for, as there was access to the trap at the bottom of the bend, in the usual way. It is needless to say the arrangement was worse than having no trap at all, as it gave the householder a false sense of security. The arrow heads in the cut show that the trapping water trapped nothing.

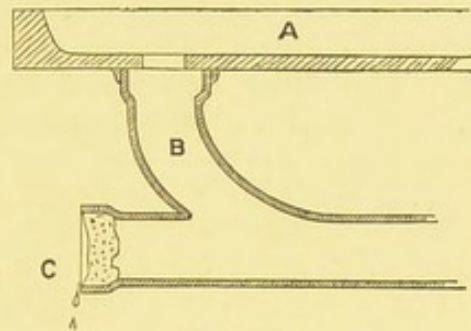
FIG. 22.

Fig. 22 shows a sink in the basement of a house rented at £45. The sink had been fitted with a bell trap, but this was lost. On making an examination beneath the stone it was found

that the sink waste was a 4in. earthenware junction pipe. A is the sink, B the pipe, and C the end which was imperfectly stopped, and through this stopping the foul water was leaking on the floor.

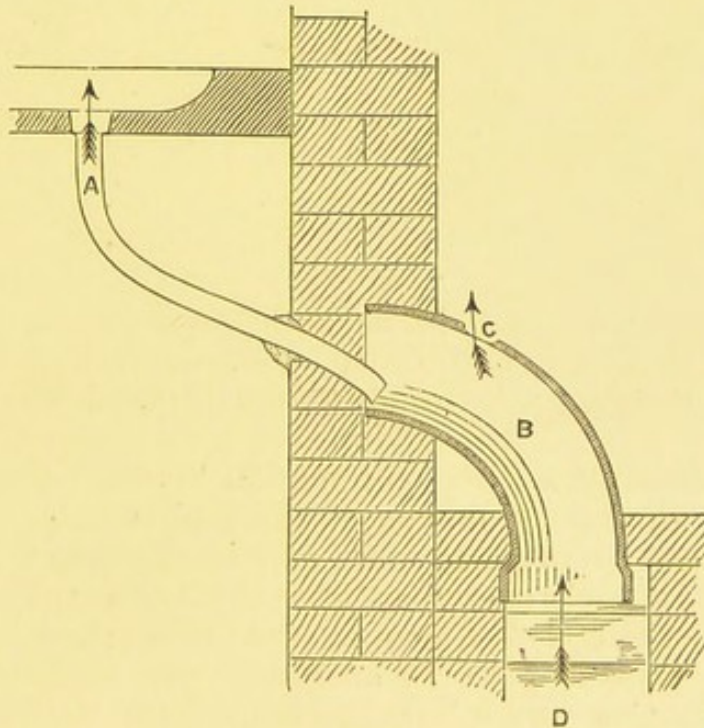
FIG. 23.

Fig. 23 represents a direct connection between a scullery and the external drains by means of the sink waste pipe. Such connections are common enough, but in the case referred to it was effected in such a clumsy unworkmanlike way, I made a sketch of it. The lead waste pipe A was taken into a 6in. earthenware curved pipe B, and this was connected to the drain D. At C a rough hole had been made in the pipe B, so that the noxious gases and vapours from the drains were admitted not only into the scullery but into the yard. This had apparently been done as a means of ventilating the drains, and

to abate the effluvium nuisance in the scullery. The arrangement described was observed on inspecting two small cottage houses tenanted by working men. A similar arrangement, but without the ventilating hole C, was noted in adjoining houses.

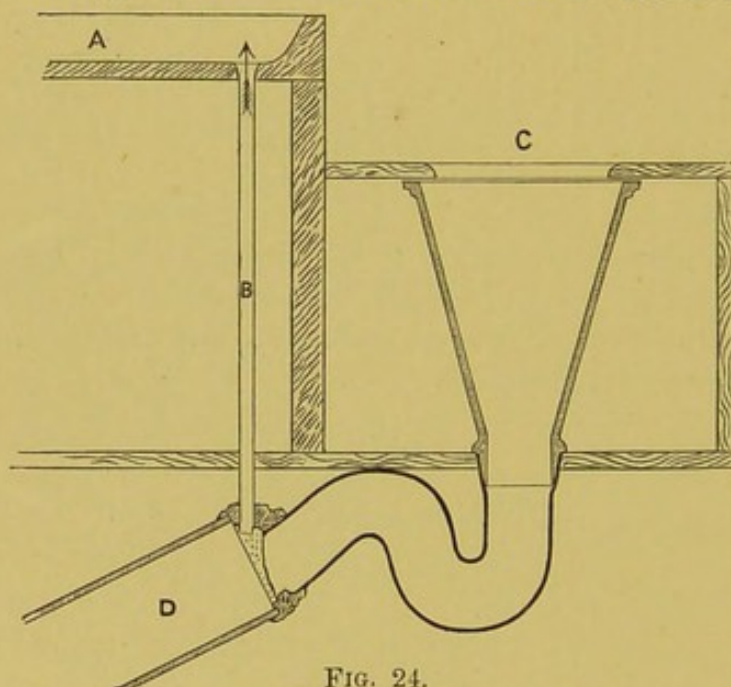
FIG. 24.

Fig. 24 represents a sink-stone and watercloset, which were placed side by side, as shown, within a scullery. The water-closet was *without water supply*. The closet basin was placed

over a syphon trap, which would frequently become choked, and this syphon trap and the sink waste were connected to a 6in. earthenware drain. A is the sink, B the untrapped waste pipe, C the closet, and D the drain.

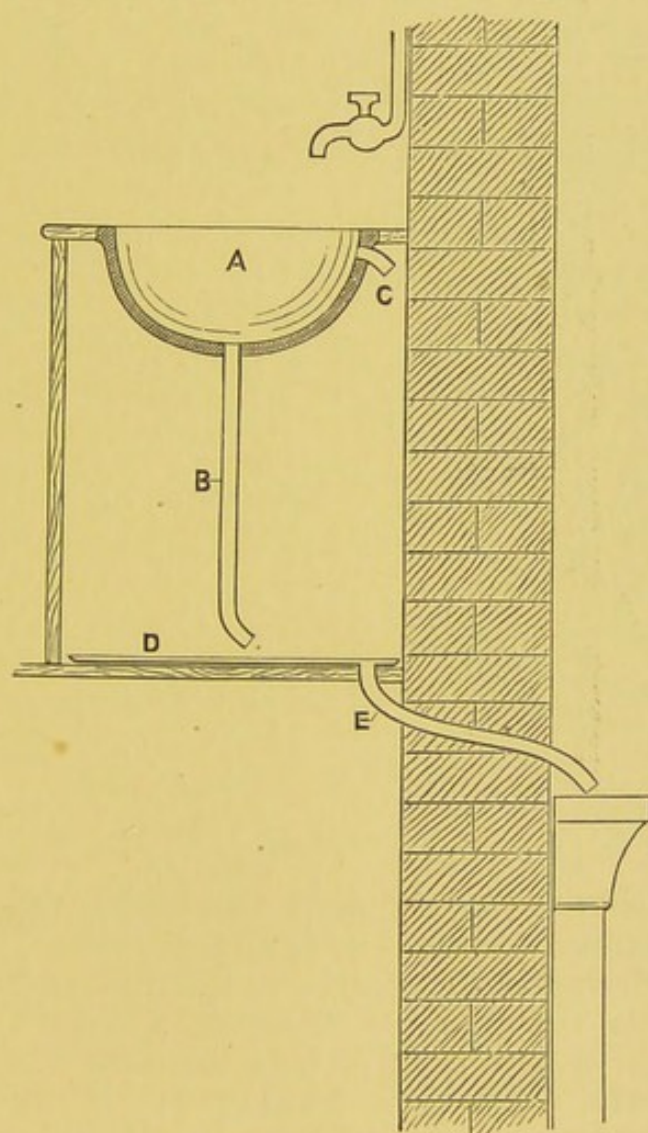
FIG. 30.

Fig 30 has been sent me by a correspondent, who writes me that he recently saw a lavatory basin as shown. It is in his experience a unique way of treating a waste pipe and overflow. The sketch explains itself. A is the basin, B the waste pipe from

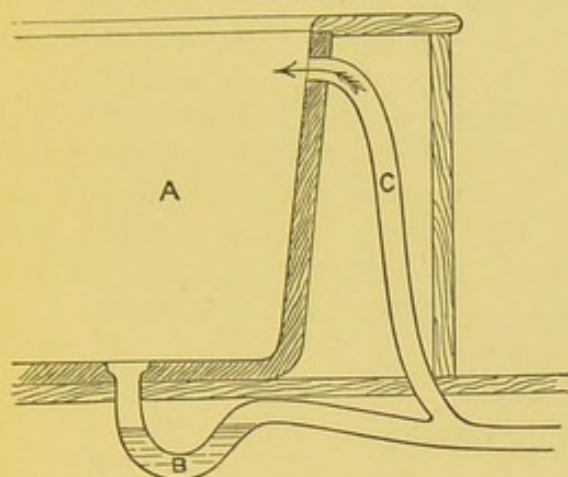
FIG. 32.

Fig. 32 illustrates the danger of an untrapped overflow pipe. A whole family occupying a house in a large town had been suffering from a low type of sore throat. The patient most severely affected had been making use of the bathroom as a bedroom. An examination of the premises, instituted by the medical officer of health, led to the discovery that though the bath waste pipe was trapped, the overflow pipe had been connected to the waste pipe between the trap and the house drain. Thus the overflow ventilated the drain into the bathroom. A is the bath, B the bath waste trap, and C is the overflow pipe.

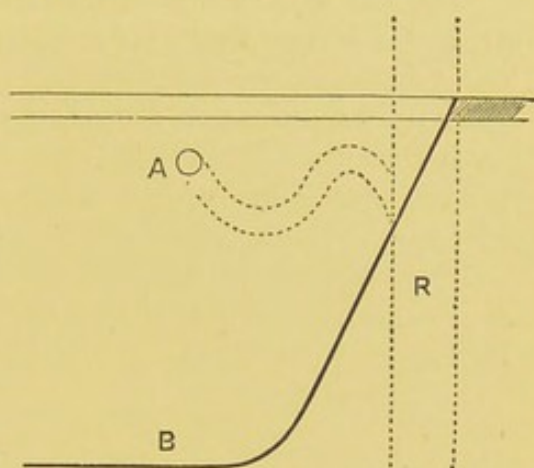
FIG. 33.

Fig. 33 shows in section the upper end of a bath B, situated against an outer wall. There was an overflow pipe at A, taken straight out through the external wall along the outside towards a rain spout R, into which it delivered. Before being connected with the rain spout it was bent downwards and upwards so as to

form a U trap. The rain spout was directly connected to the drain, and the U trap was empty, so that effluvia and noxious gases from the drains were conducted into the house and delivered close to the face of anyone using the bath. Of course,

when the bath was being used the bathroom would be unusually warm, and abundance of foul air would be drawn up. It is needless to point out that a bath overflow pipe should be disconnected. Twisting the pipe in the form of a U trap is of little service, as a bath is rarely filled so full as to bring the overflow into use.

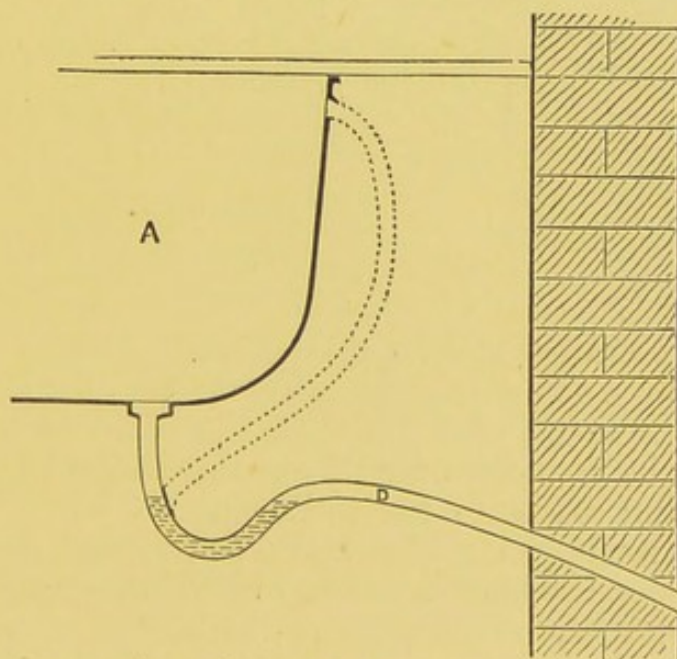
FIG. 34.

Fig. 34 illustrates a familiar defect. In a suburban villa (rent £85), lately built, the bath was found by the tenants to be without an overflow pipe. The bath waste pipe was trapped, and taken out at once, and delivered on a gully trap, and the other sanitary arrangements appeared to be satisfactory. A represents the bath and D the waste pipe, and the dotted lines indicate the position of the overflow pipe which should have been fitted.

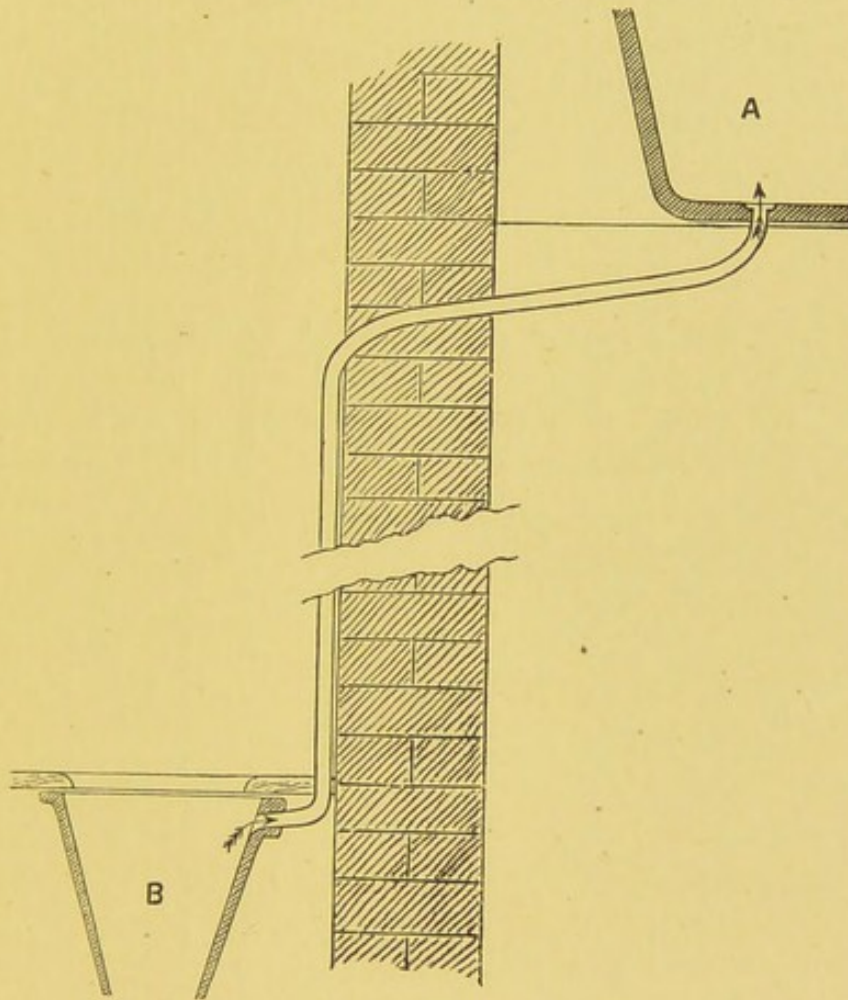
FIG. 36.

Fig. 36 requires little explanation. It represents work carried out by a competent plumber at his own house. A is a bath inside the house and B is the basin of a closet in the yard. These, it will be seen, are directly connected, the waste pipe from the bath being made to flush the closet. There was no other provision for flushing the closet, and as the pipe was untrapped, the foul air from the basin ascended to the bathroom, causing an effluvium nuisance.

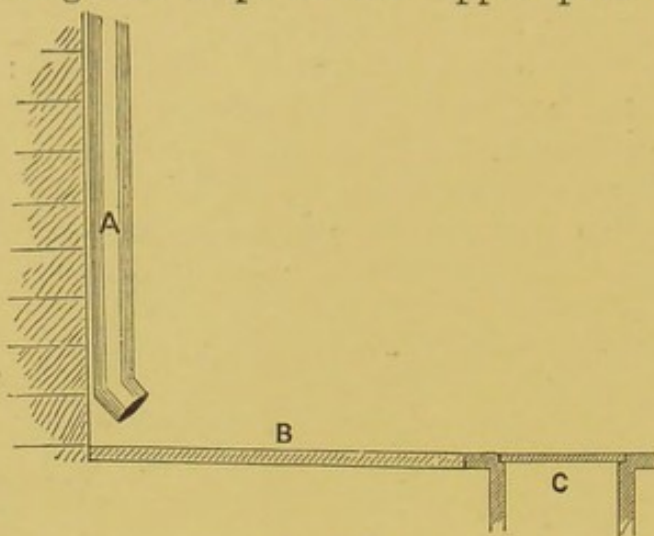
FIG. 37.

The method of delivering waste water represented in Fig. 37 is, I regret to say, not uncommon. The bath and hand-basin waste pipes are brought outside to discharge on the area flags, which are channelled to conduct the water to a trap. Only one waste pipe is represented in the cut, but I have seen three together treated in the same manner. I have also seen the trap a yard or more from the end of the pipe; and sometimes no

channel or conductor to the trap is provided. In any case the result is a nuisance from the foul state of the flagging between the pipe and the trap, and effluvia commonly find their way into the house at the kitchen or pantry window. A is the waste pipe, B the area flagging, and C the trap.

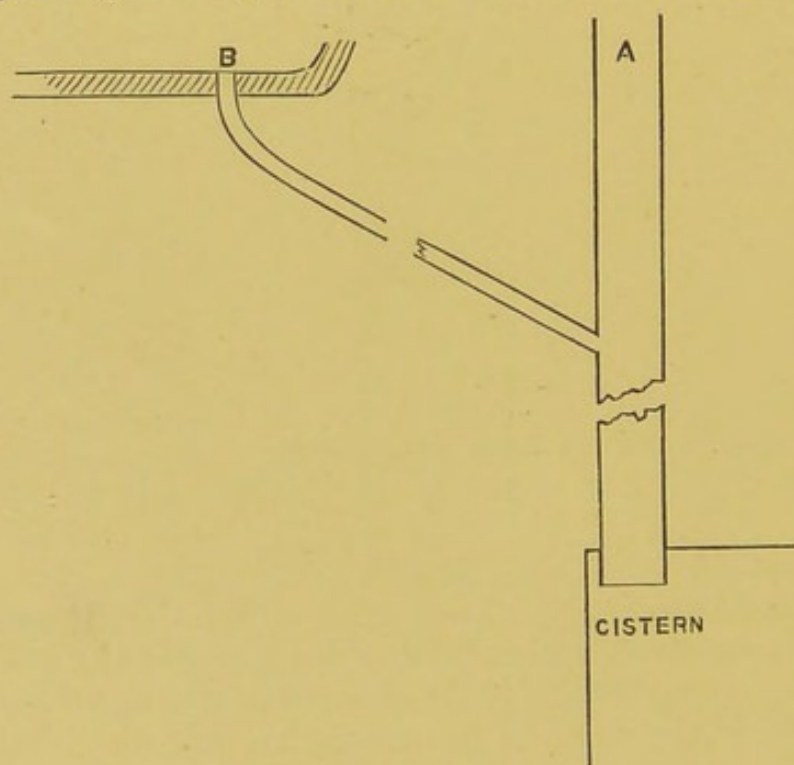
FIG. 38.

Fig. 38 is from a correspondent. He writes: "During my inspection of the sanitary arrangements of an empty house of considerable dimensions, I found that a new bath had been fixed some six or seven months prior to my inspection, and the waste pipe from same connected to a rain-water downpipe, running

close by, for convenience. It seemed to me that the rain-water pipe was in communication with a tank under the house, some distance away, and accordingly I gave instructions for opening the tank, with the result I anticipated. The bath had been in use for three or four months before the house was vacated." In the figure B is the bath and A the rain pipe.

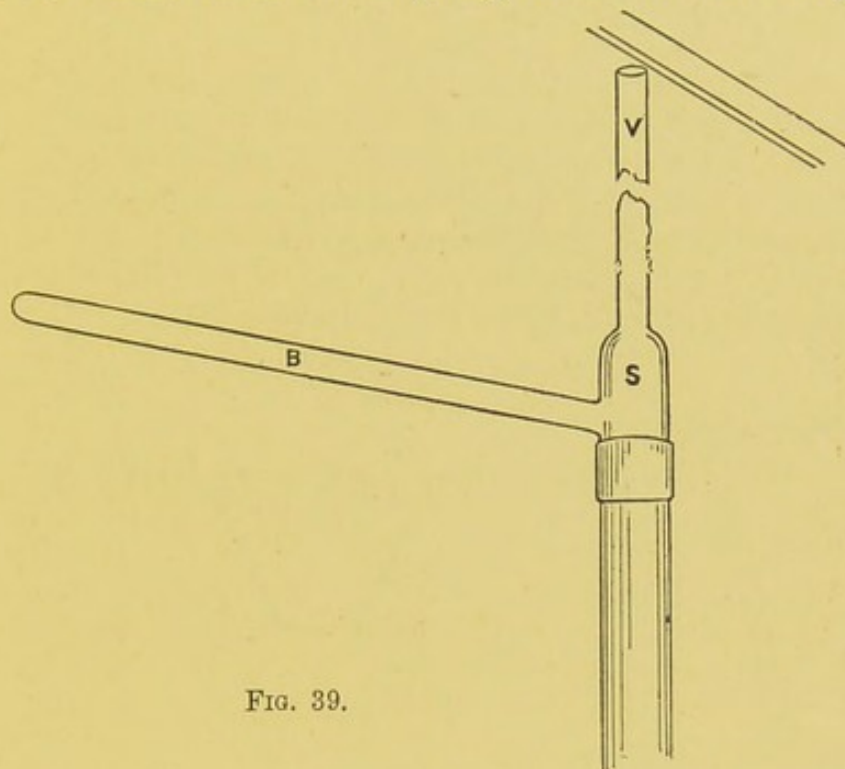
FIG. 39.

Fig. 39 represents a soil pipe and bath waste pipe, as seen from the outside, in a villa residence I lately examined. S is

the 4in. lead soil pipe jointed to an iron one; V is a 2in. ventilator, terminating just under the projecting edge of the roof; and B is a 2in. bath waste going direct to the soil pipe. Of

course, the bath waste pipe acted as a supplemental ventilator, ventilating the soil pipe into the bathroom.

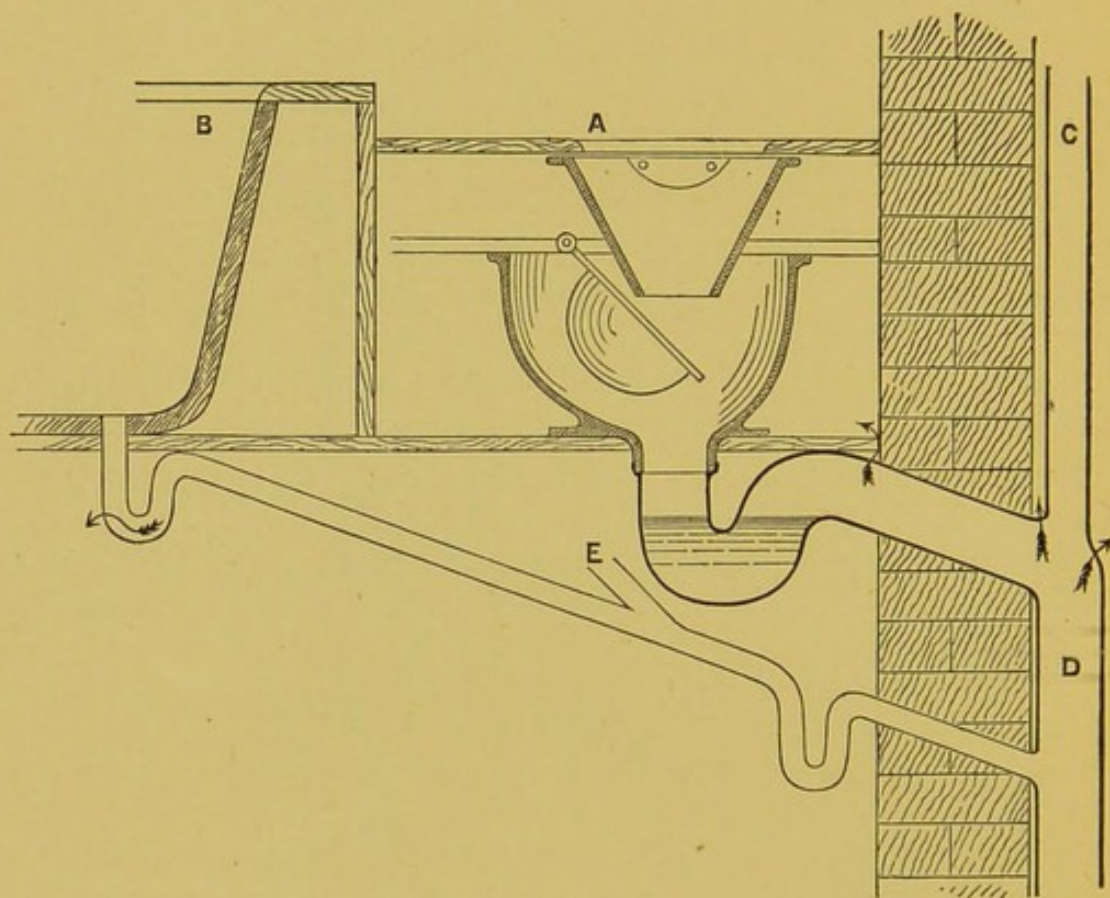
FIG. 41.

Fig. 41 shows the cause of an effluvium nuisance, which was most manifest near the bath. It was found that the trap under the bath was leaky, and an ineffectual attempt had been made to repair it with canvas, while the trap on the bath waste, next the wall, appeared to have been syphoned. A is the closet, B the bath, D a 4in. soil pipe, C is a 2½in. rain spout, made to act as a ventilator for the soil pipe, and E is a waste pipe from a urinal. As there was no trap between the sewer and the soil pipe, and the connections of the closet trap and soil pipe, and rain spout and soil pipe, were imperfect, sewer gas could escape into the bath and urinal, and at the points indicated by the

arrows in the illustration. That sewer gas actually did find its way into this house there is little doubt. A child died there, the cause of death being returned as "ulcerative pharyngitis;" and other inmates (mother and children) suffered from sore throats. Instead of complaining of the bad smell, attempts were made to smother it with carbolic powder, &c., and it was not till the death of the child that the attention of the sanitary authorities was directed to the house.

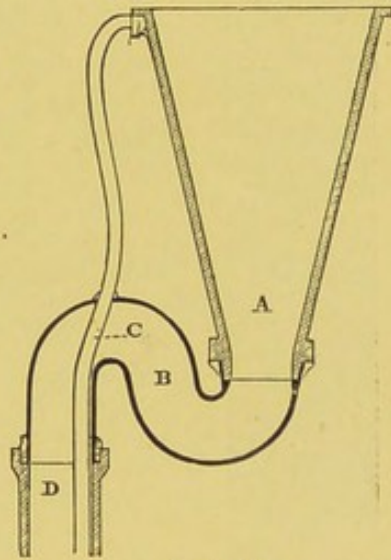
FIG. 43.

Fig. 43 shows the arrangement. A represents the basin, B the lead trap, C the lead service pipe, and D the earthenware soil pipe. Where the service pipe came through the trap it was carefully soldered round, but where it entered the earthenware soil pipe, about 14ft. lower down, the stopping was of mortar, and imperfect, allowing the passage of foul air from the soil pipe into the basement. Thus was the nuisance caused which led to this extraordinary service being brought under the attention of the sanitary authority. The closet and soil pipe, which were against the party wall, 13ft. back from the front of the house, were removed, and the nuisance has therefore been effectually abated. I find the terrace in which this house is situated was built in 1871, and each house has a watercloset against an external wall, and fitted with a separate service cistern. A previous tenant of the house complained of had a bedridden relation, for whom he desired to provide a closet in the upper storey, and employed a local plumber with the results shown.

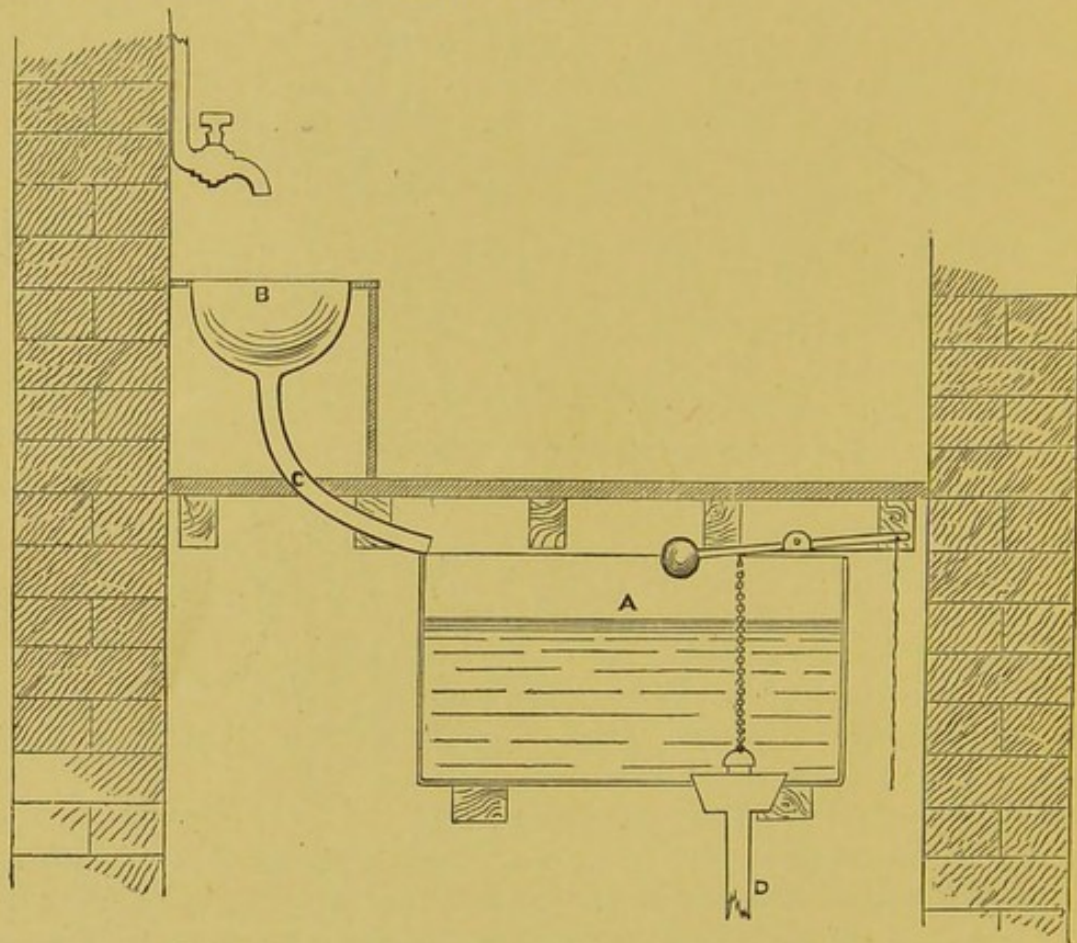
FIG. 44.

a villa residence he inspected. It seems strange how a plan so obviously objectionable came to be adopted. The sketch is reproduced in Fig. 44. A is a cistern serving the closet beneath, the cistern being supplied with rain water through a pipe not shown. B is a housemaid's sink, and C the waste pipe from the same, discharging into the cistern A. D is the pipe flushing the closet. An effluvium nuisance having arisen each time the closet was flushed, the apparatus was carefully examined, and it was then discovered that the closet was flushed, not with rain water only, as was supposed, but also with the slops daily thrown down the housemaid's sink.

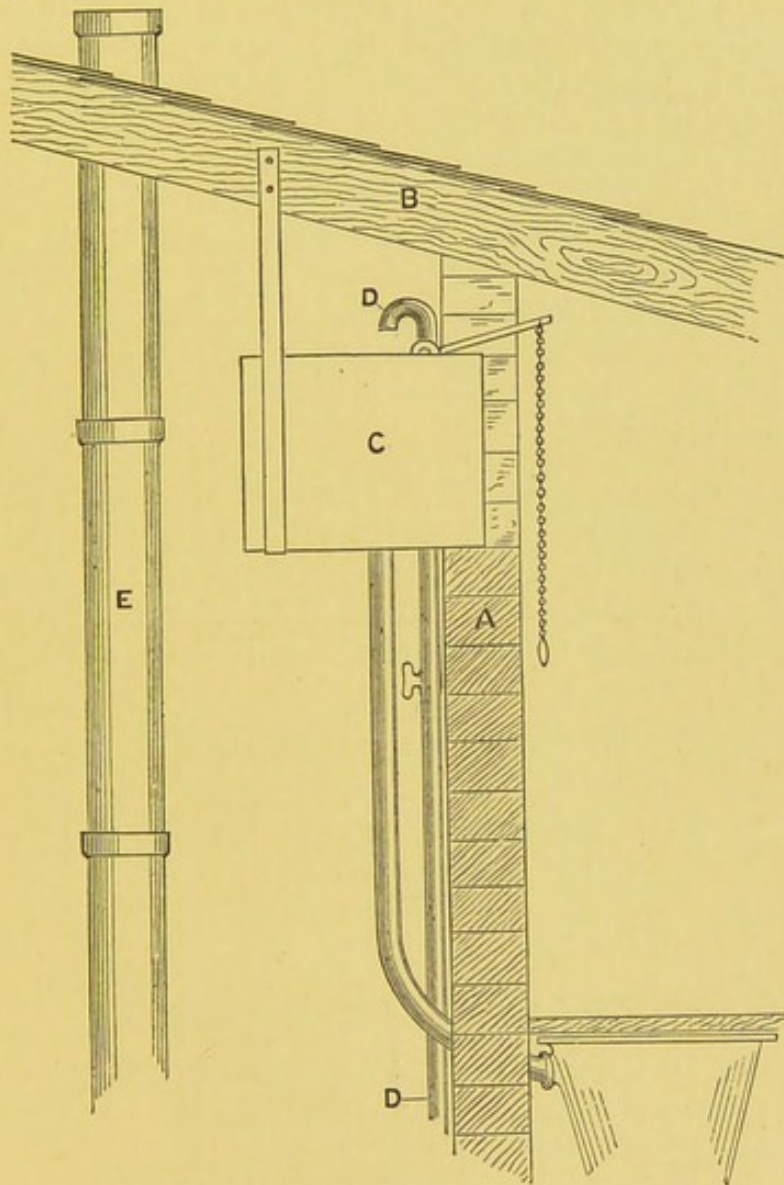
FIG. 45.

Fig. 45 shows how some midden privies were converted into dry ashpits and waterclosets. A hole was made in the wall A, just under the rafters B, large enough to admit the end of the cistern C. The cistern in each case was of light galvanised iron, 15in. by 6in., and 12in. deep. The whole of the cistern, excepting the small portion resting on the wall, is actually in the ashpit. Cisterns in such a situation are exceptionally liable to get foul, and are almost inaccessible. No overflow is provided, and the supply pipe D passes up a corner of the midden, through the ashes and refuse. The drain from the closet is ventilated (or, to be more correct, an exit for the drain air is provided) by means

of 4in. earthenware pipes E, built up the end wall of the middenstead, and delivering effluvia at a low level.

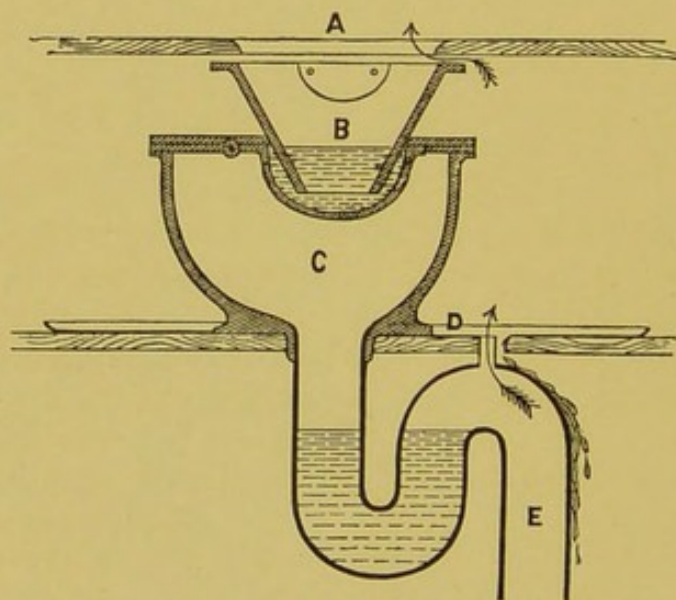
FIG. 48.

Fig. 48 represents a much more serious blunder on the part of a local plumber. The safe or tray to catch any foul water, &c., overflowing from the basin had been fixed, but in order to drain it a lin. pipe from the safe had been carried into the soil pipe. The

soldering of the top of this short pipe to the safe had given way, and it was found that the safe had been draining on the outside of the soil pipe. However, the foul air and gases in the soil pipe had ready access to the house, as shown by the arrows in the illustration. A is the closet seat, B the basin, C the container, D the safe, and E the soil pipe. The house in this instance was a very old one (rent about £40), and the closet fittings were old and worn.

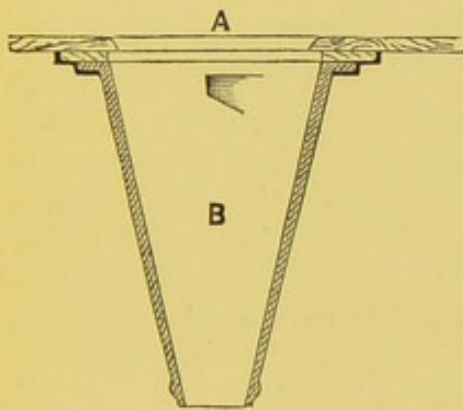
FIG. 49.

Fig. 49 shows in section a curious fixture, which, I think, cannot be very common. I can only describe it as a privy got up to look like a watercloset. A long earthenware basin B was screwed up to the underpart of the seat A, and the surface of the earthenware had become exceedingly foul. The quaint name was given it—"a dry watercloset."

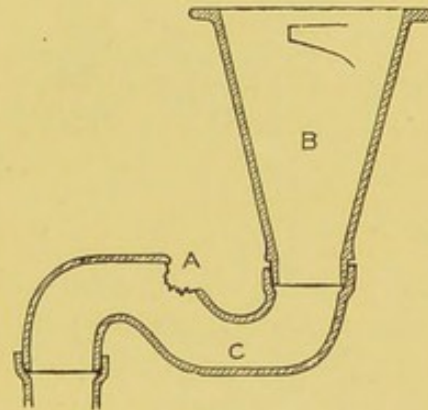
FIG. 50.

Fig. 50 represents a watercloset without water service, which was fitted in the yard of a cottage situated in a back court. On seeing there was no arrangement for flushing, I was surprised

the basin was not full, and I directed a further inspection, when it was found that a hole had been made in the top of the earthenware trap, which was jointed to the basin. I made particular inquiries as to this hole, and was told that "the man that fettled the thing, for fear it would get choked," made the hole—in other words, the hole was made that the contents of the pipe beyond might be pushed on with a stick, or otherwise. In the woodcut, B is the basin, C the earthenware trap, and A the hole referred to. As the hole was made on the drain side of the trap, it established a direct communication between the drain and the closet, which would have remained even if the trap had been kept charged with water.

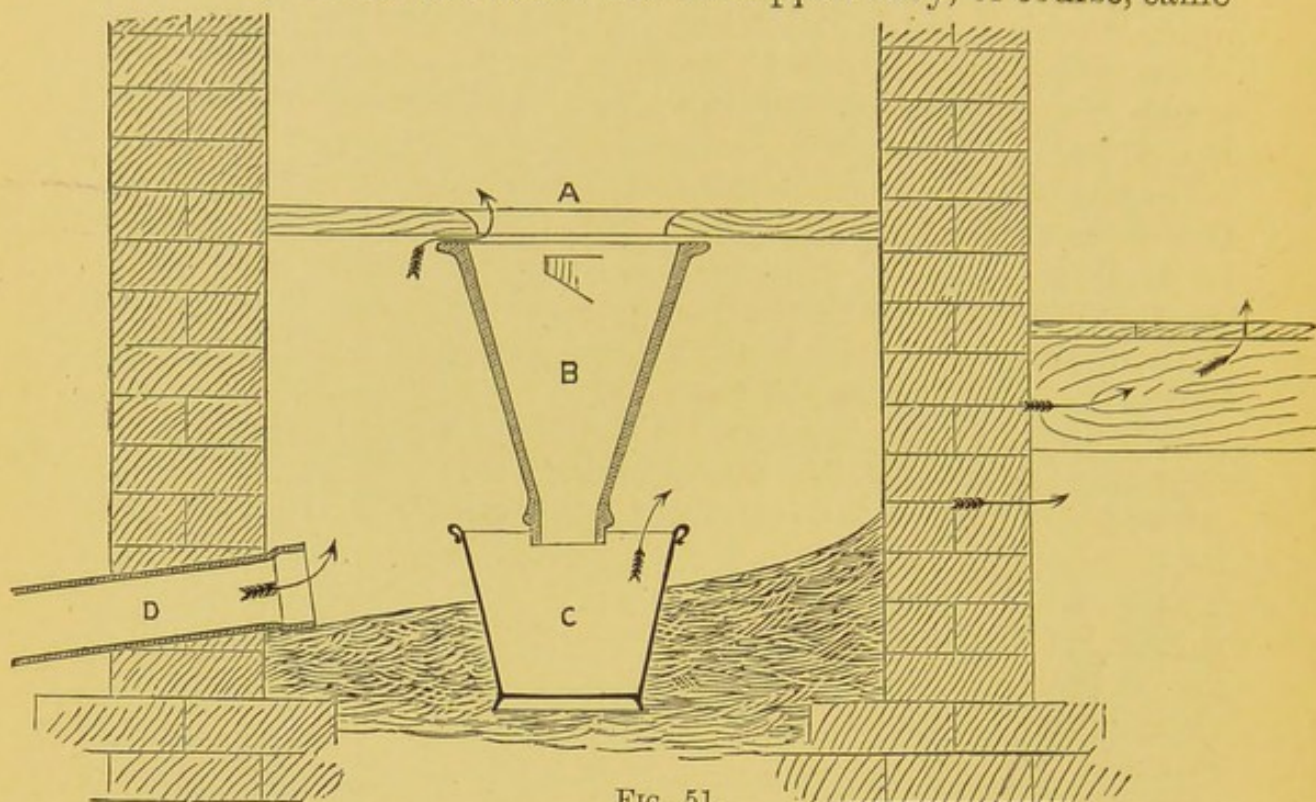
FIG. 51.

Fig. 51, sent me by a correspondent, represents a closet basin trapped into a galvanised iron bucket. The contents, of course, overflowed and found their way into the open drain shown to the left in the sketch. Next to this abominable closet was the kitchen, and the foul air and foul smells went through the joints

of a wall, almost destitute of mortar, and between the planks of the floor into the kitchen. The man who fitted this closet seems to have aimed at preventing the sewer gases from coming up the basin; but as the drain was untrapped they, of course, came

up without check external to the basin. The result of his contrivance was that he produced even a worse nuisance than if he had simply jointed the untrapped drain to the basin. A is the seat, B the basin, C the bucket, and D the drain.

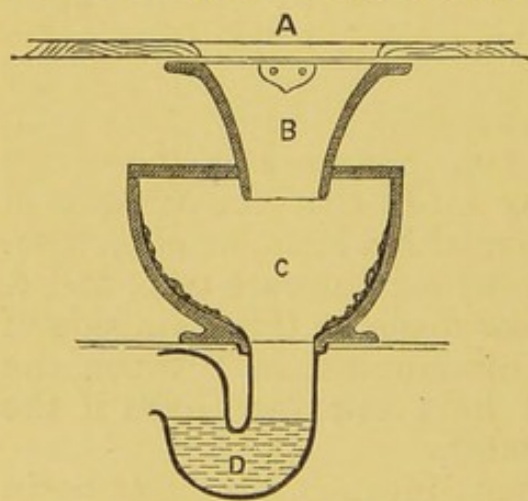
FIG. 52.

Fig. 52 shows an ordinary "pan" closet, which was fixed without a pan. The tenant had been in the house upwards of

a year, and told me the closet was as I found it from the first. If the pan had merely become broken off at the hinge it would have fallen, and probably caused an obstruction; if from any defect in the apparatus the pan could not recover its proper

position after flushing, it would have been hanging empty in the container. As it was, it was simply missing, and the plumber must have fixed the apparatus as I found it. The whole of the inner surface of the container, which was, of course, foul, was exposed, and a cause of more or less effluvium nuisance. A is the seat, B the basin, C the container, and D the trap.
