Defects in plumbing & drainage work / described by Francis Vacher.

Defects in Plumbing and Drainage Work

described by **Francis Vacher**
upwards of 100 illustrations

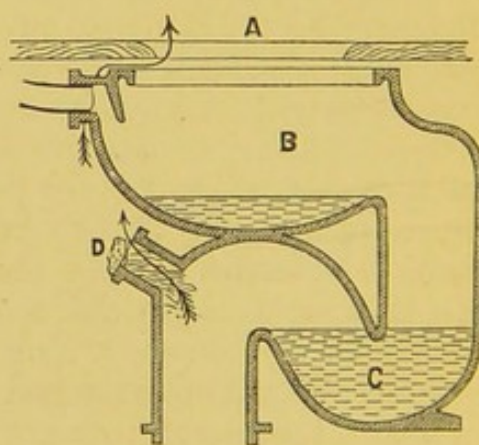
FIG. 53.

Fig. 53 indicates a danger from certain new forms of closets which had not occurred to me till the defect shown in the cut came under my attention. Many of these closets have an opening placed behind the trap for connecting a ventilator. The "National," the closet shown in section in the illustration, is thus contrived. It appears to be a good closet, and, if properly fixed and kept clean, is free from nuisance. However, very great nuisance was experienced from the particular closet I refer to, and, on uncovering it, it was found that the man who fixed the apparatus, instead of attaching a ventilator, filled up the hole where the ventilator should have been connected with *paper*, and covered this over at the top with putty. In course of time the putty loosened, and then the foul air from the soil pipe had ready access into the house. Of course, this foul air was rendered more foul by passing through a plug of paper saturated with the filth of years. A is the seat, B the basin, C the trap, and D the "stopped" vent hole.

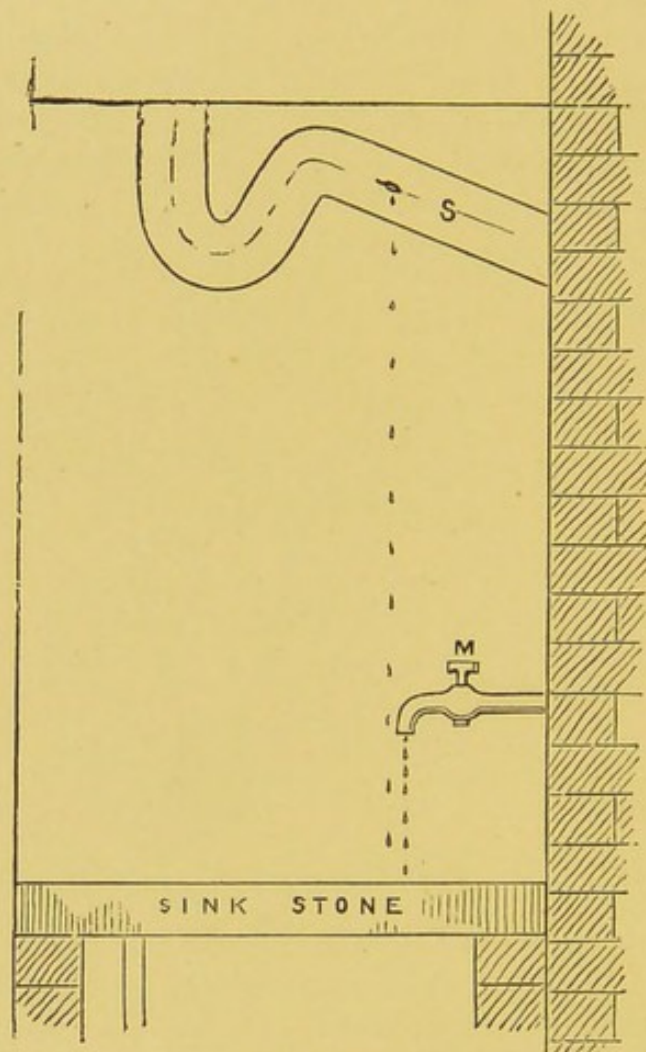
FIG. 57.

Fig. 57 is, I consider, one of the most interesting cuts in this series, and I desire to draw special attention to it. I received notice of a case of typhoid fever in a very old house in a poor neighbourhood. The patient was forthwith removed to the fever hospital, and the usual report as to the state of the premises was submitted to me. From the latter I

gathered that the house was dirty, and that there was a water-closet built out from the back wall, a separate service cistern for the same, and a pipe from the main for drinking and domestic purposes. Not satisfied with this report, I examined the premises myself. I found the closet was entered from a small landing on the stairs, between the ground floor and first floor. On looking to see what was under this (on the ground floor), I was surprised to find a sink-stone, and a tap from the main. Immediately over the sink-stone was the lead trap from the closet and a transverse portion of soil pipe connected therewith, which was carried through the back wall into the house. In the soil pipe close to the trap was a corroded hole, the position of this being shown in the cut. Through this hole foul gases must often have been discharged, and foul liquids from the closet must often have overflowed. Indeed, here were all the conditions present which one would expect to find resulting in an outbreak of typhoid fever. What in all probability happened is that drinking water drawn from the tap was polluted with excremental liquid dropping into it, and that water thus polluted was actually drunk. The illustration indicates how easily a jug of water drawn from the main tap M might be polluted by foul liquid running from the hole in the soil pipe S.

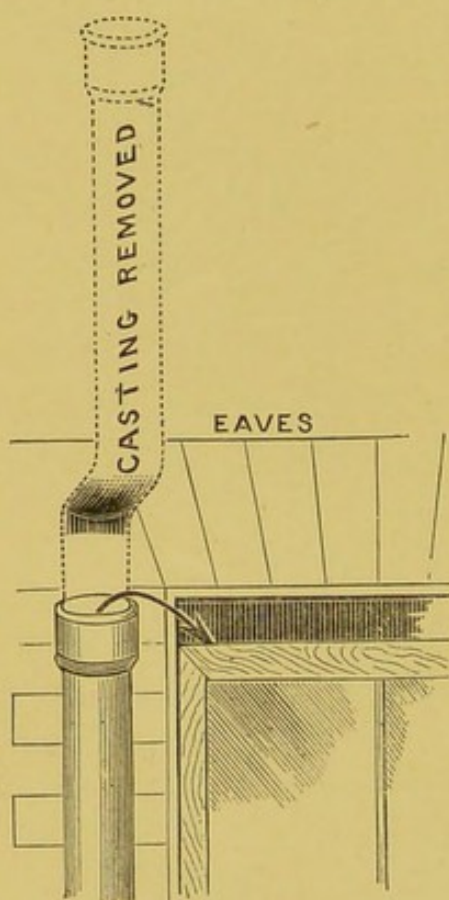
FIG. 58.

My attention was called to four houses where the soil pipe venti-

lators terminated close to back windows. In three cases the ends were on a level with the tops of the windows, and in one case a foot above the top. As the requirement with respect to soil-pipe ventilators is that they shall be carried up not less than 2ft. above the roof eaves, and the houses were quite new, special inquiries were instituted. Under the local Act, passed in 1881, it is "not lawful to let or occupy as a dwelling-house any building, not so used before the commencement of the Act, until

such building has been certified by the surveyor, or other officer appointed for the purpose, to be as to drainage, supply of water for domestic purposes, and in every other respect fit for human habitation, and constructed and completed in conformity with the provisions of the Act and the local bye-laws." It transpired that these four houses were submitted to examination, the soil pipe ventilators then terminating as required 2ft. above the roof eaves, and were duly certified fit for human habitation. How-

ever, shortly afterwards other houses approached completion, and iron castings necessary to carry the ventilators 2ft. above the roof eaves not being ready to hand, those belonging to the four houses already certified were removed, and made to do duty in obtaining a certificate for other houses. When the houses thus robbed were visited, three were occupied, and in each of these three the window next the soil pipe end was open for two or

three inches at the top. The accompanying illustration (Fig. 58) explains itself.

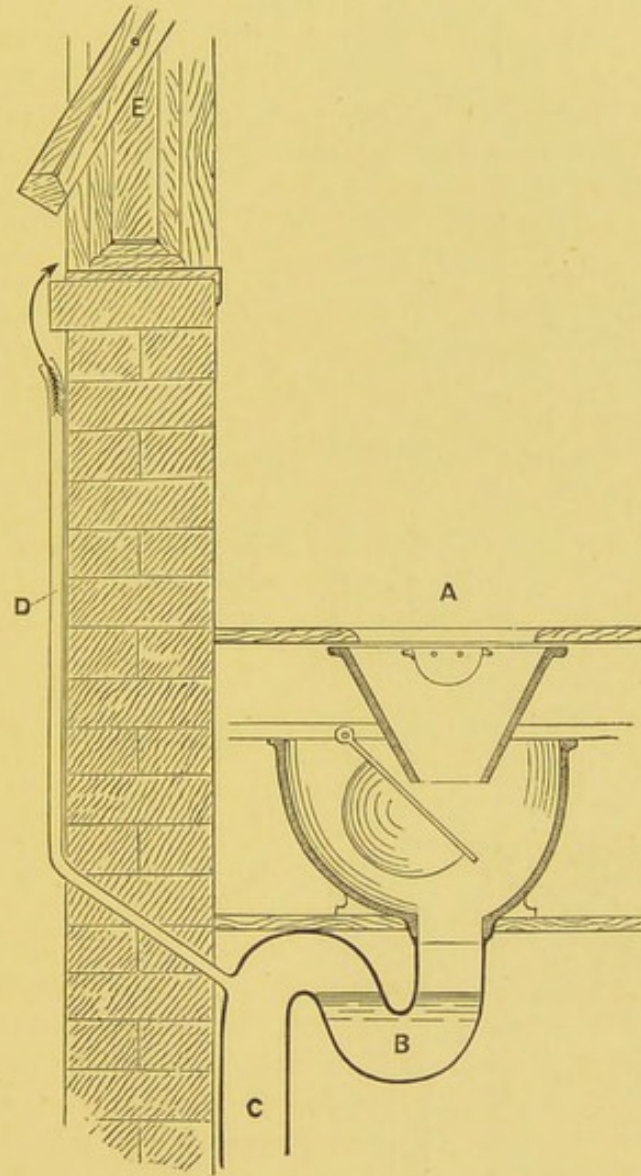
FIG. 59.

Fig. 59 represents an old pan closet which, although placed next an external wall, delivers into a soil pipe carried down inside the house. The closet A delivers into a lead syphon trap B, which is continuous with the soil pipe C. The soil pipe is connected with an earthenware pipe drain running under the

house. Neither the closet nor the position of the soil pipe and drain can be approved of, but the special defect to which attention is directed is the device for ventilating the soil pipe. A 1 in. lead pipe D is carried from the soil pipe through the wall, and made to terminate just below the closet window E. Of course a pipe of this capacity is a very inefficient ventilator, and much of the foul air it does afford escape for is likely to

be drawn into the closet whenever the swing window happens to be open. In the figure the ventilator is represented as a $\frac{3}{4}$ in. instead of a 1 in. pipe.

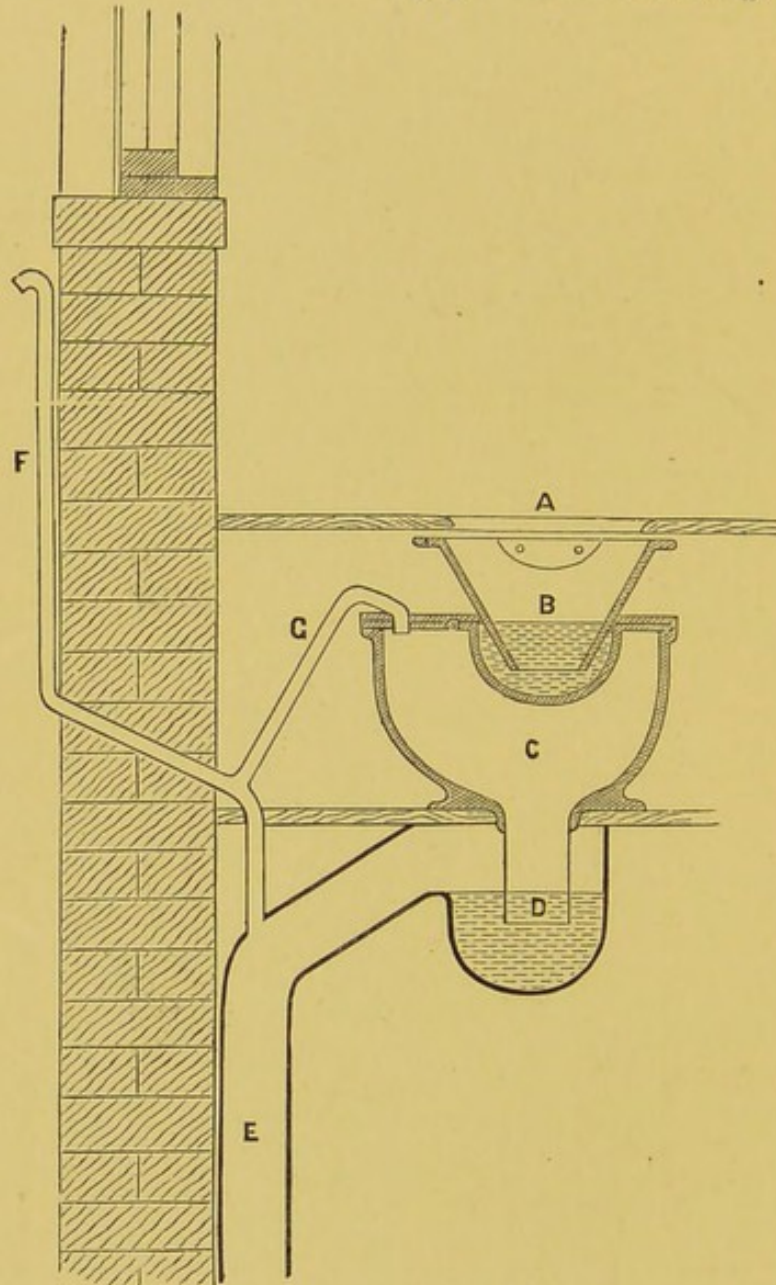
FIG. 60.

Fig. 60 explains itself. It gives a section of the closet fittings found in a large ecclesiastical residence, where what were alleged

a window, which, as noticed in the last example, is a very unsatisfactory arrangement. However, matters were made much worse by carrying a lin. pipe from the container into the soil pipe ventilator. By this device the D trap is rendered useless, as whenever the pan falls the foul air and gases from the soil pipe have free access to the house. It may be added that trapping a closet with a D trap is objectionable, as the end of the pipe submerged sooner or later corrodes, and the trap ceases to be of any use.

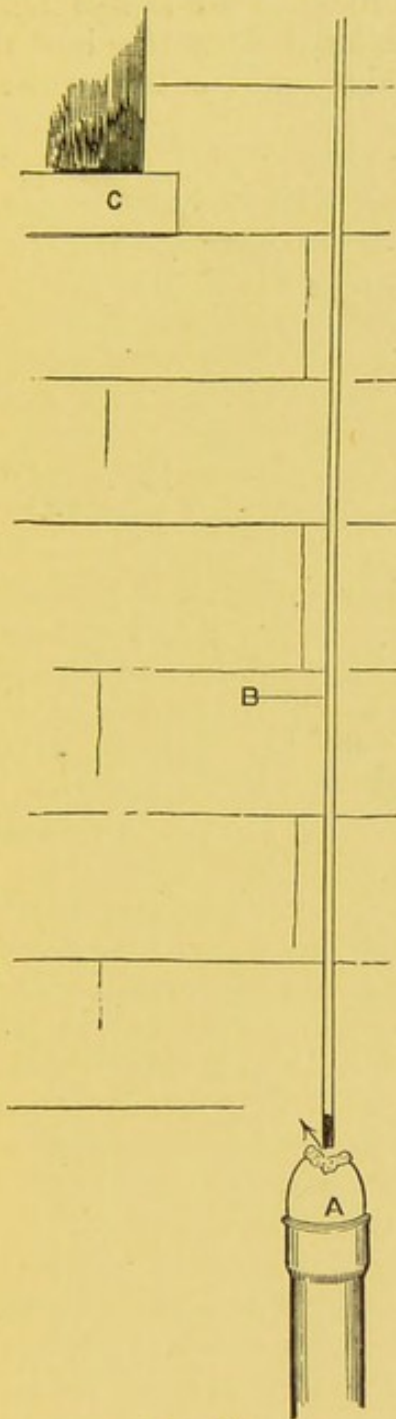
FIG. 61.

Fig. 61 shows a "ventilator" to a soil pipe which I discovered at a large suburban house. It was put up with the approval of the local surveyor and medical officer. A 4in. lead soil pipe was brought through the wall and efficiently connected with an iron soil pipe. A large hole had then been made in the lead at the top, and a $\frac{1}{2}$ in. iron pipe connected to this hole with putty. The iron pipe was quite closed up at the lower end with rust, &c., and was just too short to meet the lead pipe. Through a large hole in the lead and putty, effluvia ascended to the window 5ft. above. A is the lead pipe, B the "ventilator," and C the window.

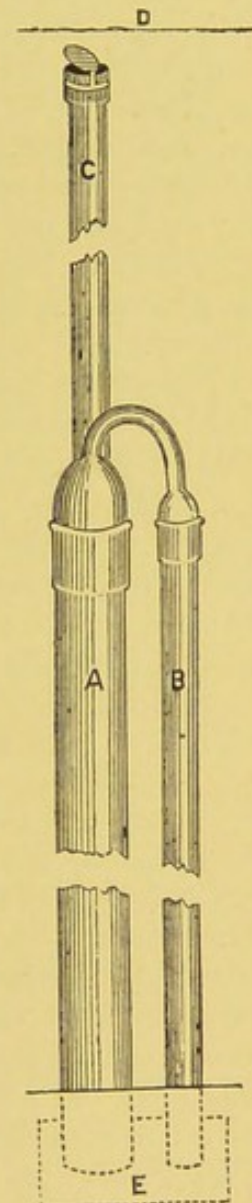
FIG. 62.

Fig. 62 illustrates a somewhat similar defect. S is a 4in. lead soil pipe at its exit from the house. Below it is connected with an iron pipe, and above a hole has been made, and 2 $\frac{1}{2}$ in. of 2in. lead pipe jointed thereto. Just 4 $\frac{1}{2}$ yards to the left of this short "ventilator" is a window. It is probable that the work, as originally planned, included a 2in. ventilator to be taken above the roof eaves, some 8ft. above the short pipe V, and this ventilator, owing to carelessness or economy, was never fixed.

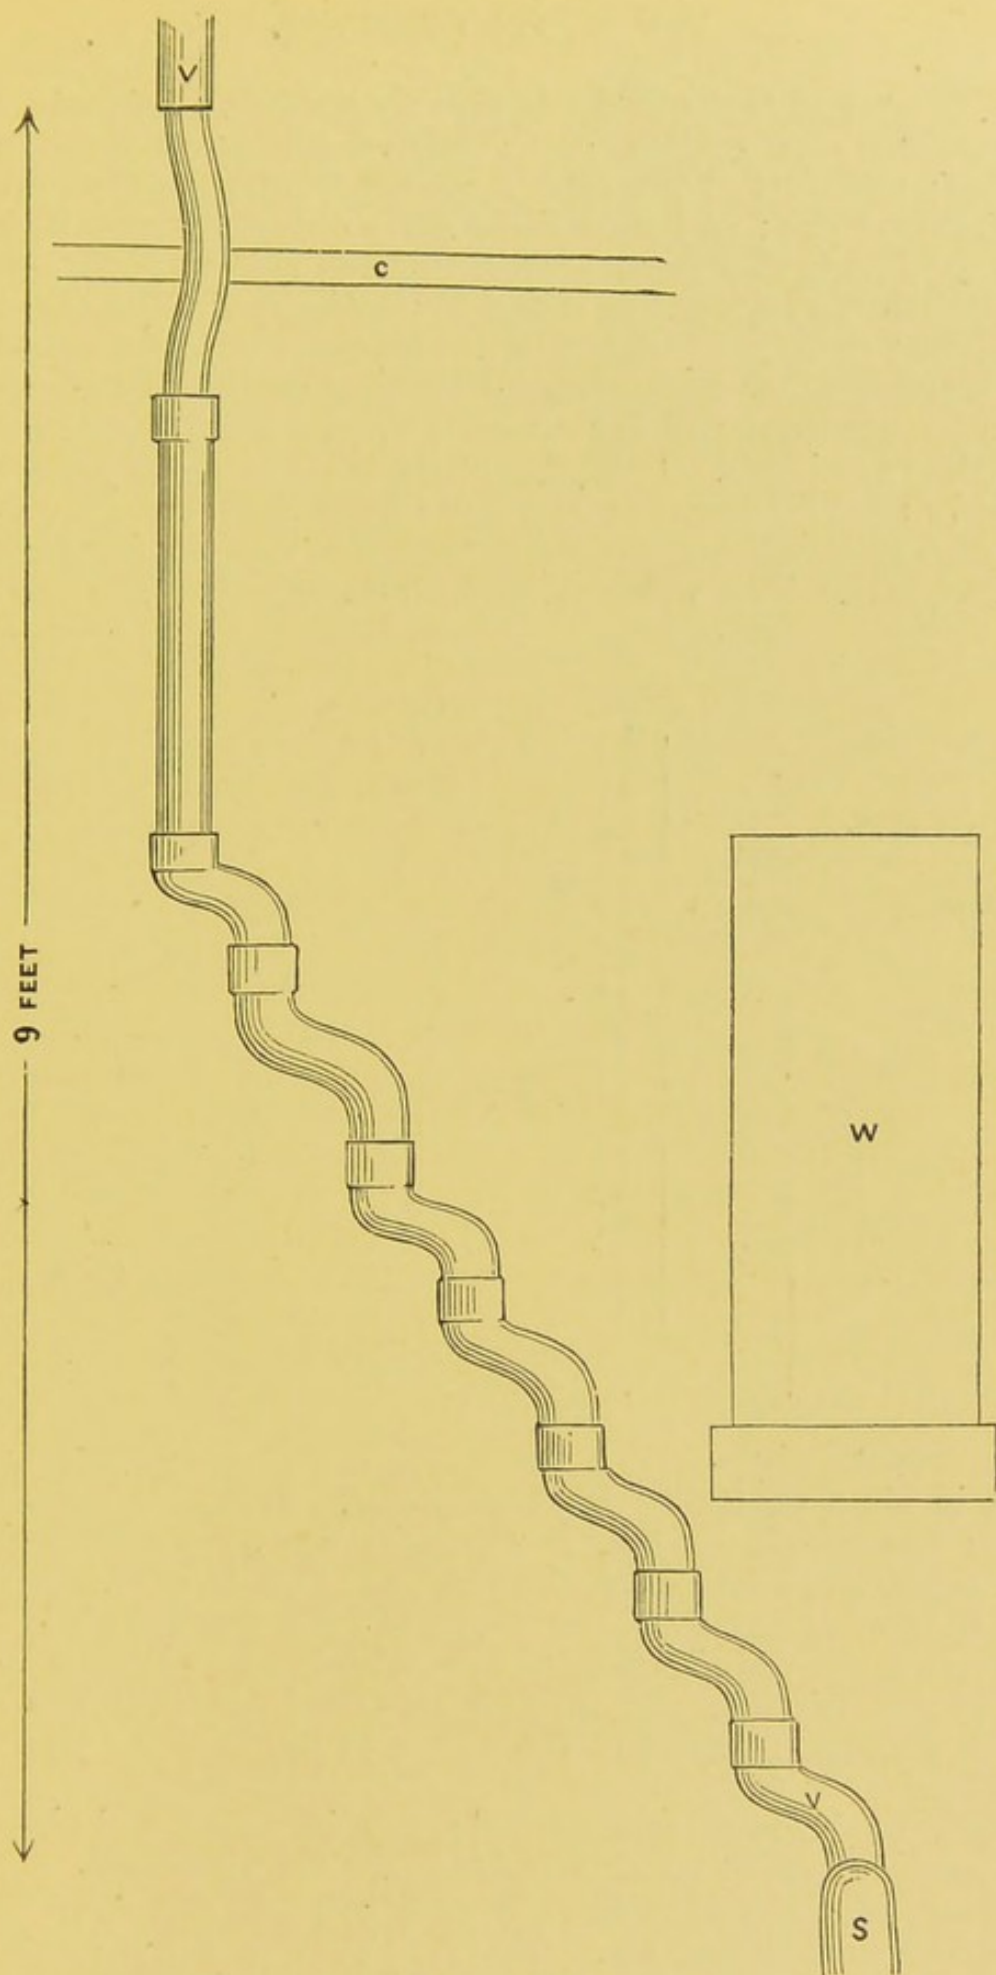
FIG 64.

A correspondent has kindly drawn my attention to a soil pipe ventilator which is certainly noteworthy. Such an unworkman-like contrivance I hope and believe is not common. (*Vide* Fig. 64, which is carefully drawn to scale.) W represents the window

of a closet, and S the lead soil pipe from same. Jointed to this was an iron pipe casting, which carried the ventilator up nine inches; and next to this came a second, third, and fourth casting of the same size; and then three more castings similar in shape and averaging the same length. Above this was 2½ ft. of iron pipe, then the rain gutter C had to be "jumped," and there was a further length of about 8 ft. of iron pipe, the ventilator terminating a few inches above the top of the gable. It will thus be seen that the ventilator VV, in ascending 9 ft., had no less than ten joints. It is not likely that all these joints were tight in the first instance, and quite impossible that they would remain so after the expansions and contractions of a few summers and winters. Two windows, one above the other, to the left,

were in close proximity to these joints. It is to be noted that while the soil pipe is 4 in. in diameter the curved castings are 3 in. pipes, and above a smaller diameter pipe is used. My correspondent remarks that the plumber responsible for this work was probably uninformed on the subject of resistance to air currents by friction, and that he sacrificed efficiency to a taste for ornamental device and the desire to sell as much piping as possible.

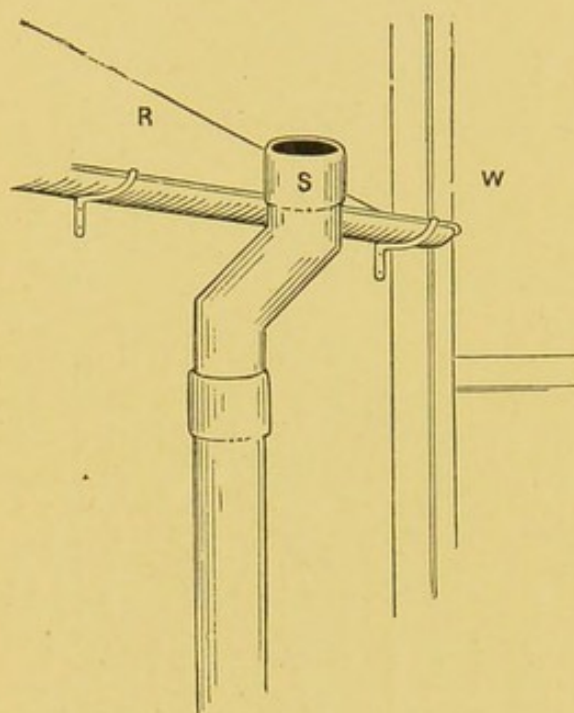
FIG. 65.

Fig. 65 indicates yet another way in which soil pipes are deliberately ventilated into bedrooms. The defect was noticed in several newly-built houses forming one side of a main street. A portion of each house projects into the yard, and is one storey lower than the rest of the building. These portions contain the

closets. The soil-pipe ventilators should, of course, have been taken up 2ft. or so above the eaves of the roofs of the main buildings. As it is, however, the ventilator has, in each instance, been carried just above the gutter of the lower roof, and terminates close to a bedroom window, as shown in the illustration. R is the lower roof, S the soil pipe ventilator, and W the window.

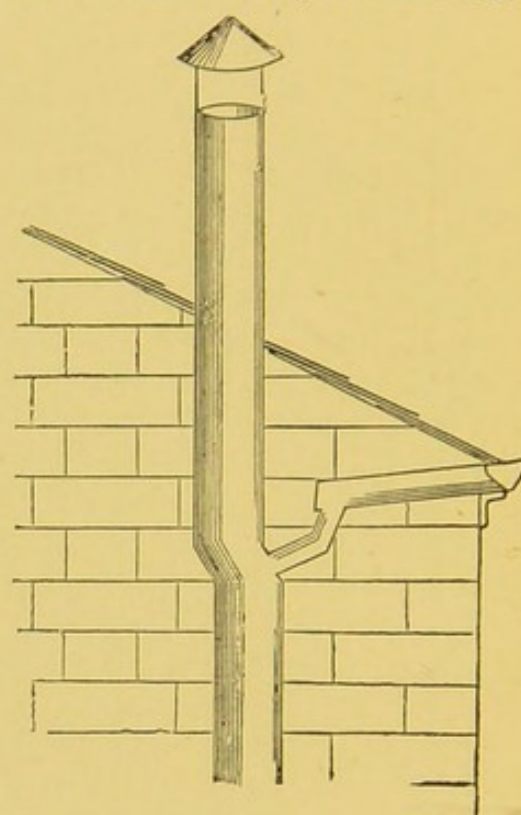
FIG. 66.

Fig. 66, from a correspondent, represents a soil-pipe ventilator into which the rain is conducted. The trapped bath waste and overflow, as well as the rain pipe, are connected with what is

intended as a ventilator to the soil pipe; but as this is sealed at its base by the contents of a syphon trap, the soil pipe is really unventilated. A pipe such as this, remarks my correspondent, is expected to convey rain and waste water downwards and a current of air upwards, and this occasionally at one and the same time, the effects of the compression of the contained air below the points of discharge, and of syphoning and trapping water, not being apparently considered. Ventilators as described

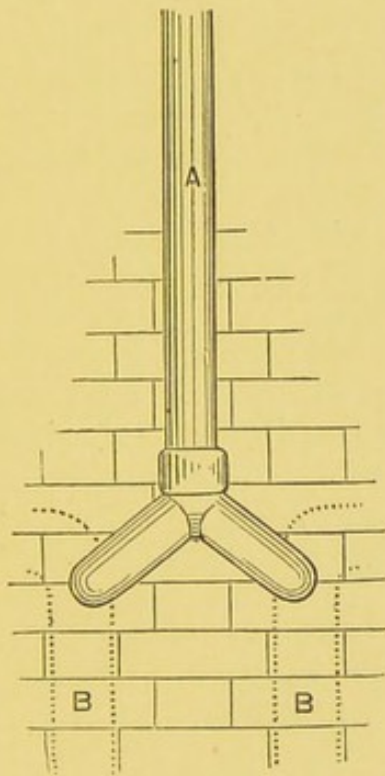
FIG. 67.

Fig. 67 represents two soil pipes built into the wall, and ventilated in a novel way. A pair of semi-detached villas had closets in the front, on the first floors over the lobbies. The soil pipes coming very near the surface of the wall on the inside were covered by about an inch of plaster; and in one villa the staining of this plaster and an effluvium nuisance gave indications of a leak. On calling at the villas with reference to this nuisance, the first thing noticed was the iron ventilator as shown which was connected with both soil pipes. It was not ill-fitted, and was carried up 9in. above the roof eaves. If a stoppage had occurred in either of the soil pipes, the contents would probably have overflowed into the common ventilator and choked it. A indicates the ventilator, B and C the two soil pipes.

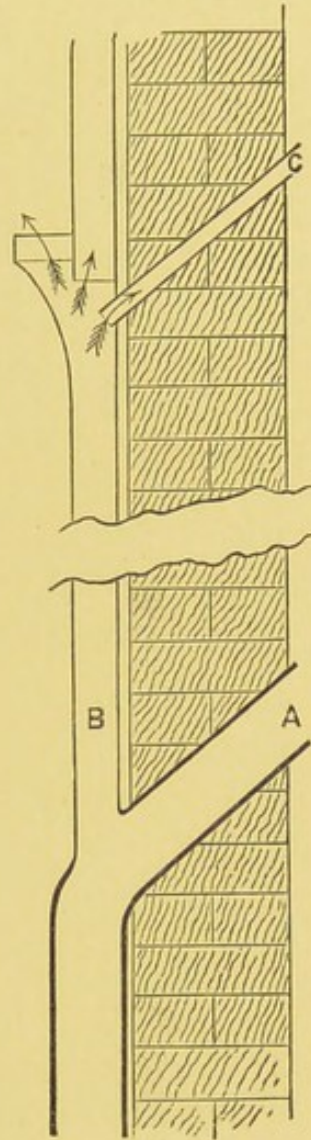
FIG. 68.

Fig. 68 represents an ingenious device for ventilating a soil pipe into a bedroom. Offensive smells in the bedroom were noticed and complained of. On inspection it was found that there was an open cistern in the bedroom, and that the overflow pipe from this was carried into the rain spout, which was made to act as a soil-pipe ventilator. A is a 4in. soil pipe taken out direct from a closet, B is a 2½in.

part of the foul air from the soil pipe was conveyed up the overflow pipe into the bedroom, part ascended the upper portion of the rain spout to the roof gutter, where a portion got in under the slates, and part was delivered externally to be drawn in at contiguous windows when open.

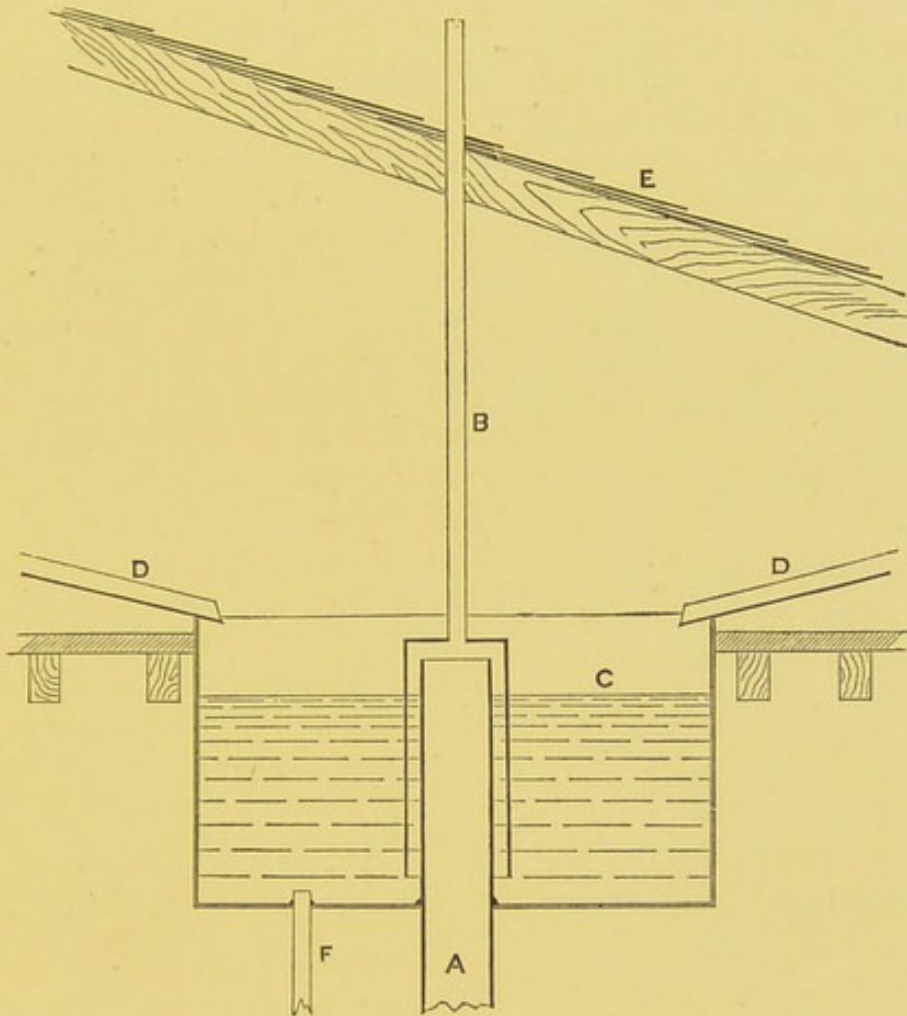
FIG. 70.

Fig. 70 represents part of a series of defects found in each of fifteen suburban residences, erected about twelve years ago. The soil pipe, of 4in. cast-iron pipes, was carried up through the bottom of the rain-water cistern to within two or three inches of the top, and made to act the part of overflow for the cistern. This is marked A in the cut. A zinc cap, in diameter two inches larger than the soil pipe, was placed in position over the end of this pipe, as a bell over a sink pipe. A zinc pipe B, an inch in diameter, was soldered round a hole at the top of the zinc cap, and the upper extremity continued above through the roof E, as shown. C is the rain-water cistern for flushing the closets, D and D the gutters from the roof, and F the flush pipe. As the soil pipe was directly connected with the main sewer, and the closet, soil pipe, and cistern were situated in the centre of the house, with no ventilation to the closet, sanitary arrangements could scarcely have been more defective. There were, however, houses in the same district in which the soil pipes were found continued upwards into the cisterns, and where not even one inch ventilators had been provided.

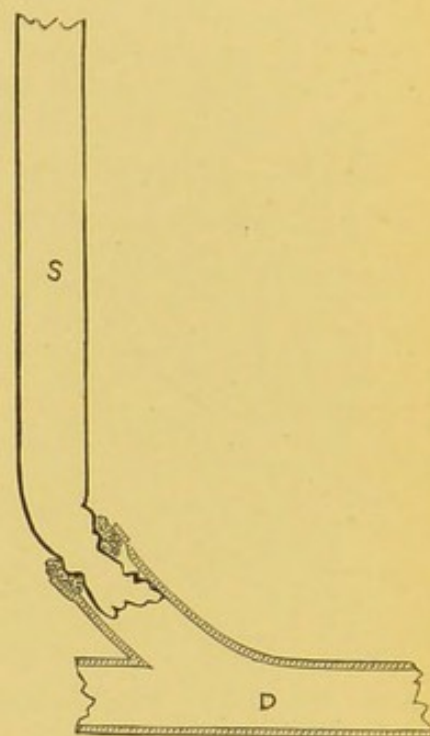
FIG. 72.

Fig. 72 shows a lead soil pipe S connected by a junction pipe D to the house drain. Instead of making a proper joint the workman had crumpled up the end of the soil pipe, and roughly thrust it into the pipe anyhow. It was cemented round, so that the joint did not actually leak, but at the joint the capacity of the soil pipe was reduced from being 4in. in diameter to being scarcely 2in., thus preparing the way for a stoppage sooner or later.

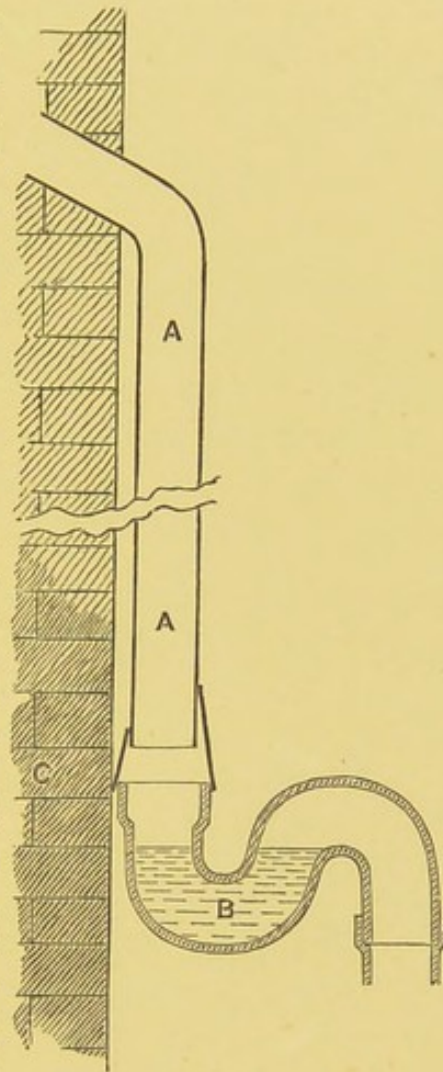
FIG 73.

Fig. 73 was sent by a correspondent in one of the largest towns in the kingdom. It represents an unventilated soil pipe, imperfectly connected with the trap at the foot. The connection consisted of four slates laid round the end of the soil pipe and trap. The result was that the contents of the soil pipe soaked into the ground and the contiguous portion of the wall, causing an effluvium nuisance inside the house. A indicates the soil pipe, B the trap, and C the saturated portion of the wall. Here

are three defects—the bad connection, the absence of a ventilator, and the trap at the foot of the soil pipe.

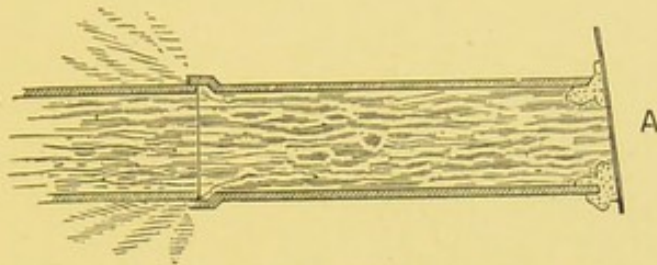
FIG. 75.

Fig. 75 illustrates the cause of a nuisance in a suburban villa. On inspection it was found that the 6 in. drain from the closet came to an abrupt termination close to the garden wall dividing this property from the next. The end of it had been deliberately closed up as shown at A, and the drain was full and leaking at some of the joints. A reference showed that two villas were built at the same time, and were allowed to drain together to the same sewer in front. Subsequently the villa in which the nuisance occurred was sold, and the other remained the property of the builder. It seems probable that about the date of the sale the vendor must

have severed the drain from the villa he was selling, and reserved the drain running down his garden for the exclusive use of his own villa. A similar case was brought under my attention some time since. A drain serving two adjoining houses became frequently choked, and the tenants quarrelled about the payment of the charges made for cleansing it. Eventually the tenant of the garden in which the drain was situated cut off his neighbour's drain. Here, however, the disconnection was done openly and avowedly, and no attempt was made to close the end of the pipe, so that the resulting nuisance was manifest, and a separate drain was provided without delay.

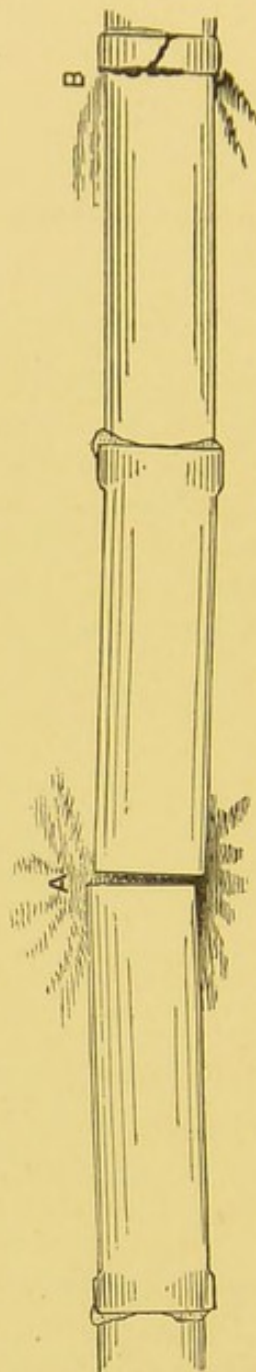
FIG. 78.

Fig. 78 shows another small portion. It will be noticed that two pipes are placed with the plain ends together, leaving an open joint at A, and the flange is broken off the pipe at B. Many of the flanges were found to be broken, and plain ends were placed together at two or three points.

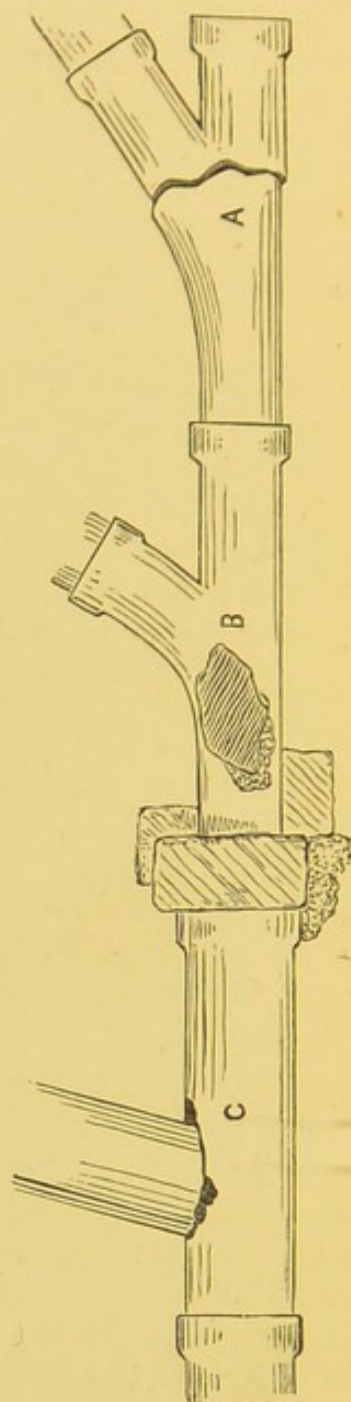
FIG. 79.

Fig. 79 represents the exact appearance of three pipes when the earth was removed from them. They are seen in plan, that is from above. At A is a 4in. junction, fractured right across, no proper bed having been made to support the pipe beneath.

the drain. Pipe B delivers into a 6in. pipe, there being a distance of fully 4in. between the pipes, the joint being roughly

made with brickbats and mortar. At C a hole had been knocked in this 6in. pipe, and another 6in. pipe from a gully trap roughly brought into it as shown. These three pipes are three consecutive pipes just as discovered. Of course the leakage from such a drain was enough to account for dampness in the neighbouring wall. However, the worst part of the drain is shown in section in

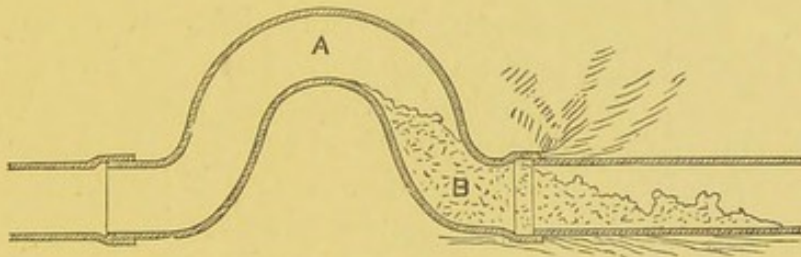
FIG. 84.

Fig. 84 illustrates an instance of remarkable stupidity that came under the observation of a correspondent from a small urban district. A 4in. earthenware pipe drain was not running, and it was exposed at the point where the stoppage appeared to be. The cause of the obstruction was at once brought to view. A trap had been introduced in the course of the drain, but it had been set *upside down*. None of the joints were properly made, and the pipe delivering into the trap had not been pressed into the flange that received it, and the drain contents had leaked out at this joint, saturating the surrounding earth. A is the trap set upside down, and B is the solid matter causing the obstruction.

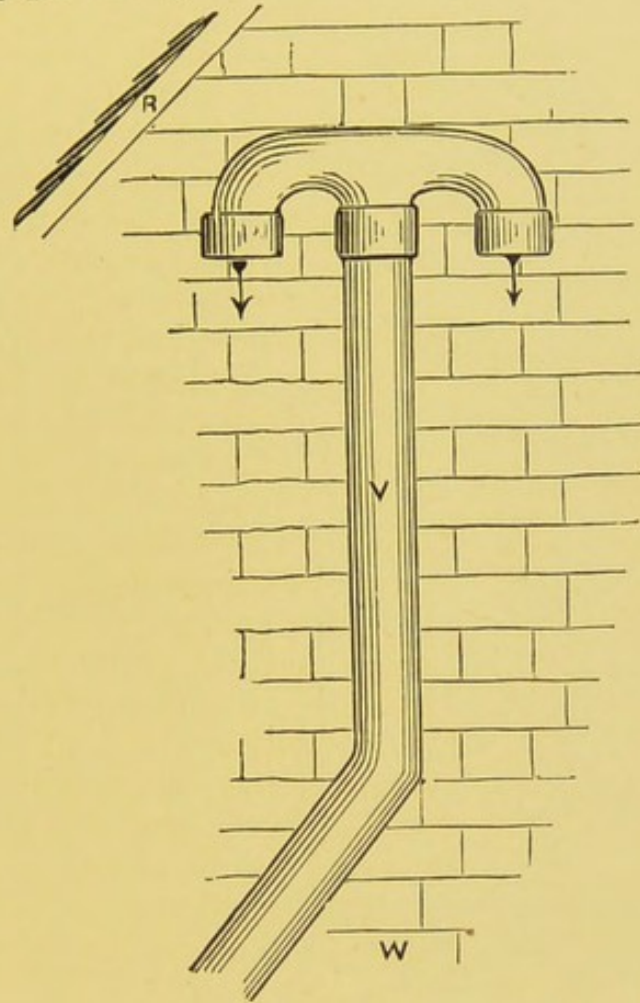
FIG. 87.

Fig. 87 shows the upper extremity of a drain ventilator. It was fixed to the gable wall of a large house, and instead of being carried up above the roof, in the usual way, it was turned obliquely to the right, apparently for no other purpose than to bring it over a window, and then it was capped with a terminal to direct any foul air it discharged downwards towards the window. V indicates the ventilator, which, with the terminal, was of 4in. cast-iron pipe. R shows a portion of the roof, and W indicates the position of the bricks just above the top of the window.

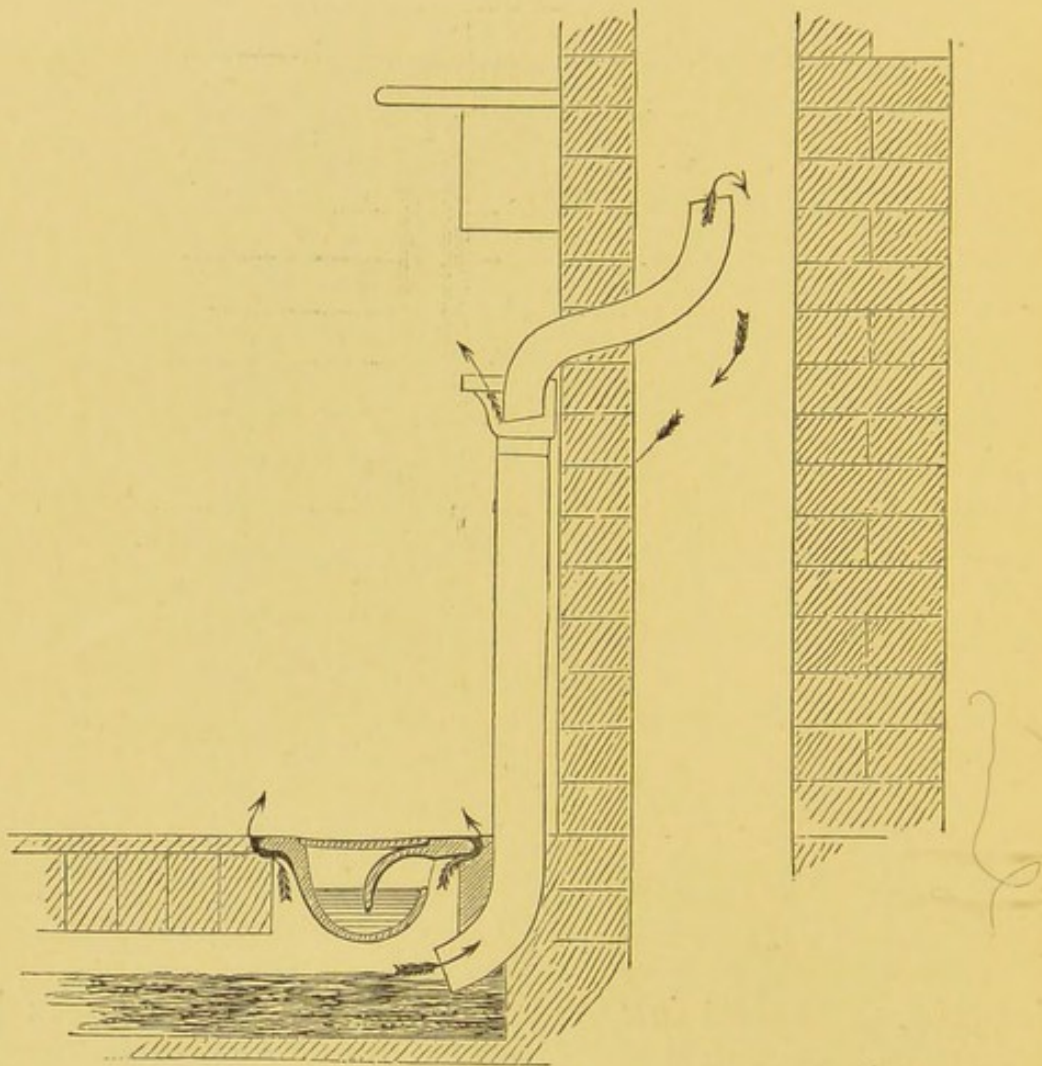
FIG. 88.

Fig. 88 represents a resident owner's attempt to remedy a defect in his house. In the basement of the premises was a rubble drain, laid without fall, the entrance to which was guarded by a loose D trap. Such a drain (it was continued from this house under three or four others) was necessarily a drain of deposit, and the effluvia arising therefrom had free access to the house, the traps notwithstanding. The owner thought he could remedy the nuisance by fixing a perpendicular pipe as shown, through which he could flush the drain and keep it clean.

The pipe was accordingly fixed, and buckets of water poured down, but the nuisance remained. Having an idea (not an uncommon one) that the current of air is always upwards in a chimney, the

owner next carried a pipe, from the head of the flushing pipe, for about a foot up the chimney. The result of the owner's remedial measures was that the effluvia, instead of coming up merely at the edges of the loose trap, had free exit at the flushing

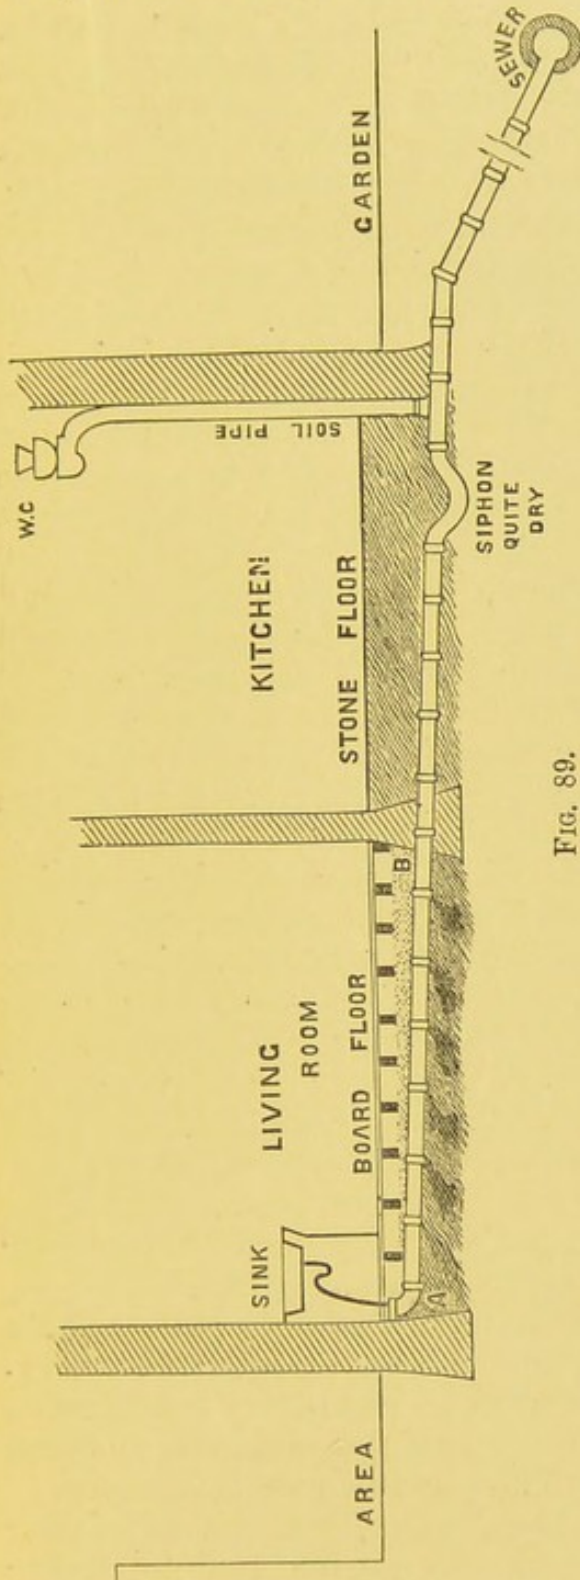
FIG. 89.

Fig. 89 shows the sanitary arrangements of a large boarding-house at an inland watering-place. The correspondent who supplied the sketch was recently called on to make an investigation, and the section of the basement of the building represented in the cut correctly indicates what he discovered. My correspondent writes: "There was no intercepting trap between the public sewer and house connections, but a syphon trap had recently been inserted in the drain passing under the house, and new pipes had been laid under the living room. This had been done to get rid of a bad smell which had been noticed in the living room. On pulling up the floor of the living room I found the pipes laid on the ground, the joints being quite open, the pipes loose, and partially covered with sawdust. The sawdust and soil were saturated with foul water from the sink in the pantry adjoining the living room, the water from this sink having all escaped through the open joints. Although the trap under the kitchen floor had been inserted nearly a year, no water had ever reached it. The sewer gas had therefore free access to the house by the living room." A is the saturated soil and B the saturated sawdust. All the joints from A to B were open.

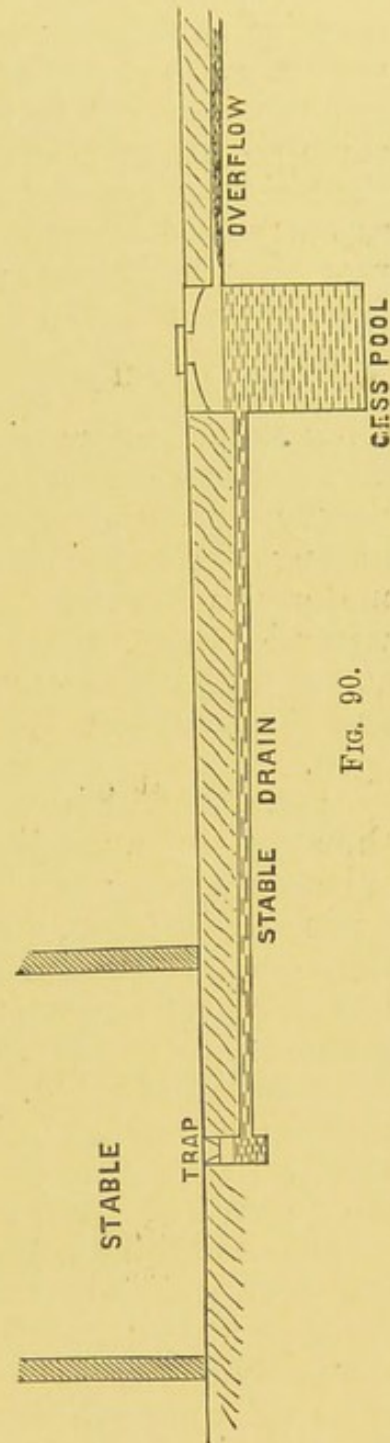
FIG. 90.

Fig. 90, which was received with the above, is a section showing the arrangements found at large stables, where, an epizootic among the horses had led to an investigation. The drain was of brick, 6in. by 6in., laid without mortar or cement; the cesspool was 7ft. by 4ft., and 5ft. deep; and the overflow was made of agricultural drainage pipes. "On opening up," writes my correspondent, "I found the stable drain charged and the overflow blocked. The overflow had been placed at too high a level, and the drain itself was flat. On the same premises the overflow from the cistern from which water was obtained for the horses had direct communication with a cesspool."

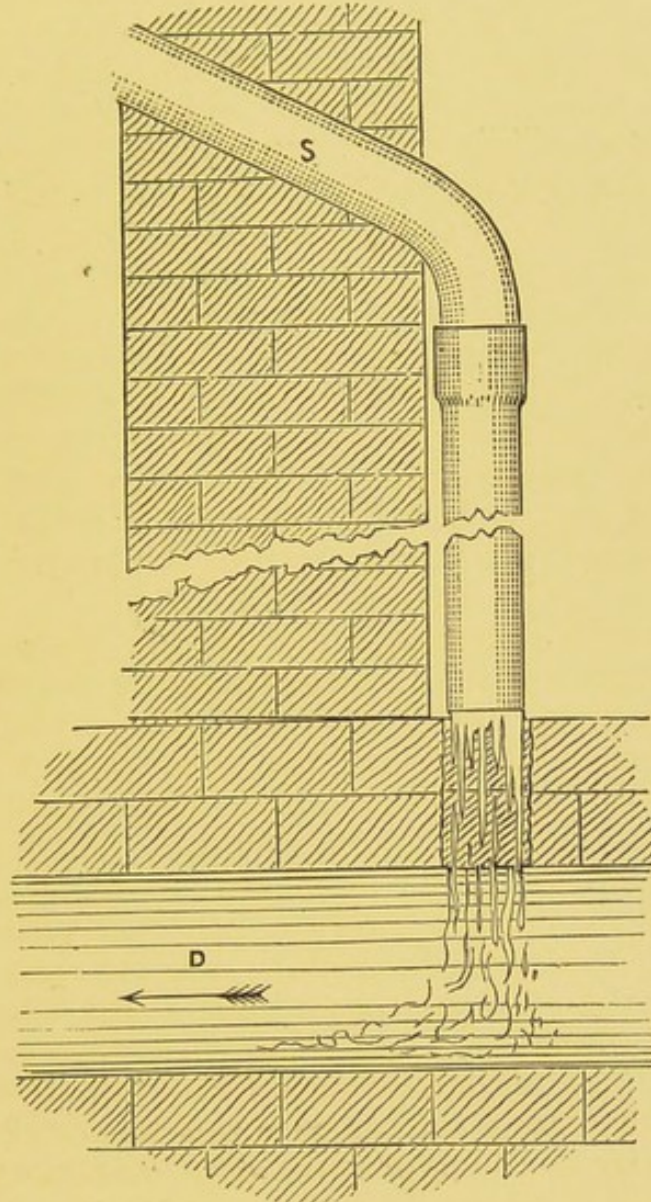
FIG. 91.

running under the house. The length of iron soil pipe ($4\frac{1}{2}$ in. pipe) had not been quite long enough to reach to the sewer, so a hole had been roughly cut in the sewer and the soil pipe delivered over it, no joint having been attempted. In Fig. 91, S is the lead soil pipe properly jointed to an iron soil pipe. The way this delivered into the drain D is shown.

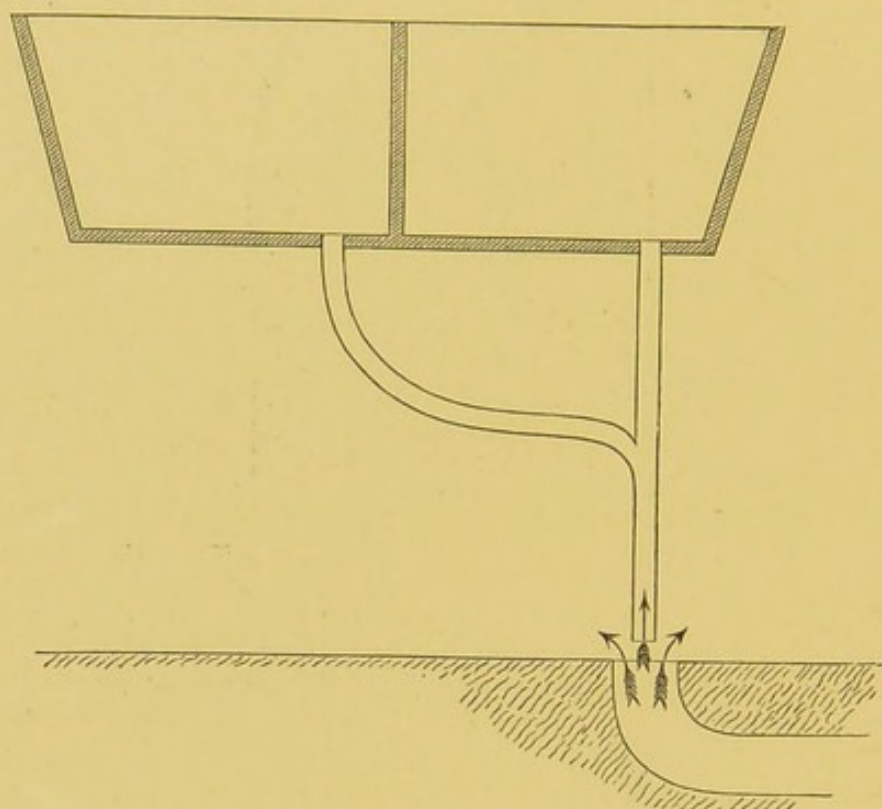
FIG. 92.

Fig. 92 represents an untrapped drain in a washhouse adjoining a kitchen. Complaint was received from the occupant

of the premises of an effluvium nuisance. Two fixed washtubs discharged over a grating in the floor, and on the grating being removed it was found that the washhouse drain was without a trap of any kind, and delivered into the sewer direct. The arrangement is shown in the illustration. The owner of the house was a builder, and yet when communicated with and directed to abate the nuisance he at first insisted on connecting

the waste pipes from the washtubs with the washhouse drain. It was pointed out to him that this could not check the ingress of sewer gas, but would merely deliver it at a higher level, and that whether the waste pipes from the tubs were connected with the washhouse drain or not, the latter would have to be severed from the sewer by a gully trap, or in some other efficient manner.

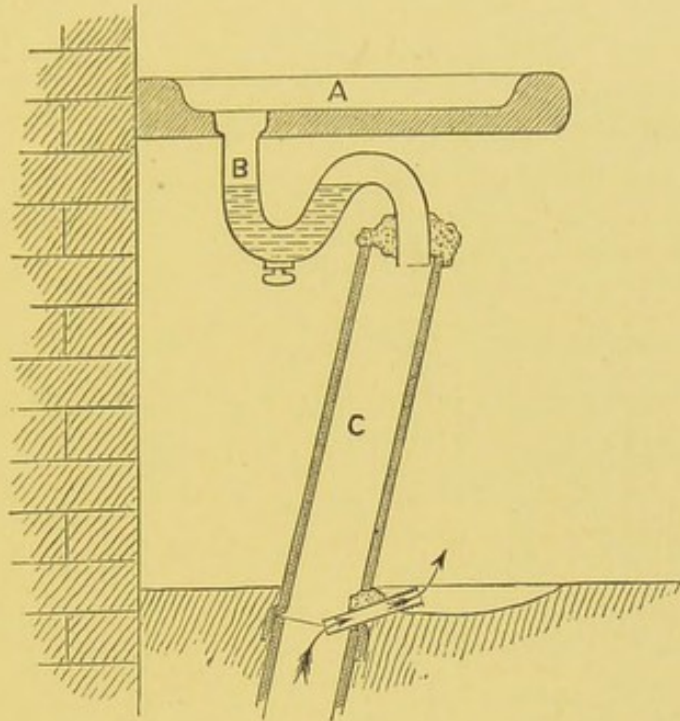
FIG. 93.

Fig. 93 shows in section a sink as fitted in the basement of a small house let at about 8s. a week. The sink waste pipe was trapped with a large iron (S) trap, and delivered into a 4in. glazed earthenware pipe, and thus to the drain. The basement being used as a washhouse, some sort of drain was required for the floor, and this was provided in the following way: A small dish-shaped depression was made near the sink, and a short

length of iron pipe carried from this to the glazed earthenware pipe. This iron pipe was fitted with a brass cap, which screwed on. After the washing was over for the day, the cap was screwed off and the tubs emptied, and then the cap screwed on again. Of course, in practice, the cap was not always screwed on at once; and one night that it chanced to be left off, the effluvium nuisance was so bad as to cause the woman of the house to get up and search for the cap and put it on. A is the sink, B the iron trap, and C the glazed earthenware pipe. The whole arrangement was unworkmanlike, but B was jointed to C quite securely with cement, and the floor near the sink was finished off with cement, so that the only direct communication between

the inside of the house and the drain was through the short iron pipe described.

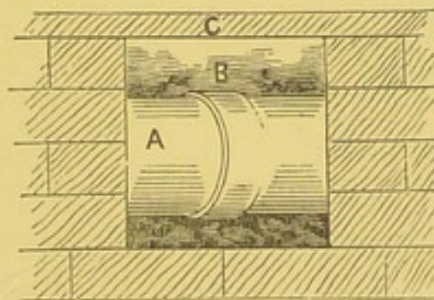
FIG. 94.

Fig. 94 represents a curious case of obstruction which I discovered in making an examination of a very large house. It was ascertained that the obstruction was in an old drain under

the area. On removing the flags a square brick-lined drain was brought to view, and crossing this obliquely was a 6in. pipe drain, which was the immediate cause of the obstruction. The pipe drain had been laid in connection with additional sanitary accommodation recently provided, and those responsible for the work seem to have been indifferent as to the effect it must have

on the old drain. A is the pipe drain, B the old brick drain shown in section, and C the area flagging.
