Defects in plumbing & drainage work / described by Francis Vacher.

Defects in Plumbing and Drainage Work

described by **Francis Vacher**
upwards of 100 illustrations

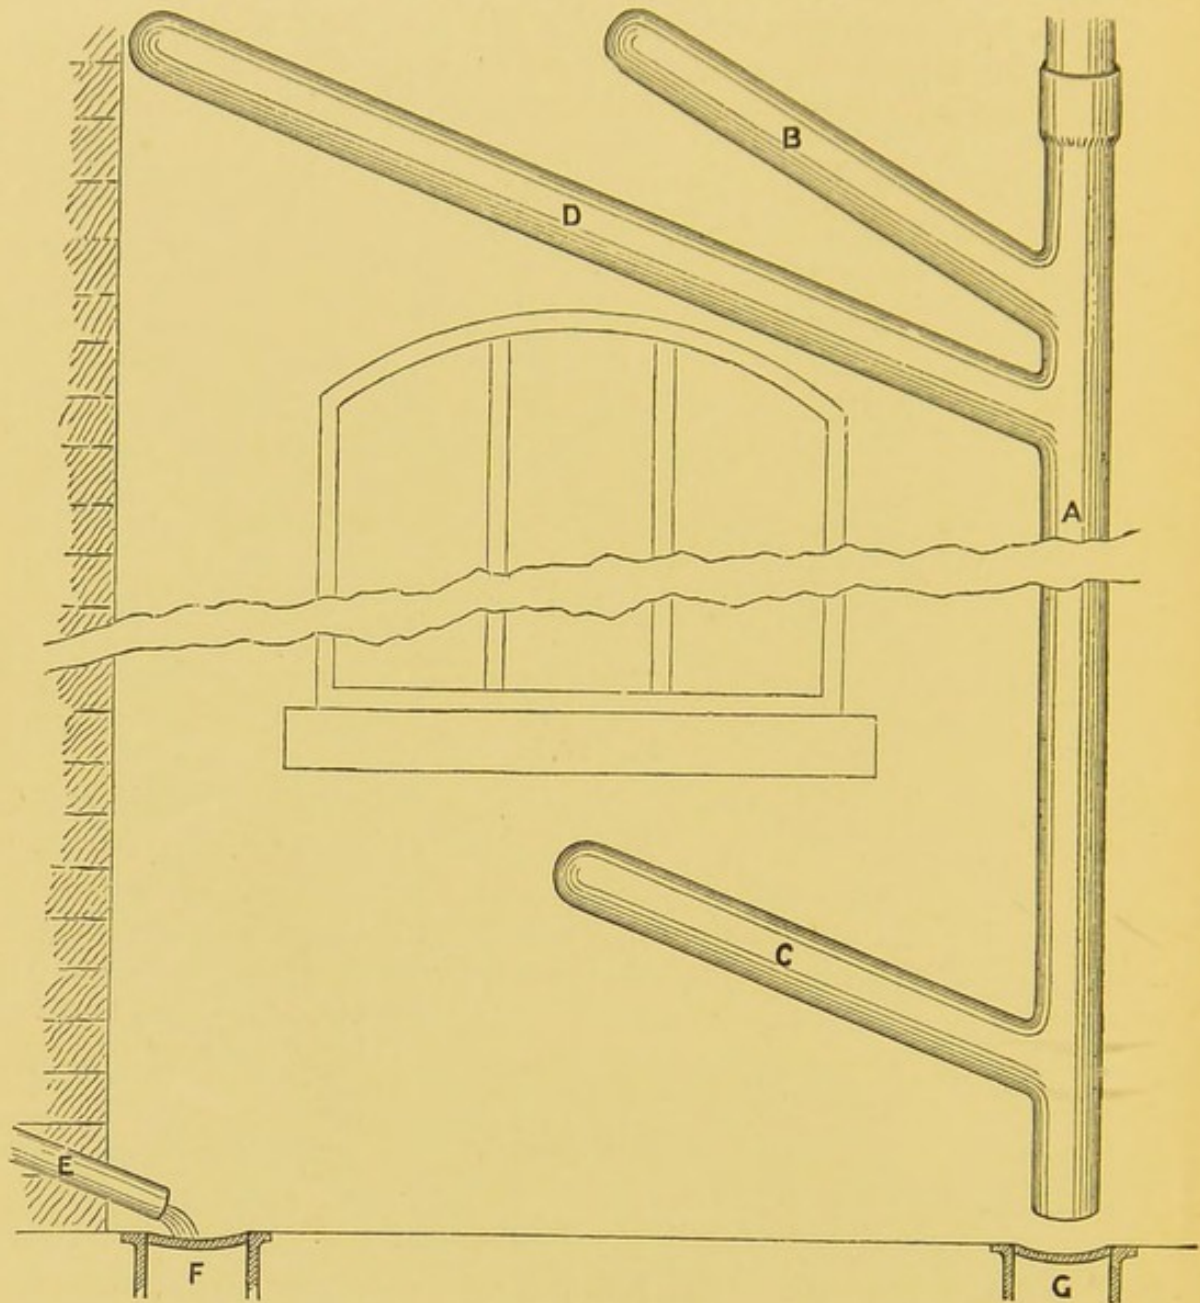
FIG. 95.

Fig. 95 is a specimen of ill-planned work in connection with a hospital. One of the peculiar features of the hospital is that there are two distinct drainage systems—one for so-called "sewage," which is specially treated, and one for surface water,

which passes into a pond. It was arranged that all bath and lavatory waste water was to pass into the foul water, or "sewage" system. As the work was carried out, it seems to have been left to chance as to which system of drains the waste pipes delivered into. A is a rain spout from the roof, delivering on a gully trap G, *connected with the surface water drain*; B and C are dis-

charge pipes from the first floor and ground floor lavatories; D is the discharge pipe from the first floor bath—all these being connected with the rain spout A. E is the discharge pipe from the ground floor bath, delivering on a gully trap F, *connected with the foul water drain*. The 4in. earthenware pipe drain leading from F crossed over the 4in. earthenware pipe drain from G, the one lying almost close to the other. A, B, C, and

D are 4in. iron pipes. E is a small lead pipe, as shown. "The object of this blundering," writes the correspondent who furnishes me with these particulars, "is difficult to see, as it would have been far simpler to discharge all the bath and lavatory water on a grid in F." The most economical way of remedying the mistake appeared to be to connect the gully G with the foul-water system, and this has now been done.

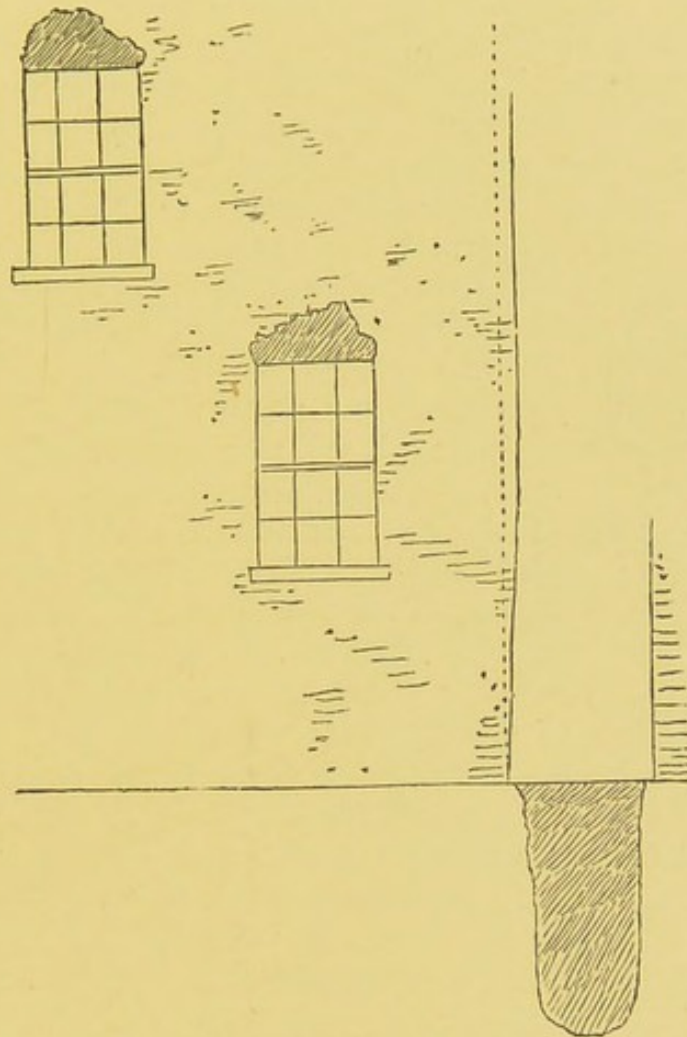
FIG. 96.

Fig. 96 shows the effects of not shoring up a wall before digging a trench close to the wall footings. Earth was removed

from a back passage, to the depth of about 9ft., in order to reconstruct a drain, and as a result the wall parallel to the trench got out of the perpendicular, as shown in the dotted lines in the sketch. Some time after the ground had been filled in, the brick arches over the windows fell out as indicated. Workmen often appear to think that shoring up the sides of the trench in such a case is sufficient. The house on the opposite side of the passage was much larger and higher, and thus not so liable to be affected.

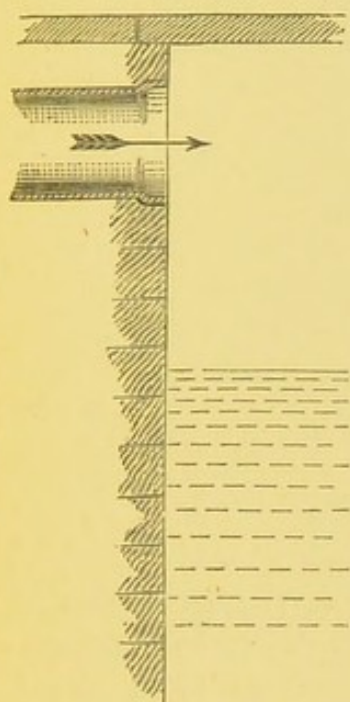
FIG. 97.

Fig. 97 represents a portion of the interior of a terra cistern, the overflow pipe from which is carried directly into the drain. Connecting the cistern overflow to a drain is, I regret to say, a

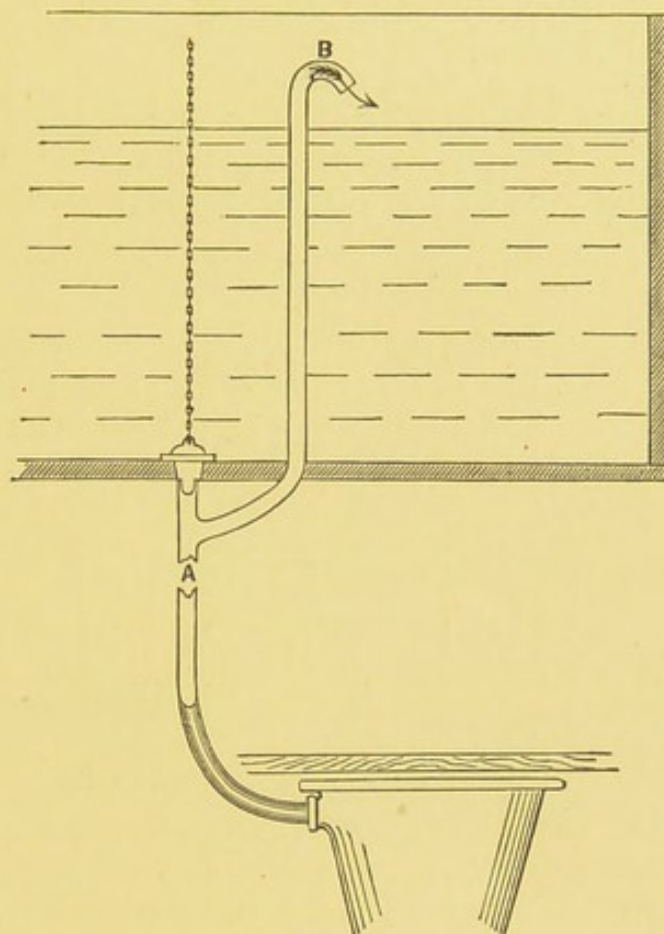
FIG. 98.

Fig. 98 represents a portion of the interior of a domestic store cistern, used for flushing a closet, and for other purposes. A is the flushing pipe brought down to the closet basin, and B is a so-called air pipe, which discharges foul air out of the flushing pipe on the surface of the water in the cistern. Of course it would be just as simple an arrangement for the air pipe to deliver externally, and if the flushing pipe is big enough no air pipe is required.

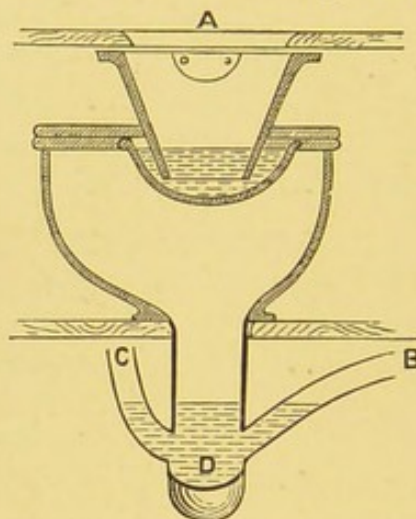
FIG. 99.

In a house in which there had been much sickness, and where there was reason to believe the water had become polluted, was found an old pan closet of the ordinary form—*vide* Fig. 99, A.

Into the trap D below were carried two pipes, the bath waste B entering on the one side and *the overflow from the cistern* C, at the top of the house, entering on the other side. The trap was continued as a soil pipe (inside the house and unventilated), delivering into an ill-jointed drain under the basement.

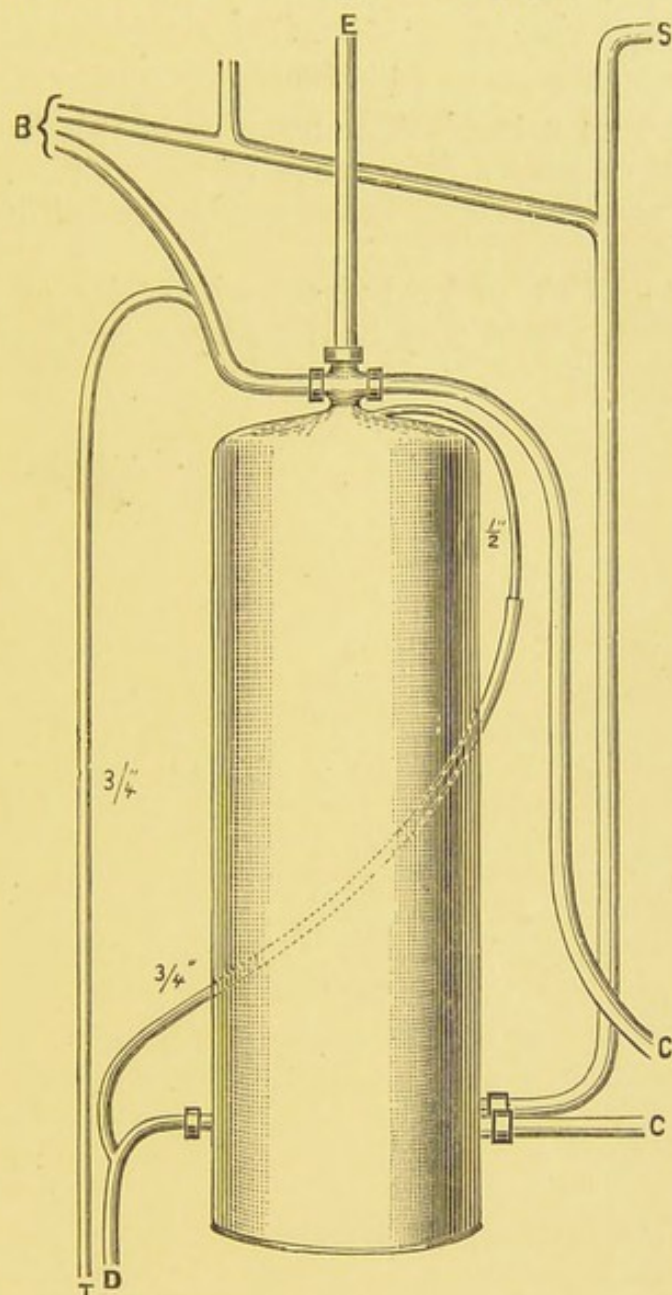
Fig. 100 illustrates an instance of defective plumbing which was made manifest owing to frost. I was informed that a copper cylinder, which had been fixed ten years since, and had hitherto given no trouble, had suddenly collapsed, the copper being rent in two places. On arriving at the premises I found the cylinder a hopeless wreck, and water still spurting from one of the rents. The cylinder measured 4ft. by 1½ft., and was fitted as shown. C and C are the circulating pipes, E the expansion pipe, S the cold supply, T a hot water tap for the kitchen, D the draw-off pipe for emptying the cylinder, which

was also used to supply a bath on the kitchen floor, and B a hot and cold pipe leading to a bath on an upper floor. I traced the supply pipe, and found that from the point S it was horizontal for 39ft., out of which 30ft. ran along an external wall, then it ascended along an external wall to a cistern, at the top of the house. It was not surprising that this pipe had frozen. The next thing was to trace the expansion pipe, which was led up

and made to pierce the roof, where the end had become choked with snow and ice. The bath had been in use once or twice since the frost, and as the cylinder cooled, the collapse had taken place. All the pipes were $1\frac{1}{4}$ in. except those marked. It is not easy to understand the intention of the $\frac{3}{4}$ in. extending from the pipe D, and continued as a $\frac{1}{2}$ in. to the top of the cylinder. It appears to have been put in as an afterthought. Probably the water in the bath supplied from D was not found to be hot enough, as

it came from the cold end of the cylinder, and matters were improved in the "jerry" way indicated. It will be noticed that the return pipe from the boiler is entered at the top of the cylinder—the approved practice is to enter this as well as the flow at the bottom of the cylinder. It is interesting to note that although this cylinder collapsed it had been fitted with a

so-called "vacuum valve." The function of this little apparatus appears to be to give a false sense of security. How often it happens that when its services are really needed it is stiff and does not act!

The fixing of 39ft. of lead pipe horizontally, as just referred to, is work which would only be done by a careless or ignorant

plumber. A pipe should always be given a sufficient fall to enable it to be emptied if required, and when nearly horizontal should be laid on a piece of wood.

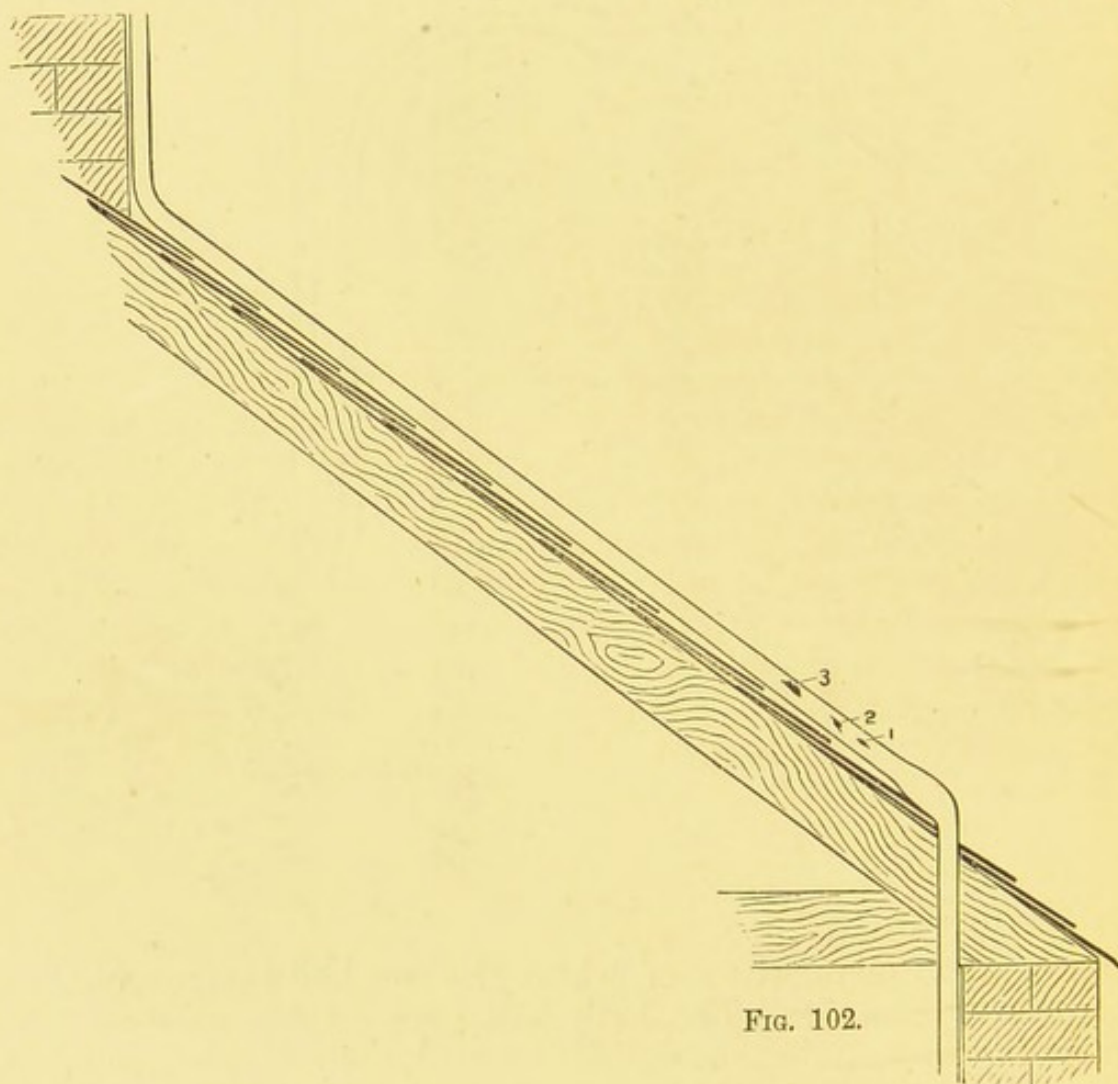
FIG. 102.

The next illustration, Fig. 102, shows the expansion pipe from a hot water cylinder, which was ruptured by frost three times between Christmas and the middle of January. Every plumber knows that an expansion pipe should not be exposed to the action of frost, yet the pipe shown was carried along the roof, unprotected for five feet, and then up a chimney for four feet. Just beyond the point where it pierced the roof there was a joint, and the first rupture occurred close to this at 1. After it was mended, a second rupture occurred at 2; and after this was mended, the pipe burst for the third time at 3. The

chimney was from a kitchen, and was practically always warm, and if the pipe, instead of being carried along the slates, had been made to pierce the roof where the chimney came through, it would have been efficiently protected from the action of frost.
