Defects in plumbing & drainage work... Illustrated by upwards of a hundred woodcuts. / described by Francis Vacher.

London : John Heywood, 1889.

Defects in Plumbing and Drainage Work

described by **Francis Vacher**
upwards of 100 illustrations

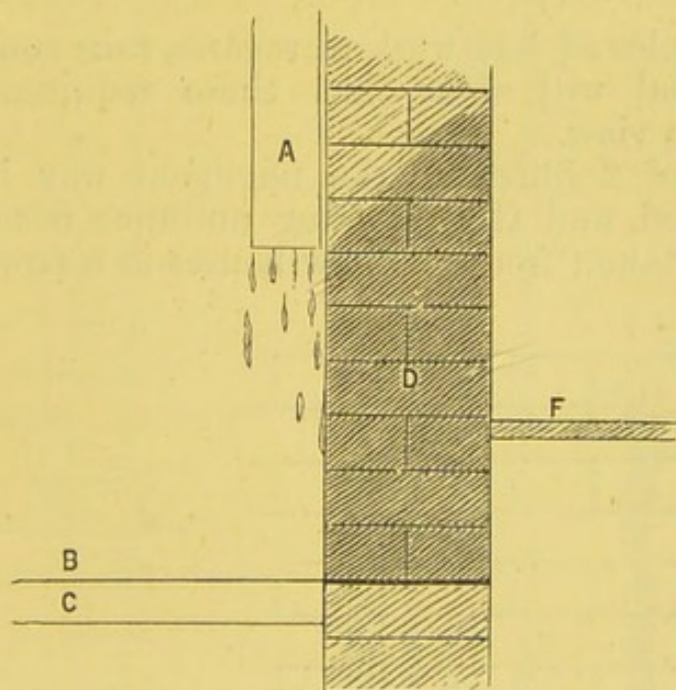
FIG. 1.

Figs. 1 and 2 illustrate the negligent way in which rain spouts are fixed, and the resulting nuisance from damp. The examples are taken from two new houses in a new street.

Fig. 1 shows the rain spout terminating 18in. above the surface of the pavement, and consequently discharging large quantities of rain directly on the wall of the front parlour.

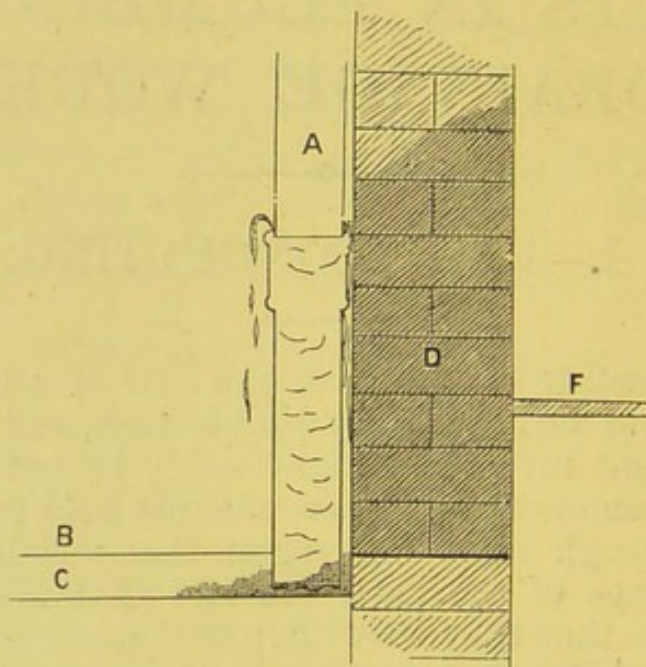
FIG. 2.

Fig. 2 shows the spouting continued by a length which has been broken off too short, and fastened too low. The end being

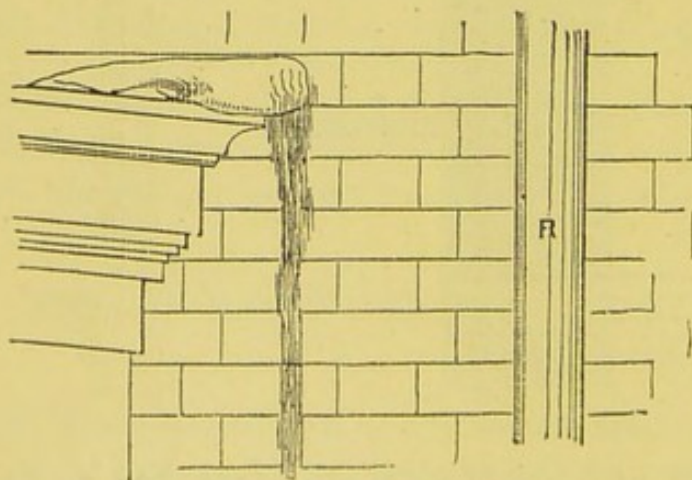
FIG. 3.

Figs. 3 and 4 represent defects lately brought to my notice in a row of new buildings. The bay windows in the front of four small houses have the rain conducted from the roofs, as shown in Fig. 3. In each house a piece of lead, cut too large for the window, is rolled up one side, and conducts the rain on the front wall, where it has already left a large stain. A rain spout R, terminating in a channel in the pavement, passes close by. The bay windows in front of the remaining six houses in the same row have the rain conducted from the roofs as shown in Fig. 4. The lead-covered roof of each window is provided with a short lead pipe, which pierces the coping stone, and delivers, as shown, like a watering pipe.

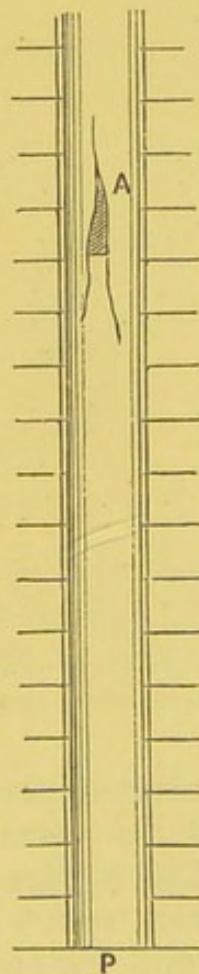
FIG. 6.

Fig. 6 indicates a defect I noticed lately. In the wall of a new building, flush with the street line, is a chase containing a 4 in. iron rain spout. In this is a double crack, 13 in. long, and this crack has lately been converted into a hole 1 in. across at

the bottom and 5in. long, as shown at A. The hole, being $3\frac{1}{2}$ ft. from the pavement P, causes a nuisance to foot passengers. The flaw was in the pipe originally, and could hardly have escaped the notice of the builder and his employés, and yet the pipe was accepted and used.

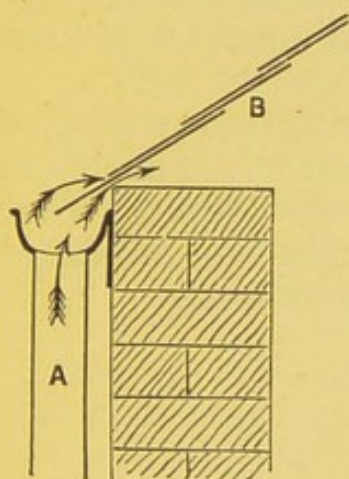
FIG. 9.

Fig. 9 is the section of the top of a wall, the slates, and rain gutter, and shows how a rain spout, carried straight into the drain, delivers gases from the drain into the house. To simplify the illustration, the framework of the roof is not indicated. B is where this framework would be; A is the 3in. rain spout made of sheet iron, and well jointed and connected to the gutter; and the arrows show how the gases find their way under the slates into the house.

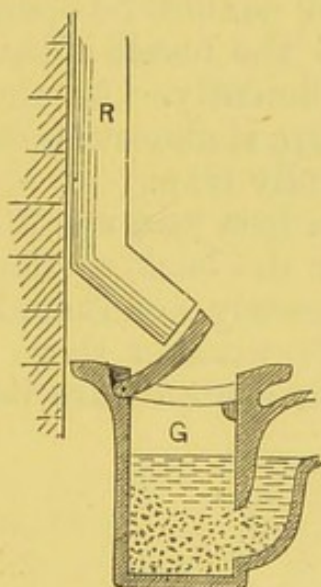
FIG. 10.

Fig. 10 illustrates a defect I saw recently, and I have frequently seen similar defects in sink-waste disconnections. In a detached villa in the suburbs the rain spouts are brought down to deliver on gully traps, in the manner shown. The grating of the trap is hinged, and made to open to a right-angle with the mouth of the trap, in order to allow of the trap being systematically cleansed. The end of the rain spout is fixed so close to the trap that the grid cannot be opened except to an angle of about 35 degrees, and the result is that it is almost impossible to cleanse the trap efficiently. As the rain spout is cast iron, the outflow of the trap is almost choked with rust. R is the rain pipe, and G the gully trap.

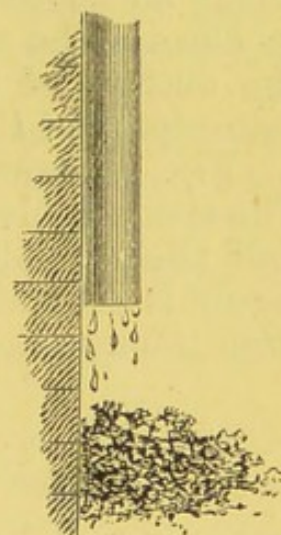
FIG. 11.

Fig. 11 shows a 3in. iron rain spout delivering into an ashpit. The spout receives from the back portion of the roof: thus about half the rainfall is directly conducted into the ashpit. The result is that after wet weather there is an effluvium nuisance from the ashpit, and the contents are usually saturated.

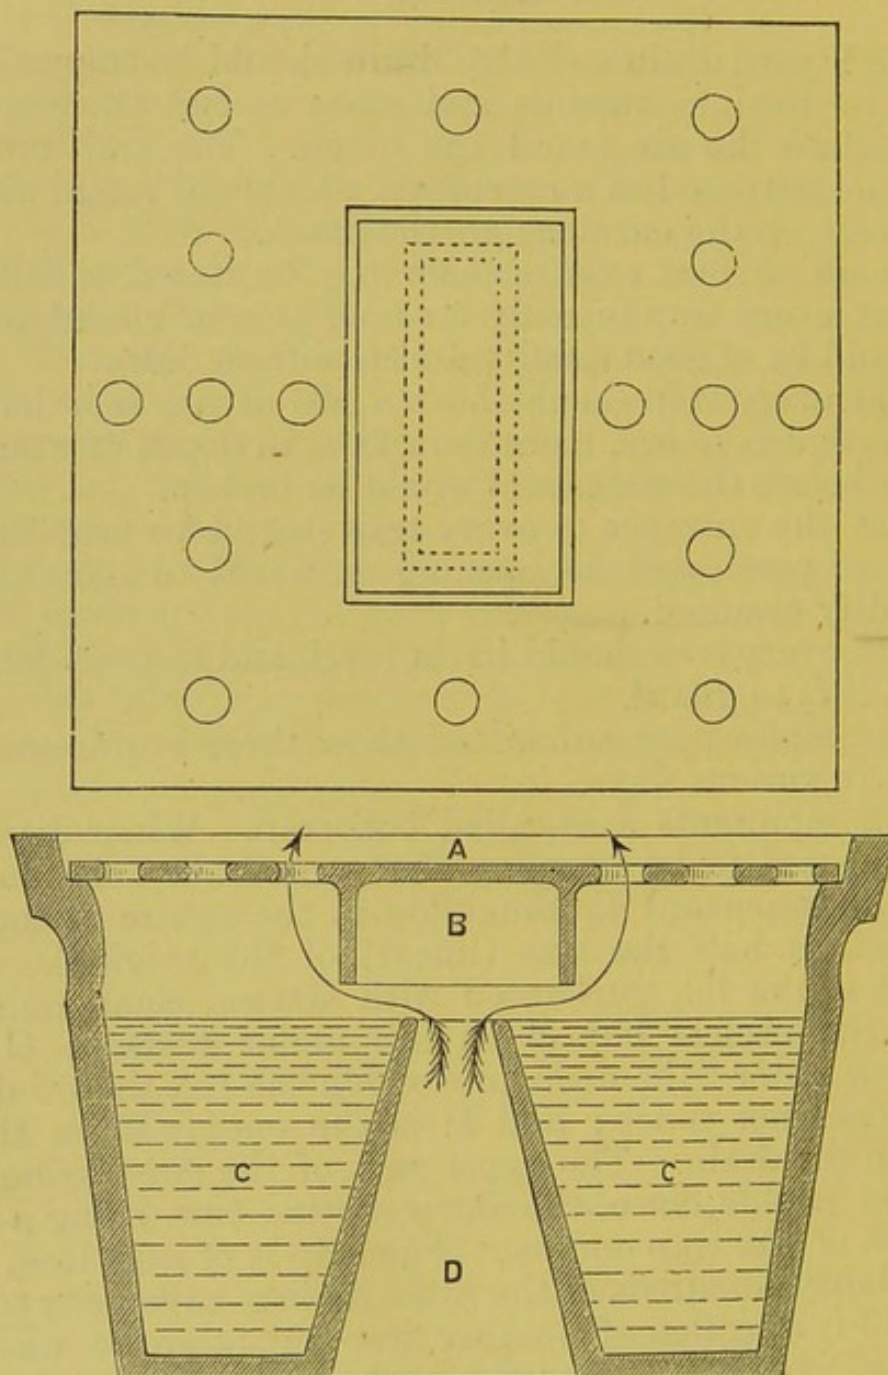
FIG. 12.

Fig. 12 represents a so-called box trap. When discovered, it was supposed to be trapping the yard drain belonging to a house in an important thoroughfare in the centre of the town. The sketch is half the size (linear) of the original. In the section, A is the lid, perforated with sixteen small holes, and carrying the useless box B on the under surface; C is the reservoir of water $2\frac{1}{4}$ in. deep, into which the box should dip, but which it does not touch; and D is the outflow from the trap leading to the drain. The upper part of the cut represents the lid turned upside down, the inner dotted line being a plan of the mouth of the trap outflow. The trap is of cast iron, and in all probability hundreds of the same casting have been sold.

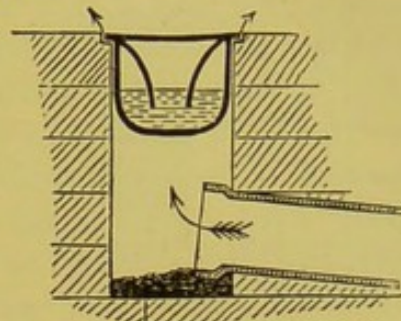
FIG. 14.

Fig. 14 shows the uselessness of trapping a yard drain with a loose trap of any pattern. The trap shown is a so-called dish

trap made of cast iron. It very easily gets choked, and for this reason it is commonly inserted without any setting, so that it may be taken up and cleansed. Any gases or vapours in the drain are not, of course, kept back, but find their way out external to the trap on all sides, as indicated in the illustration. The trap shown was found on premises owned by well-to-do

people, who would hardly have objected to the cost of providing and fixing an efficient gully trap, if the defects of the loose trap had been pointed out to them.

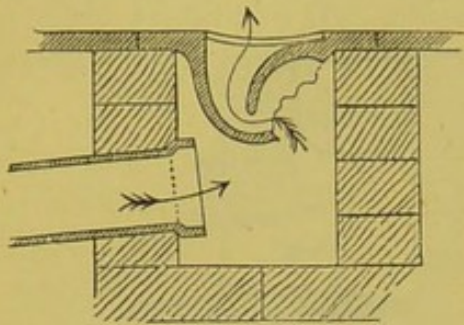
FIG. 17.

Fig. 17 represents the trapping of a yard drain as done by a local tradesman. A notice had been served on the owner of a small cottage dwelling to provide a properly trapped yard drain,

and I called to see if the work had been done. The tenant said the workmen had finished the job a day or two ago, and took me into the yard. Here was the new glazed earthenware trap, but as it did not hold water, even when freshly poured in, I had

it removed. There was a large hole in the back, as shown in the cut. I questioned the tenant as to whether anyone belonging to the house had removed the trap and broken it, and he said the trap had not been touched since the workmen left. The only course open to me, therefore, was to believe that

a tradesman had been guilty of the fraud of selling and fixing a broken trap.

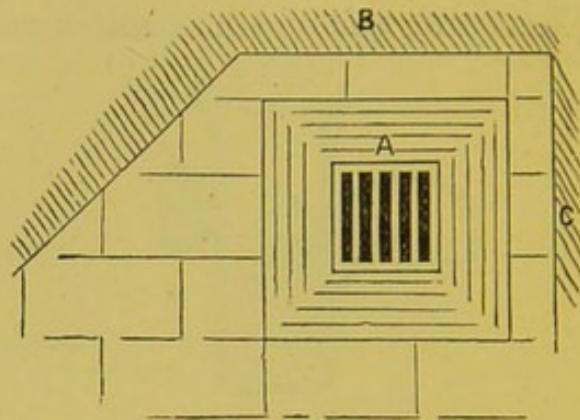
FIG. 18.

Fig. 18 shows a dummy area drain. Damp was complained of in the front wall of a kitchen. The area was paved with brick, and in the corner where the damp was noticed was a

stone collar and iron D trap. On the trap being taken up it was found to deliver its contents on the earth beneath the bricks, and the water had soaked through an 18in. wall into the kitchen. A represents the trap, B the kitchen wall, C the area wall. The workman who inserted this trap was guilty of a deliberate piece of wrongdoing; for the house was one of many in a terrace, an area drain was provided, and the corresponding traps in the houses on either side were connected.

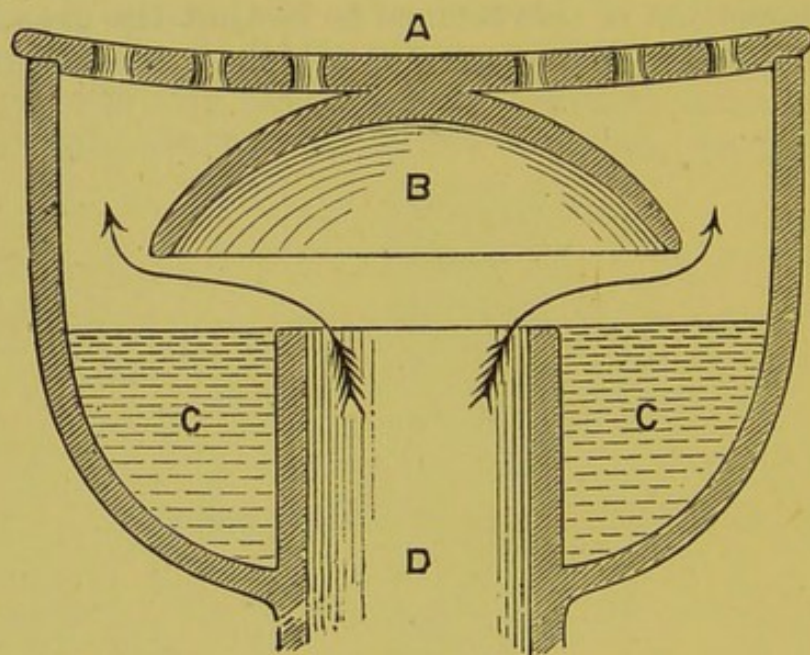
FIG. 20.

Fig. 20 shows a typically bad bell trap I discovered in the scullery of a house rented at £30. I examined it with great care, and then drew the section given, the exact size of the original. A represents the perforated grating, B the bell, CC the water reservoir—which the bottom of the bell never could have reached—and D the portion of the trap which was continuous with the sink waste that went straight into the drain. It will be seen that the whole apparatus is simply a pretence,

the depth of the bell at the centre being barely half an inch, and the distance between the bell rim and the surface of the water being just a quarter of an inch. On the same day, in the same street, I examined a sink bell trap in another house, and found the

depth of the bell at the centre three-eighths of an inch. These were not traps the bells of which had partly corroded away by means of the action of water on iron, but nearly new traps, absolutely useless when fixed.

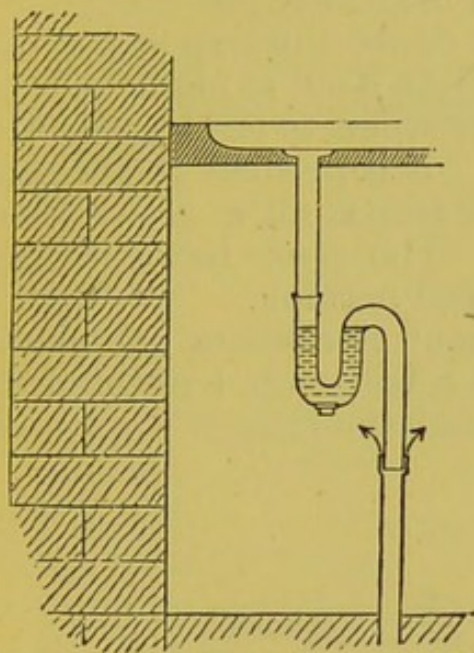
FIG. 21.

Fig. 21 indicates a sink waste pipe and its trap to which my attention was called. Being in a dark corner, it at first appeared to be a satisfactory fixing, but when closely examined it was

found the sink had a *movable trap*. The pipe to receive the lower end of the trap had been bulged out for barely an inch, and in this the lower end was placed, there being no trace of a joint of any kind having been made. The upper part of the trap had been widened out for a quarter of an inch, just enough to retain the trap in position. I have no doubt the trap had been fixed in this way to allow the tenant to clean it out at pleasure, but this was quite uncalled for, as there was access to the trap at the bottom of the bend, in the usual way. It is needless to say the arrangement was worse than having no trap at all, as it gave the householder a false sense of security. The arrow heads in the cut show that the trapping water trapped nothing.

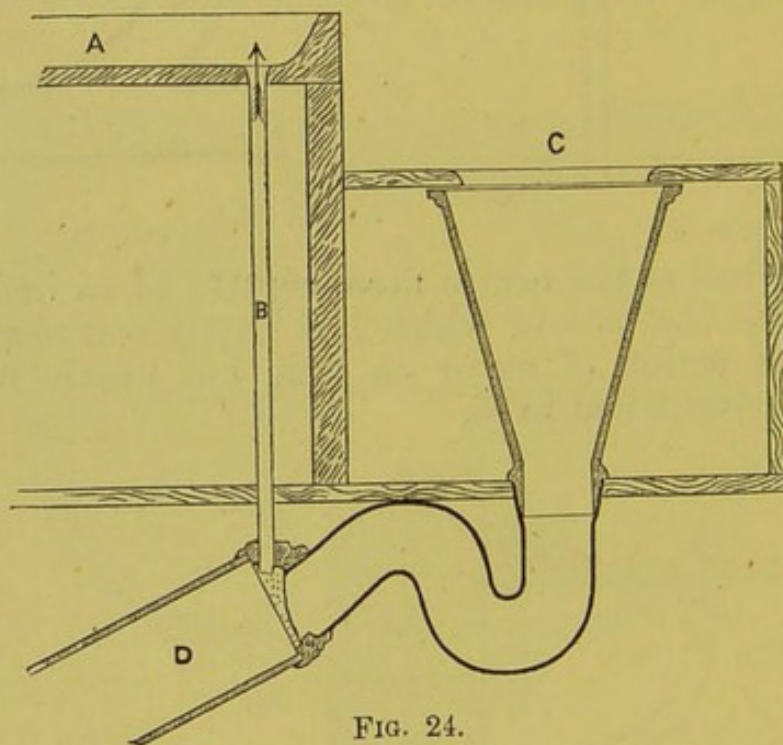
FIG. 24.

Fig. 24 represents a sink-stone and watercloset, which were placed side by side, as shown, within a scullery. The water-closet was *without water supply*. The closet basin was placed

over a syphon trap, which would frequently become choked, and this syphon trap and the sink waste were connected to a 6in. earthenware drain. A is the sink, B the untrapped waste pipe, C the closet, and D the drain.

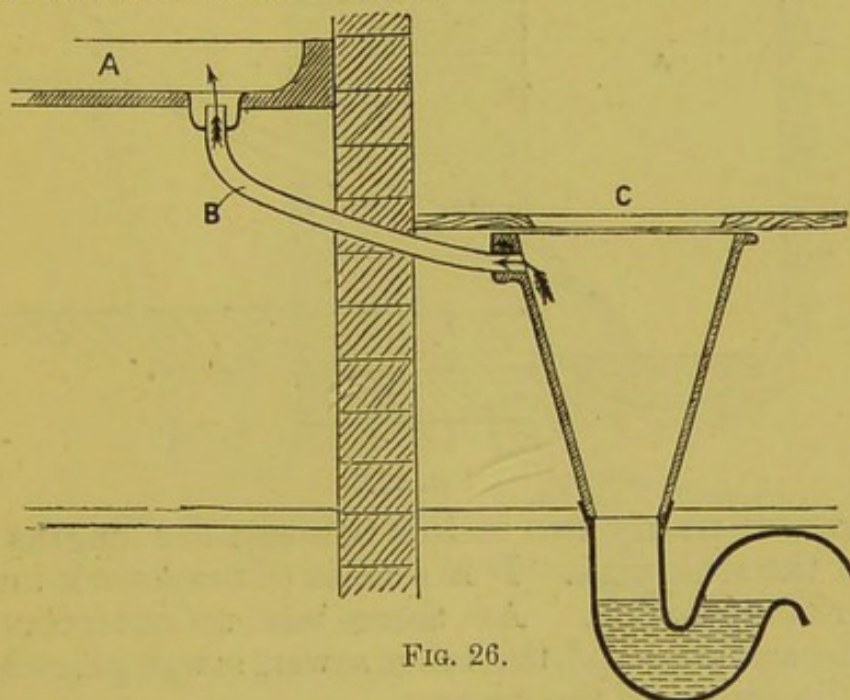
FIG. 26.

Fig. 26 shows an arrangement rather less dangerous to health and life than the one just referred to, but still horribly disgusting. A is a sink-stone, the waste pipe B of which is directly connected to the basin of closet C adjoining. The

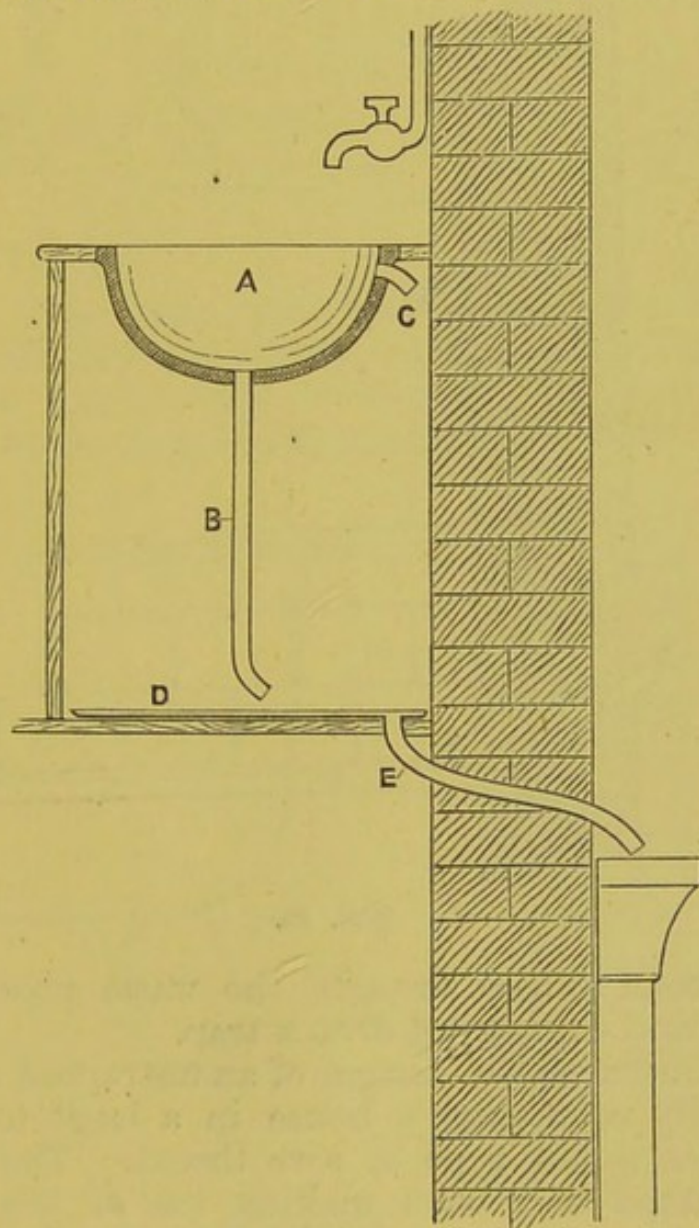
FIG. 30.

Fig 30 has been sent me by a correspondent, who writes me that he recently saw a lavatory basin as shown. It is in his experience a unique way of treating a waste pipe and overflow. The sketch explains itself. A is the basin, B the waste pipe from

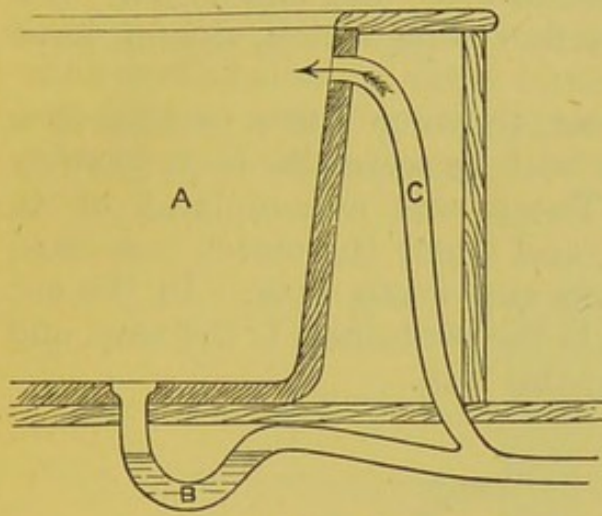
FIG. 32.

Fig. 32 illustrates the danger of an untrapped overflow pipe. A whole family occupying a house in a large town had been suffering from a low type of sore throat. The patient most severely affected had been making use of the bathroom as a bedroom. An examination of the premises, instituted by the medical officer of health, led to the discovery that though the bath waste pipe was trapped, the overflow pipe had been connected to the waste pipe between the trap and the house drain. Thus the overflow ventilated the drain into the bathroom. A is the bath, B the bath waste trap, and C is the overflow pipe.

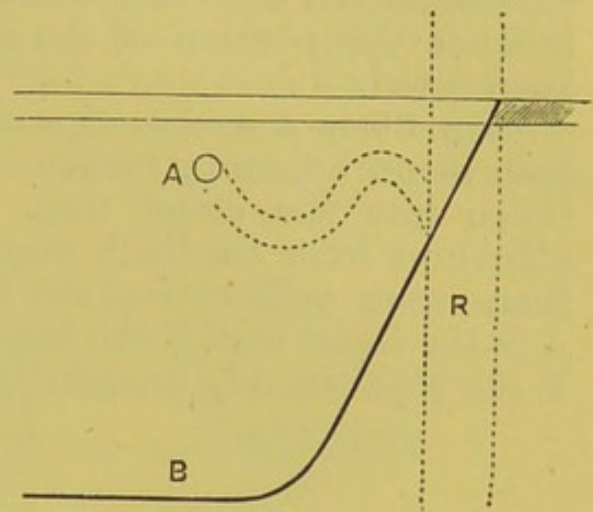
FIG. 33.

Fig. 33 shows in section the upper end of a bath B, situated against an outer wall. There was an overflow pipe at A, taken straight out through the external wall along the outside towards a rain spout R, into which it delivered. Before being connected with the rain spout it was bent downwards and upwards so as to

trap was empty, so that effluvia and noxious gases from the drains were conducted into the house and delivered close to the face of anyone using the bath. Of course,

when the bath was being used the bathroom would be unusually warm, and abundance of foul air would be drawn up. It is needless to point out that a bath overflow pipe should be disconnected. Twisting the pipe in the form of a

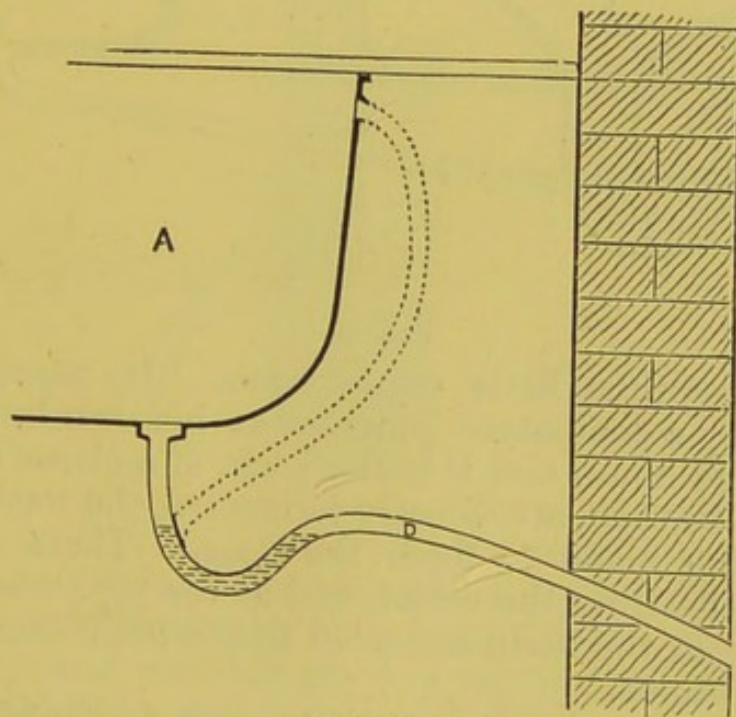
FIG. 34.

Fig. 34 illustrates a familiar defect. In a suburban villa (rent £85), lately built, the bath was found by the tenants to be without an overflow pipe. The bath waste pipe was trapped, and taken out at once, and delivered on a gully trap, and the other sanitary arrangements appeared to be satisfactory. A represents the bath and D the waste pipe, and the dotted lines indicate the position of the overflow pipe which should have been fitted.

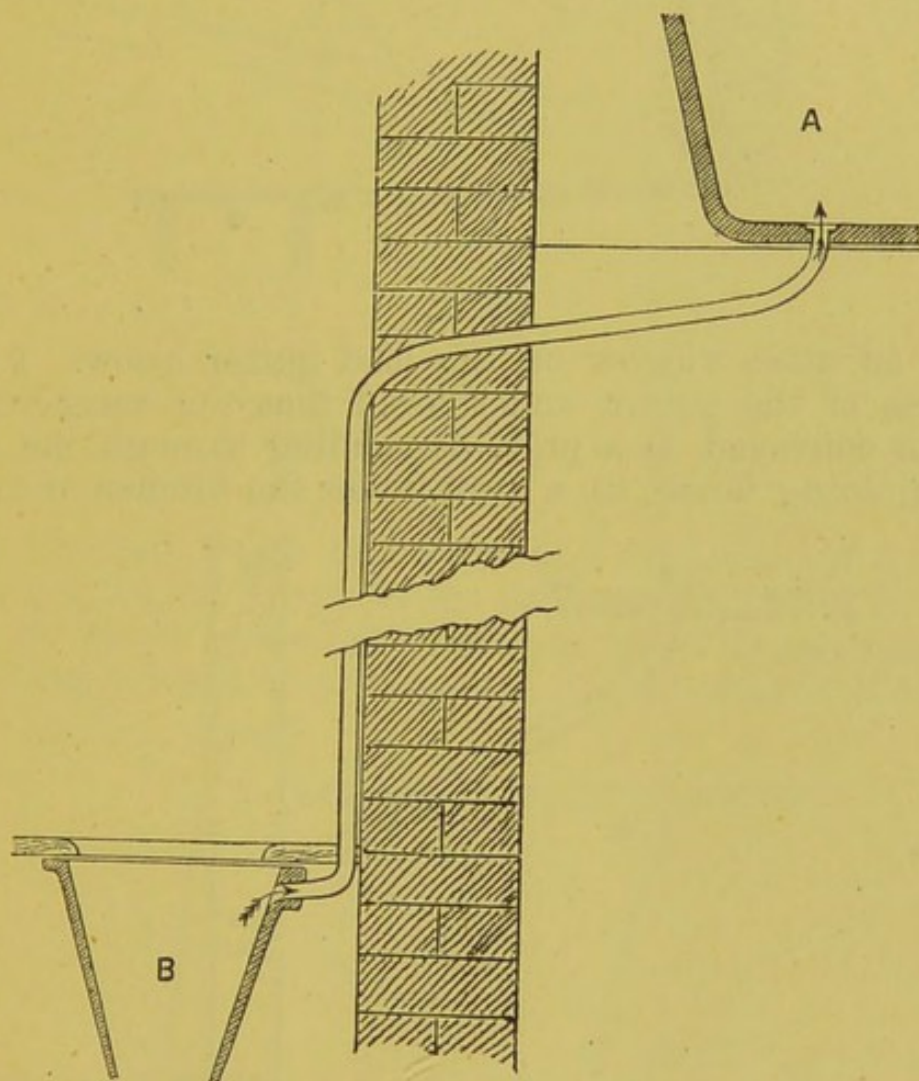
FIG. 36.

Fig. 36 requires little explanation. It represents work carried out by a competent plumber at his own house. A is a bath inside the house and B is the basin of a closet in the yard. These, it will be seen, are directly connected, the waste pipe from the bath being made to flush the closet. There was no other provision for flushing the closet, and as the pipe was untrapped, the foul air from the basin ascended to the bathroom, causing an effluvium nuisance.

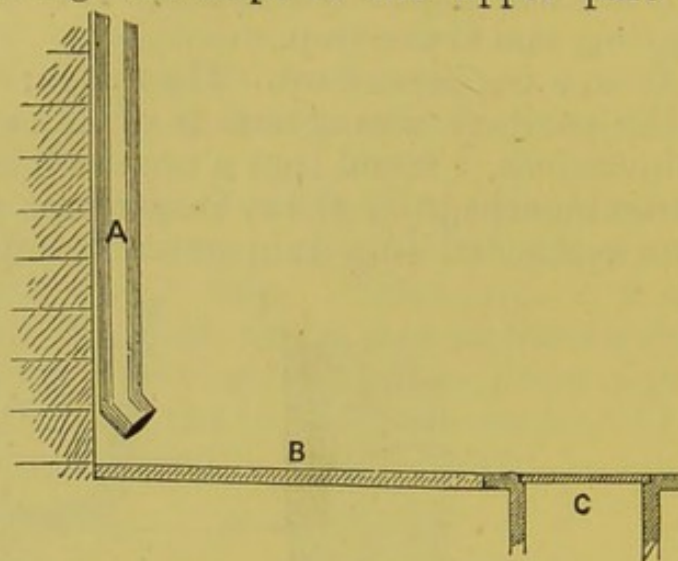
FIG. 37.

The method of delivering waste water represented in Fig. 37 is, I regret to say, not uncommon. The bath and hand-basin waste pipes are brought outside to discharge on the area flags, which are channelled to conduct the water to a trap. Only one waste pipe is represented in the cut, but I have seen three together treated in the same manner. I have also seen the trap a yard or more from the end of the pipe; and sometimes no

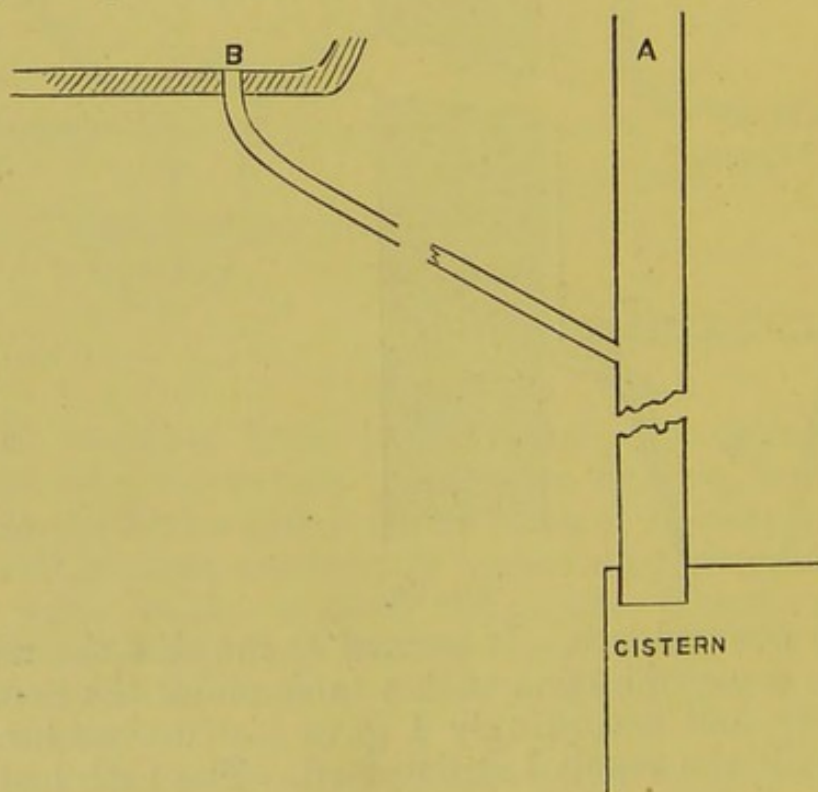
FIG. 38.

Fig. 38 is from a correspondent. He writes: "During my inspection of the sanitary arrangements of an empty house of considerable dimensions, I found that a new bath had been fixed some six or seven months prior to my inspection, and the waste pipe from same connected to a rain-water downpipe, running

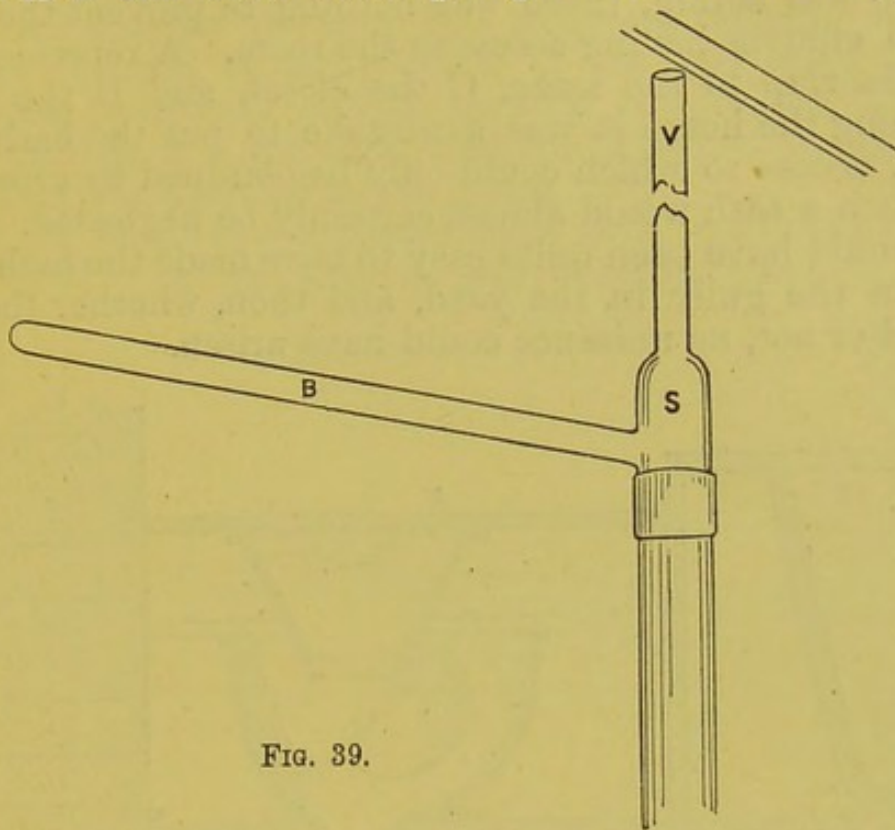
FIG. 39.

Fig. 39 represents a soil pipe and bath waste pipe, as seen from the outside, in a villa residence I lately examined. S is

the 4in. lead soil pipe jointed to an iron one; V is a 2in. ventilator, terminating just under the projecting edge of the roof; and B is a 2in. bath waste going direct to the soil pipe. Of

course, the bath waste pipe acted as a supplemental ventilator, ventilating the soil pipe into the bathroom.

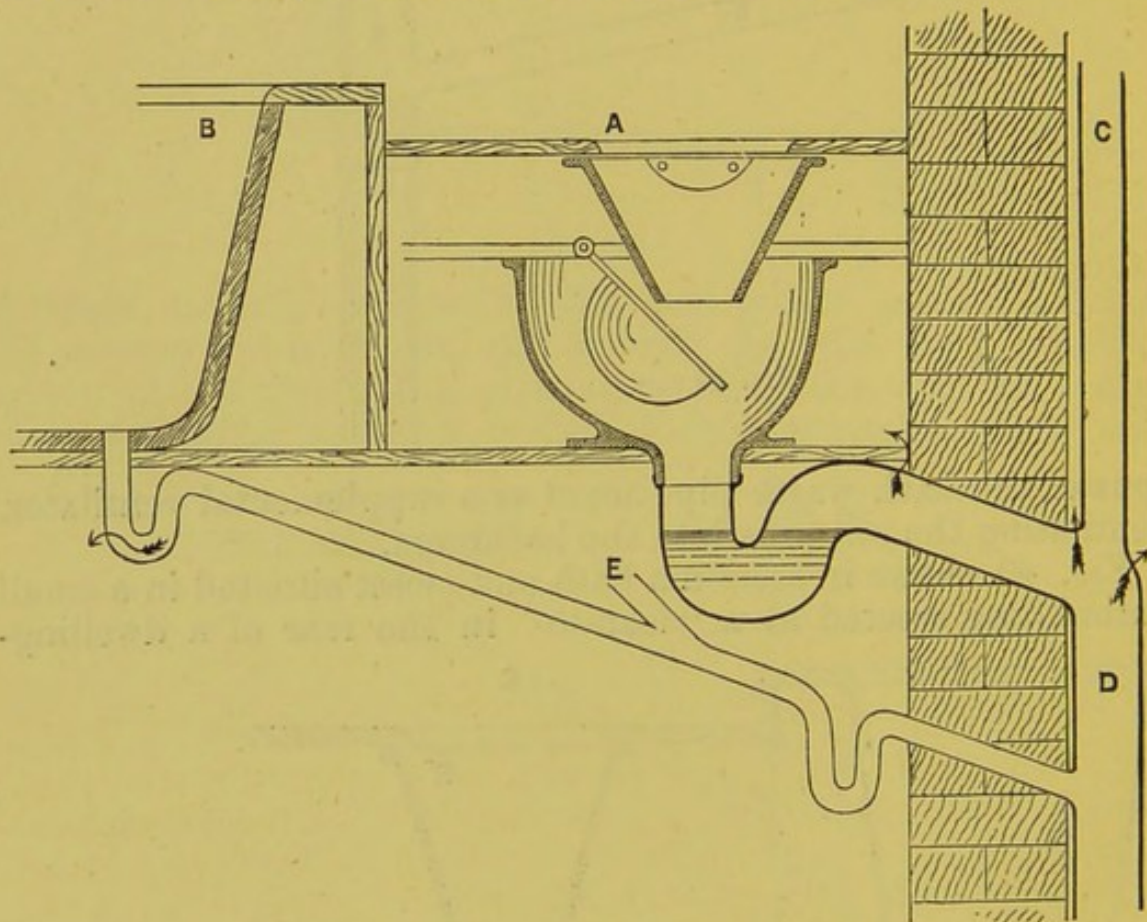
FIG. 41.

Fig. 41 shows the cause of an effluvia nuisance, which was most manifest near the bath. It was found that the trap under the bath was leaky, and an ineffectual attempt had been made to repair it with canvas, while the trap on the bath waste, next the wall, appeared to have been syphoned. A is the closet, B the bath, D a 4in. soil pipe, C is a 2½in. rain spout, made to act as a ventilator for the soil pipe, and E is a waste pipe from a urinal. As there was no trap between the sewer and the soil pipe, and the connections of the closet trap and soil pipe, and rain spout and soil pipe, were imperfect, sewer gas could escape into the bath and urinal, and at the points indicated by the

arrows in the illustration. That sewer gas actually did find its way into this house there is little doubt. A child died there, the cause of death being returned as "ulcerative pharyngitis;" and other inmates (mother and children) suffered from sore throats. Instead of complaining of the bad smell, attempts were made to smother it with carbolic powder, &c., and it was not till the death of the child that the attention of the sanitary authorities was directed to the house.

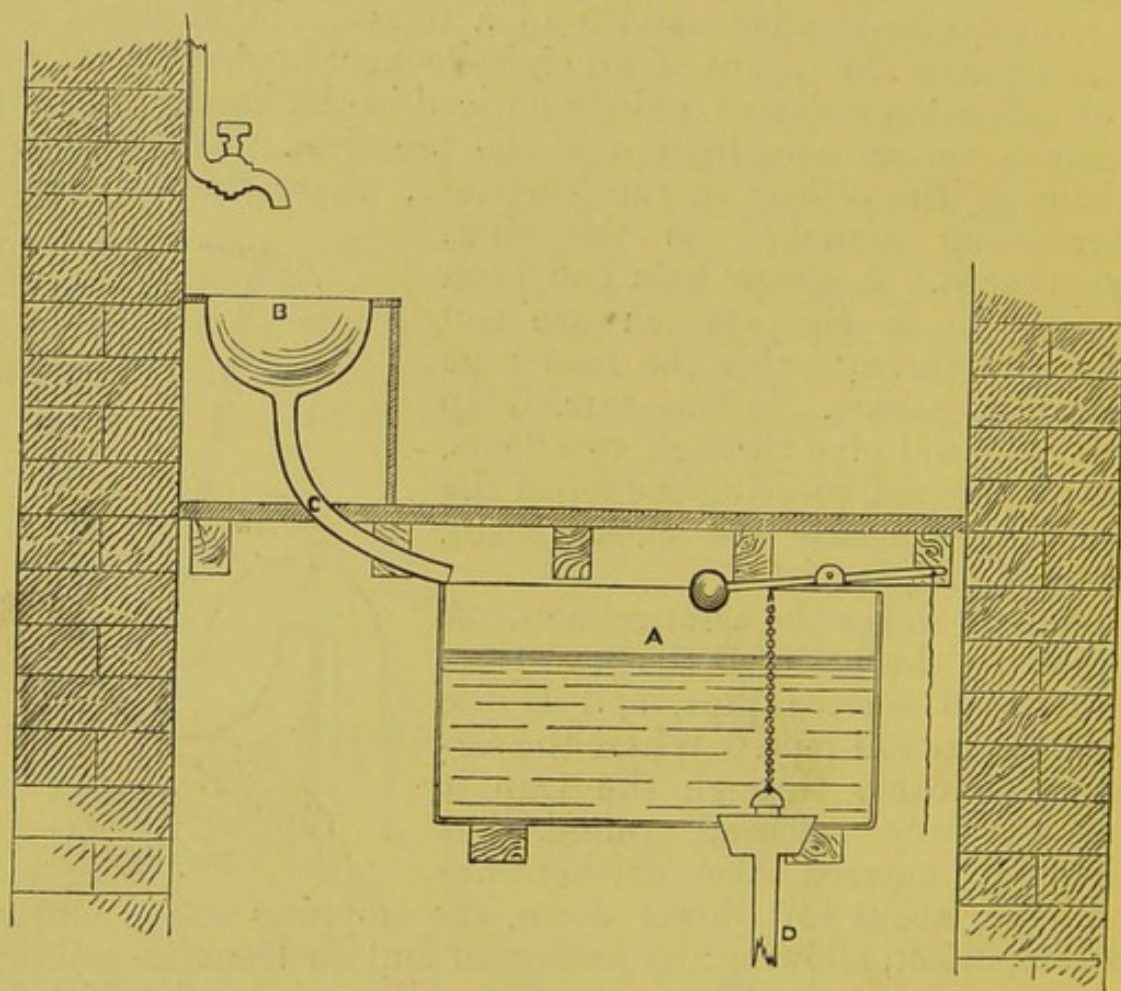
FIG. 44.

A correspondent sends me a sketch and description of an arrangement for disposing of slop water and flushing a closet in

a villa residence he inspected. It seems strange how a plan so obviously objectionable came to be adopted. The sketch is reproduced in Fig. 44. A is a cistern serving the closet beneath, the cistern being supplied with rain water through a pipe not shown. B is a housemaid's sink, and C the waste pipe from the same, discharging into the cistern A. D is the pipe flushing the closet. An effluvium nuisance having arisen each time the closet was flushed, the apparatus was carefully examined, and it was then discovered that the closet was flushed, not with rain water only, as was supposed, but also with the slops daily thrown down the housemaid's sink.

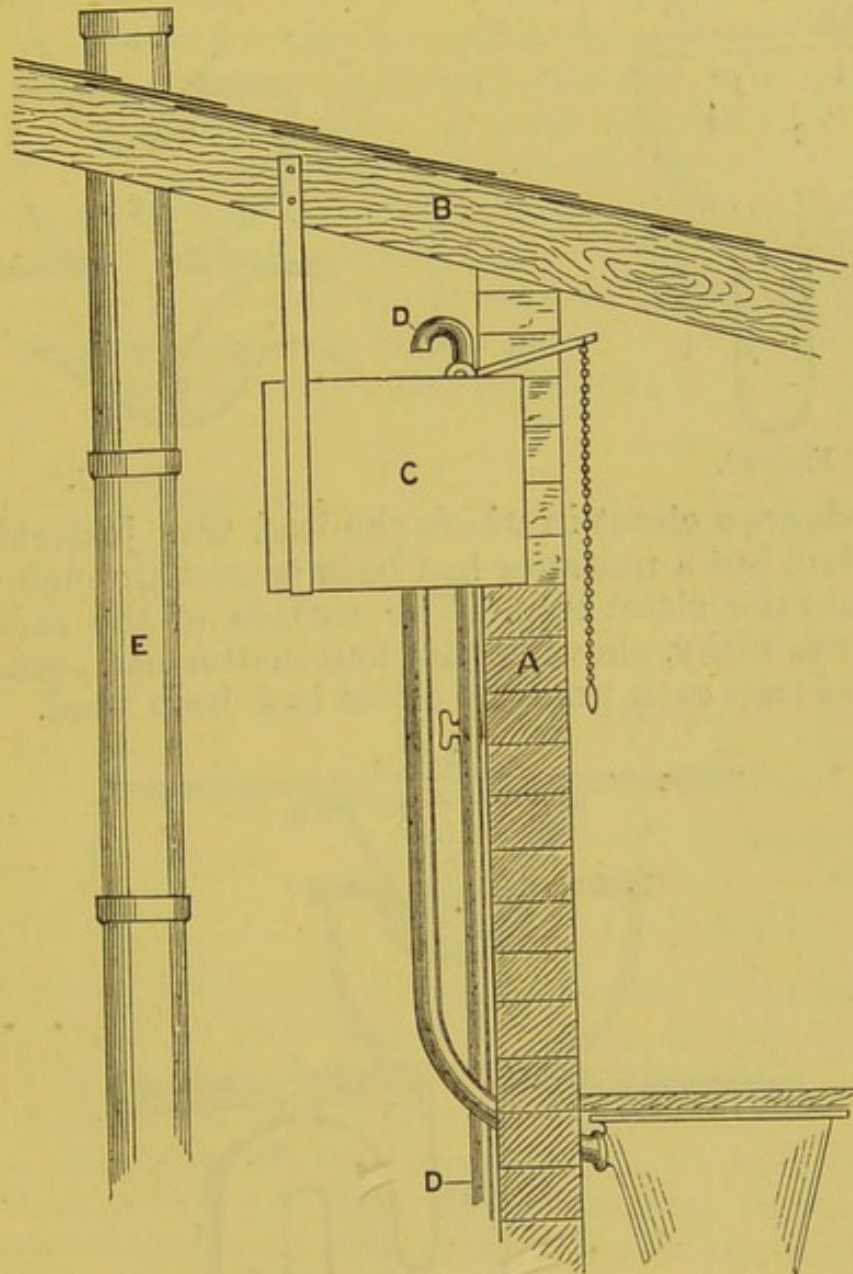
FIG. 45.

Fig. 45 shows how some midden privies were converted into dry ashpits and waterclosets. A hole was made in the wall A, just under the rafters B, large enough to admit the end of the cistern C. The cistern in each case was of light galvanised iron, 15in. by 6in., and 12in. deep. The whole of the cistern, excepting the small portion resting on the wall, is actually in the ashpit. Cisterns in such a situation are exceptionally liable to get foul, and are almost inaccessible. No overflow is provided, and the supply pipe D passes up a corner of the midden, through the ashes and refuse. The drain from the closet is ventilated (or, to be more correct, an exit for the drain air is provided) by means

of 4in. earthenware pipes E, built up the end wall of the middenstead, and delivering effluvia at a low level.

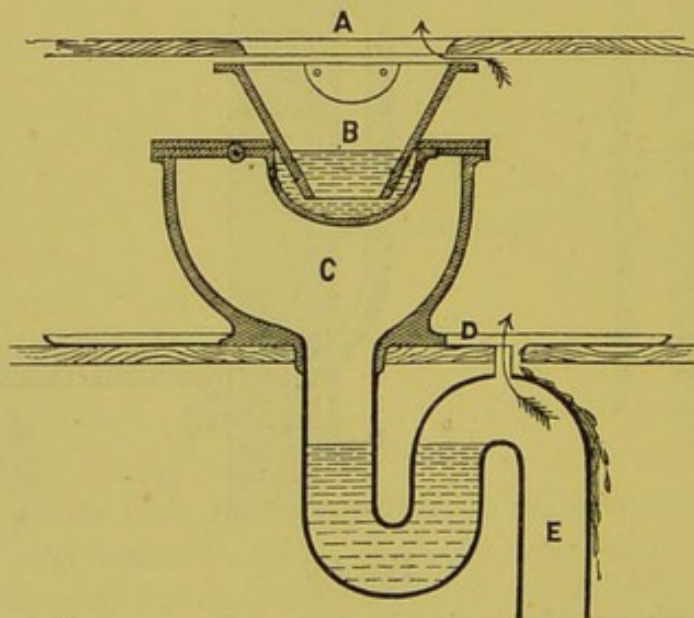
FIG. 48.

Fig. 48 represents a much more serious blunder on the part of a local plumber. The safe or tray to catch any foul water, &c., overflowing from the basin had been fixed, but in order to drain it a lin. pipe from the safe had been carried into the soil pipe. The

soldering of the top of this short pipe to the safe had given way, and it was found that the safe had been draining on the outside of the soil pipe. However, the foul air and gases in the soil pipe had ready access to the house, as shown by the arrows in the illustration. A is the closet seat, B the basin, C the container, D the safe, and E the soil pipe. The house in this instance was a very old one (rent about £40), and the closet fittings were old and worn.

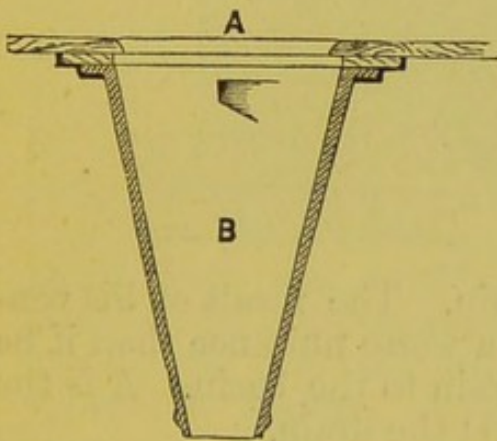
FIG. 49.

Fig. 49 shows in section a curious fixture, which, I think, cannot be very common. I can only describe it as a privy got up to look like a watercloset. A long earthenware basin B was screwed up to the underpart of the seat A, and the surface of the earthenware had become exceedingly foul. The quaint name was given it—"a dry watercloset."

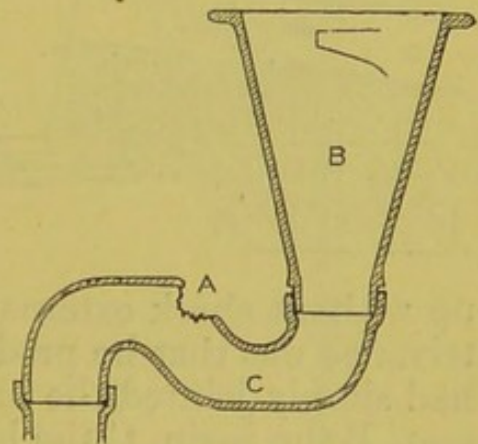
FIG. 50.

Fig. 50 represents a watercloset without water service, which was fitted in the yard of a cottage situated in a back court. On seeing there was no arrangement for flushing, I was surprised

the basin was not full, and I directed a further inspection, when it was found that a hole had been made in the top of the earthenware trap, which was jointed to the basin. I made particular inquiries as to this hole, and was told that "the man that fettled the thing, for fear it would get choked," made the hole—in other words, the hole was made that the contents of the pipe beyond might be pushed on with a stick, or otherwise. In the woodcut, B is the basin, C the earthenware trap, and A the hole referred to. As the hole was made on the drain side of the trap, it established a direct communication between the drain and the closet, which would have remained even if the trap had been kept charged with water.

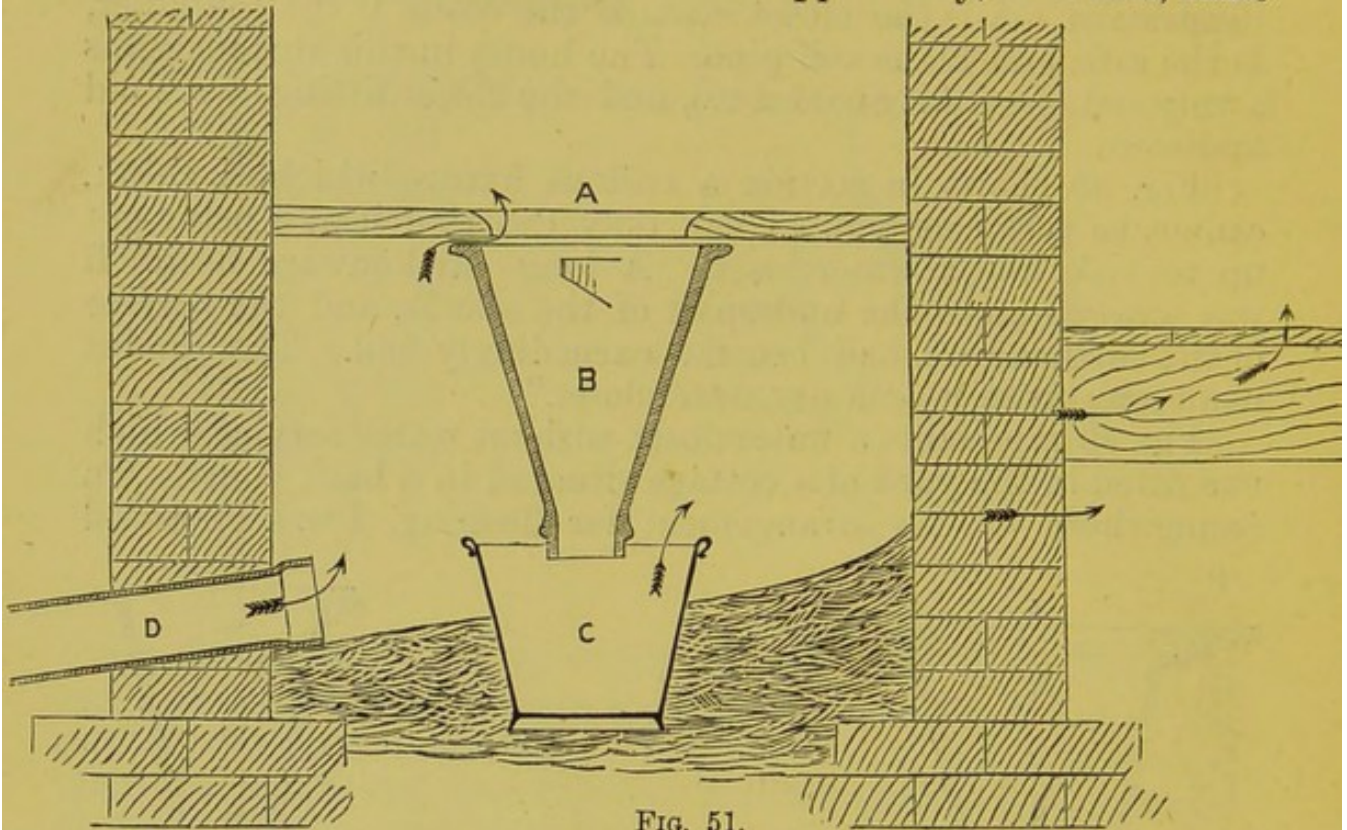
FIG. 51.

Fig. 51, sent me by a correspondent, represents a closet basin trapped into a galvanised iron bucket. The contents, of course, overflowed and found their way into the open drain shown to the left in the sketch. Next to this abominable closet was the kitchen, and the foul air and foul smells went through the joints

of a wall, almost destitute of mortar, and between the planks of the floor into the kitchen. The man who fitted this closet seems to have aimed at preventing the sewer gases from coming up the basin; but as the drain was untrapped they, of course, came

up without check external to the basin. The result of his contrivance was that he produced even a worse nuisance than if he had simply jointed the untrapped drain to the basin. A is the seat, B the basin, C the bucket, and D the drain.

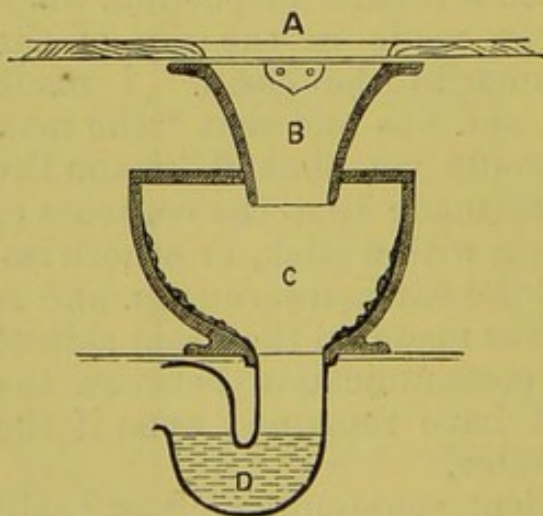
FIG. 52.

Fig. 52 shows an ordinary "pan" closet, which was fixed without a pan. The tenant had been in the house upwards of

a year, and told me the closet was as I found it from the first. If the pan had merely become broken off at the hinge it would have fallen, and probably caused an obstruction; if from any defect in the apparatus the pan could not recover its proper

position after flushing, it would have been hanging empty in the container. As it was, it was simply missing, and the plumber must have fixed the apparatus as I found it. The whole of the inner surface of the container, which was, of course, foul, was exposed, and a cause of more or less effluvium nuisance. A is the seat, B the basin, C the container, and D the trap.

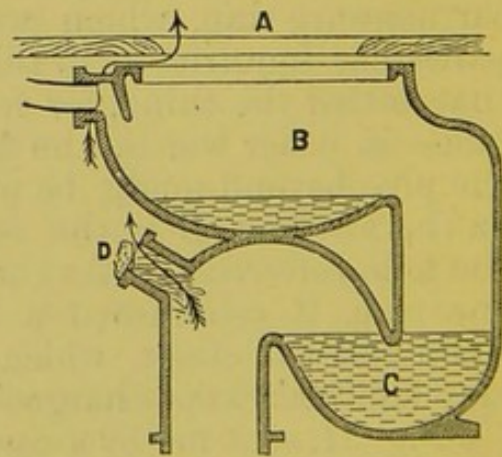
FIG. 53.

Fig. 53 indicates a danger from certain new forms of closets which had not occurred to me till the defect shown in the cut came under my attention. Many of these closets have an opening placed behind the trap for connecting a ventilator. The "National," the closet shown in section in the illustration, is thus contrived. It appears to be a good closet, and, if properly fixed and kept clean, is free from nuisance. However, very great nuisance was experienced from the particular closet I refer to, and, on uncovering it, it was found that the man who fixed the apparatus, instead of attaching a ventilator, filled up the hole where the ventilator should have been connected with *paper*, and covered this over at the top with putty. In course of time the putty loosened, and then the foul air from the soil pipe had ready access into the house. Of course, this foul air was rendered more foul by passing through a plug of paper saturated with the filth of years. A is the seat, B the basin, C the trap, and D the "stopped" vent hole.
