Defects in plumbing & drainage work... Illustrated by upwards of a hundred woodcuts. / described by Francis Vacher.

London : John Heywood, 1889.

Defects in Plumbing and Drainage Work

described by **Francis Vacher**
upwards of 100 illustrations

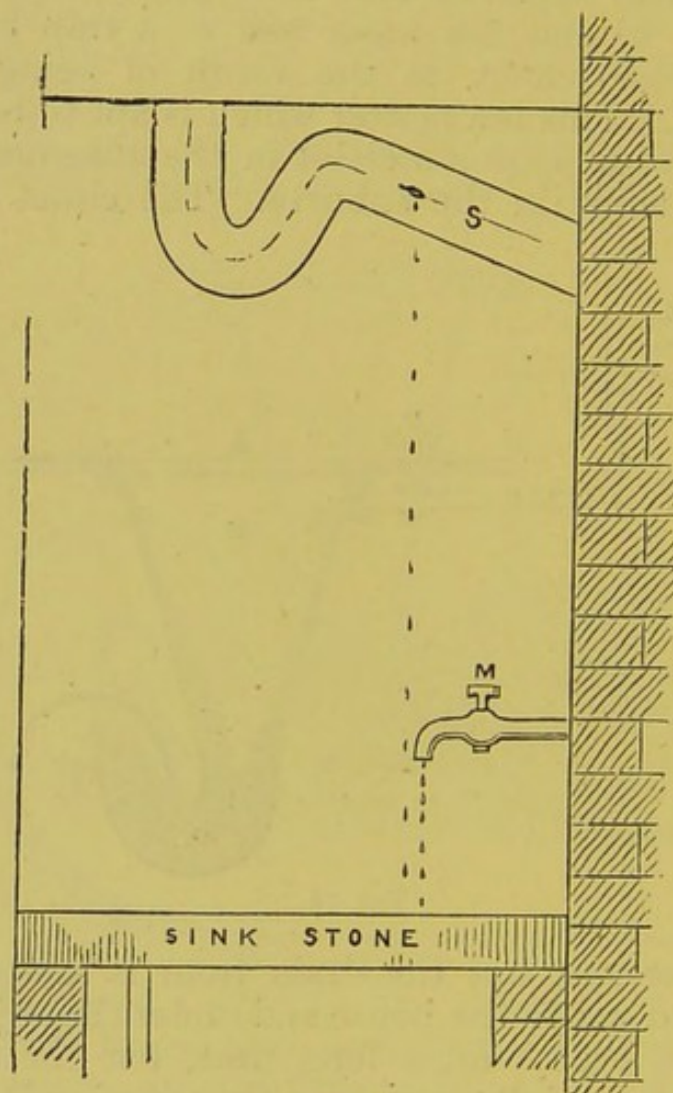
FIG. 57.

Fig. 57 is, I consider, one of the most interesting cuts in this series, and I desire to draw special attention to it. I received notice of a case of typhoid fever in a very old house in a poor neighbourhood. The patient was forthwith removed to the fever hospital, and the usual report as to the state of the premises was submitted to me. From the latter I

gathered that the house was dirty, and that there was a water-closet built out from the back wall, a separate service cistern for the same, and a pipe from the main for drinking and domestic purposes. Not satisfied with this report, I examined the premises myself. I found the closet was entered from a small landing on the stairs, between the ground floor and first floor. On looking to see what was under this (on the ground floor), I was surprised to find a sink-stone, and a tap from the main. Immediately over the sink-stone was the lead trap from the closet and a transverse portion of soil pipe connected therewith, which was carried through the back wall into the house. In the soil pipe close to the trap was a corroded hole, the position of this being shown in the cut. Through this hole foul gases must often have been discharged, and foul liquids from the closet must often have overflowed. Indeed, here were all the conditions present which one would expect to find resulting in an outbreak of typhoid fever. What in all probability happened is that drinking water drawn from the tap was polluted with excremental liquid dropping into it, and that water thus polluted was actually drunk. The illustration indicates how easily a jug of water drawn from the main tap M might be polluted by foul liquid running from the hole in the soil pipe S.

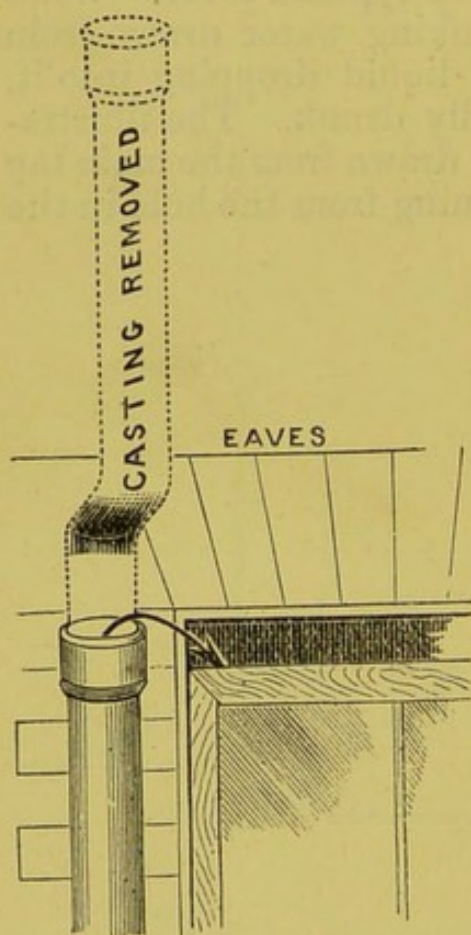
FIG. 58.

My attention was called to four houses where the soil pipe ventilators terminated close to back windows. In three cases the ends were on a level with the tops of the windows, and in one case a foot above the top. As the requirement with respect to soil-pipe ventilators is that they shall be carried up not less than 2ft. above the roof eaves, and the houses were quite new, special inquiries were instituted. Under the local Act, passed in 1881, it is "not lawful to let or occupy as a dwelling-house any building, not so used before the commencement of the Act, until

such building has been certified by the surveyor, or other officer appointed for the purpose, to be as to drainage, supply of water for domestic purposes, and in every other respect fit for human habitation, and constructed and completed in conformity with the provisions of the Act and the local bye-laws." It transpired that these four houses were submitted to examination, the soil pipe ventilators then terminating as required 2ft. above the roof eaves, and were duly certified fit for human habitation. How-

ever, shortly afterwards other houses approached completion, and iron castings necessary to carry the ventilators 2ft. above the roof eaves not being ready to hand, those belonging to the four houses already certified were removed, and made to do duty in obtaining a certificate for other houses. When the houses thus robbed were visited, three were occupied, and in each of these three the window next the soil pipe end was open for two or

three inches at the top. The accompanying illustration (Fig. 58) explains itself.

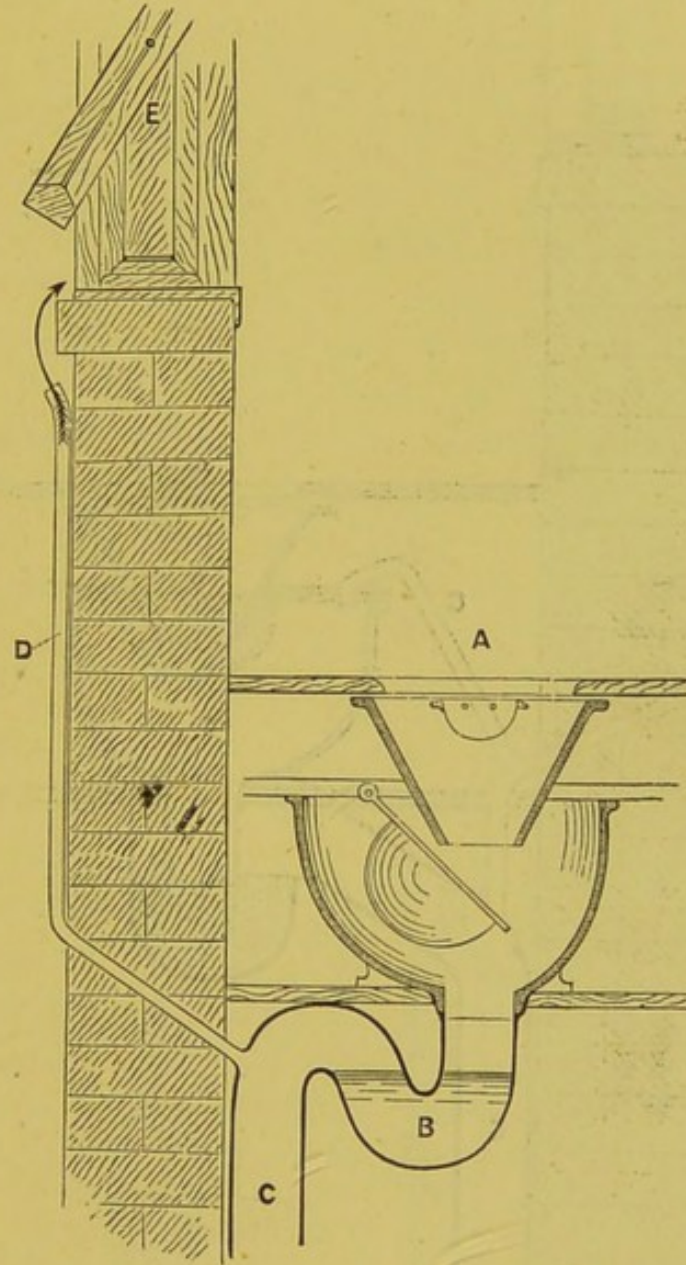
FIG. 59.

Fig. 59 represents an old pan closet which, although placed next an external wall, delivers into a soil pipe carried down inside the house. The closet A delivers into a lead syphon trap B, which is continuous with the soil pipe C. The soil pipe is connected with an earthenware pipe drain running under the

be drawn into the closet whenever the swing window happens to be open. In the figure the ventilator is represented as a $\frac{3}{4}$ in. instead of a 1 in. pipe.

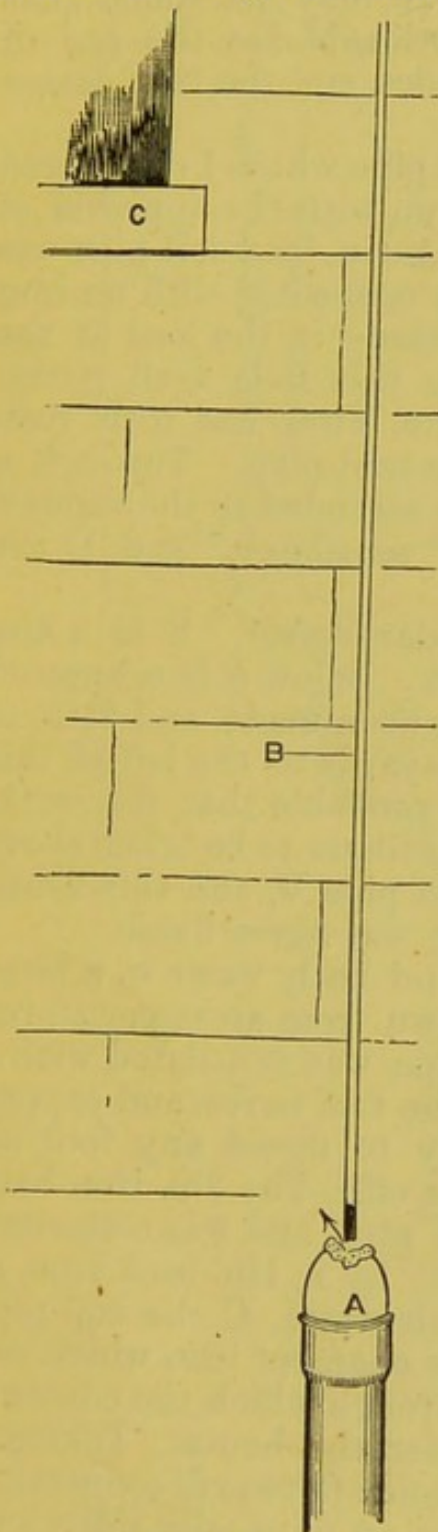
FIG. 61.

Fig. 61 shows a "ventilator" to a soil pipe which I discovered at a large suburban house. It was put up with the approval of the local surveyor and medical officer. A 4in. lead soil pipe was brought through the wall and efficiently connected with an iron soil pipe. A large hole had then been made in the lead at the top, and a $\frac{1}{2}$ in. iron pipe connected to this hole with putty. The iron pipe was quite closed up at the lower end with rust, &c., and was just too short to meet the lead pipe. Through a large hole in the lead and putty, effluvia ascended to the window 5ft. above. A is the lead pipe, B the "ventilator," and C the window.

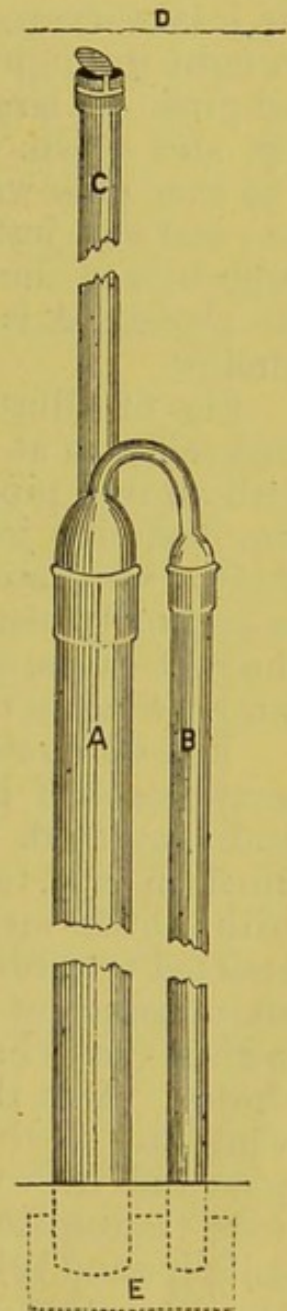
FIG. 63.

Fig. 63 shows how the soil pipe and bath waste in a large semi-detached house were brought down from an upper storey and ventilated. The 4in. iron soil pipe was ventilated with a 2in. iron pipe, terminating just under the roof eaves, and capped with a little metal top, as if purposely to direct any foul air emitted towards a window a few inches off. The 2in. iron bath waste came out by the side of the soil pipe, and was connected with it (for what purpose I know not) by a 1in. lead pipe, as shown. A is the soil pipe, B the bath waste, C the soil pipe ventilator, D the roof eaves, and E the chamber into which soil pipe and bath waste delivered, and through which the contents were transmitted to the 6in. pipe under the house. Taking a soil pipe and bath waste out separately, and afterwards connecting them together, above and below, seems an unusually ridiculous proceeding.

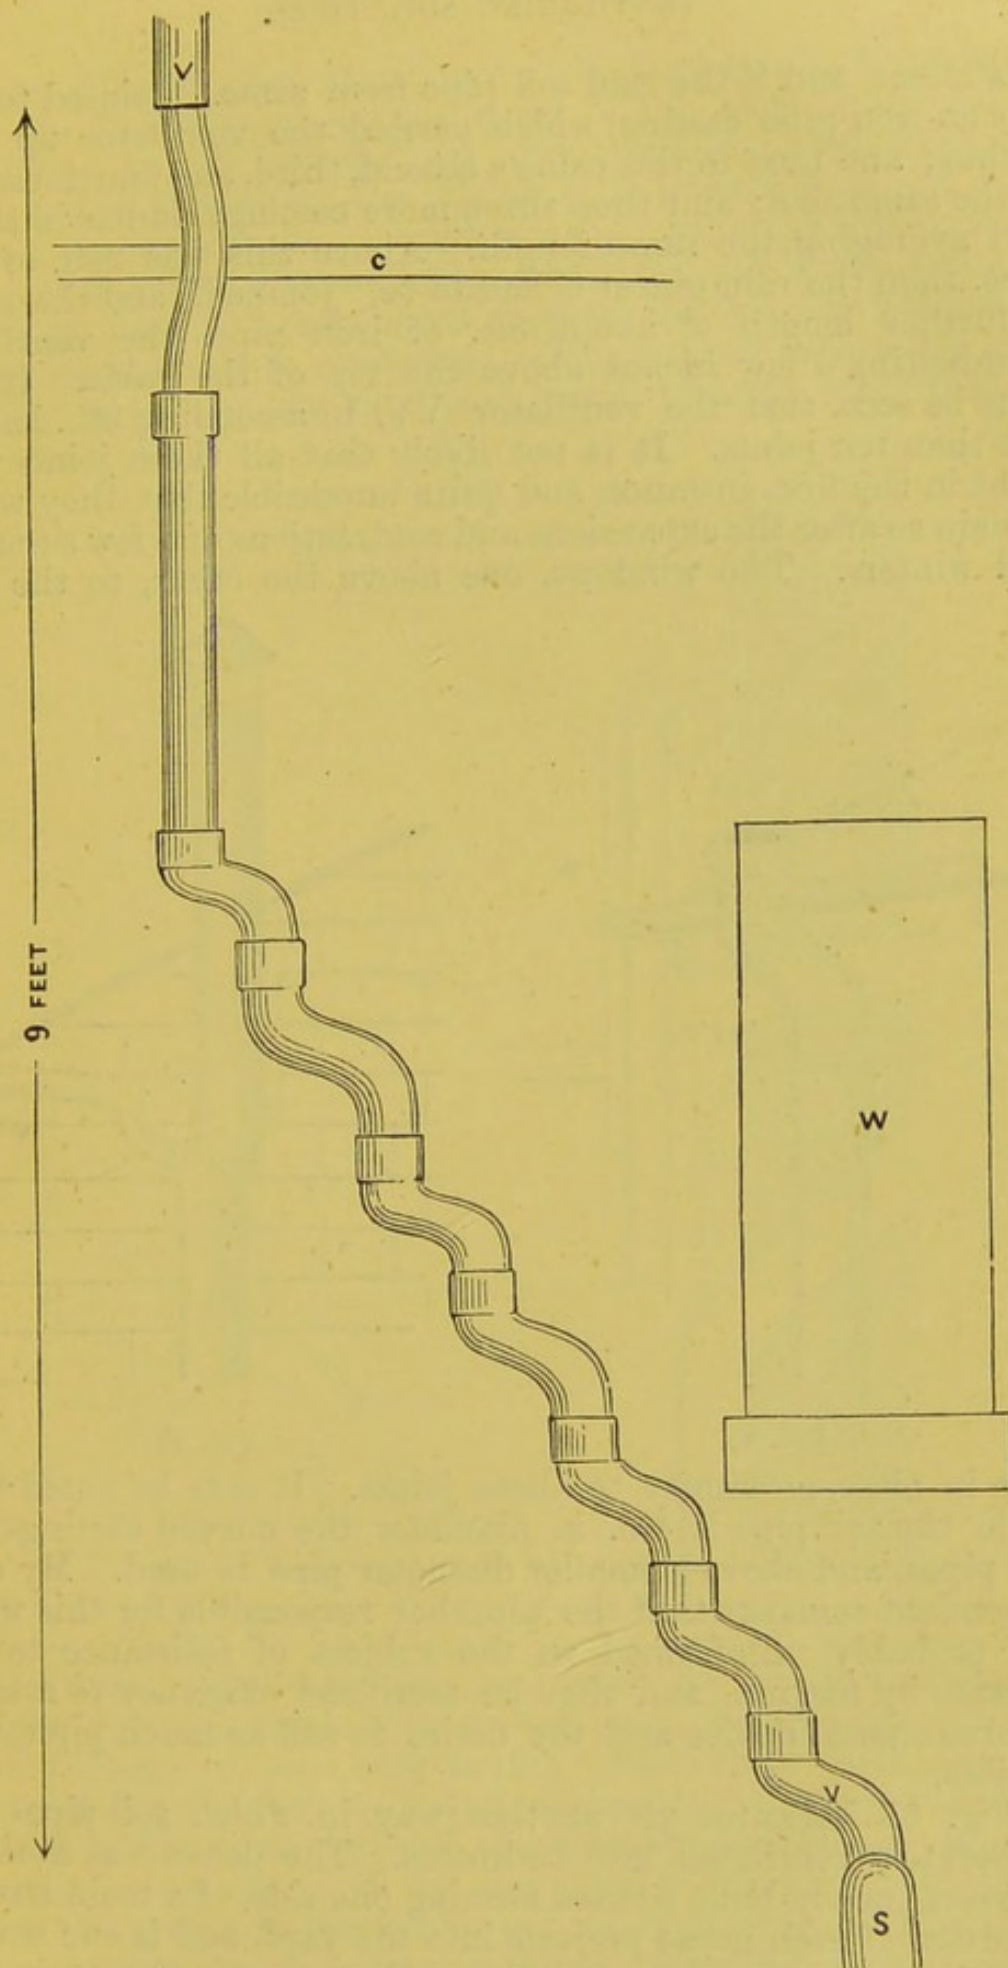
FIG. 64.

A correspondent has kindly drawn my attention to a soil pipe ventilator which is certainly noteworthy. Such an unworkman-like contrivance I hope and believe is not common. (*Vide* Fig. 64, which is carefully drawn to scale.) W represents the window

of a closet, and S the lead soil pipe from same. Jointed to this was an iron pipe casting, which carried the ventilator up nine inches; and next to this came a second, third, and fourth casting of the same size; and then three more castings similar in shape and averaging the same length. Above this was $2\frac{1}{4}$ ft. of iron pipe, then the rain gutter C had to be "jumped," and there was a further length of about 8 ft. of iron pipe, the ventilator terminating a few inches above the top of the gable. It will thus be seen that the ventilator VV, in ascending 9 ft., had no less than ten joints. It is not likely that all these joints were tight in the first instance, and quite impossible that they would remain so after the expansions and contractions of a few summers and winters. Two windows, one above the other, to the left,

were in close proximity to these joints. It is to be noted that while the soil pipe is 4 in. in diameter the curved castings are 3 in. pipes, and above a smaller diameter pipe is used. My correspondent remarks that the plumber responsible for this work was probably uninformed on the subject of resistance to air currents by friction, and that he sacrificed efficiency to a taste for ornamental device and the desire to sell as much piping as possible.

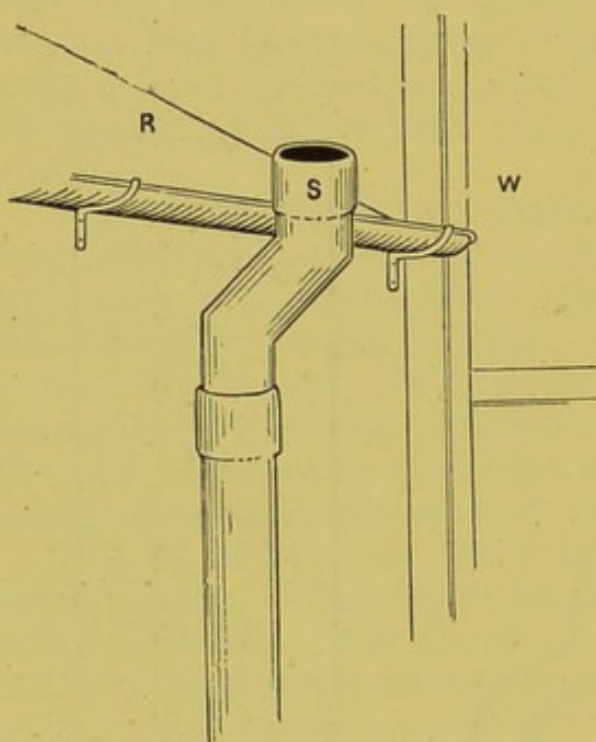
FIG. 65.

Fig. 65 indicates yet another way in which soil pipes are deliberately ventilated into bedrooms. The defect was noticed in several newly-built houses forming one side of a main street. A portion of each house projects into the yard, and is one storey lower than the rest of the building. These portions contain the

closets. The soil-pipe ventilators should, of course, have been taken up 2ft. or so above the eaves of the roofs of the main buildings. As it is, however, the ventilator has, in each instance, been carried just above the gutter of the lower roof, and terminates close to a bedroom window, as shown in the illustration. R is the lower roof, S the soil pipe ventilator, and W the window.

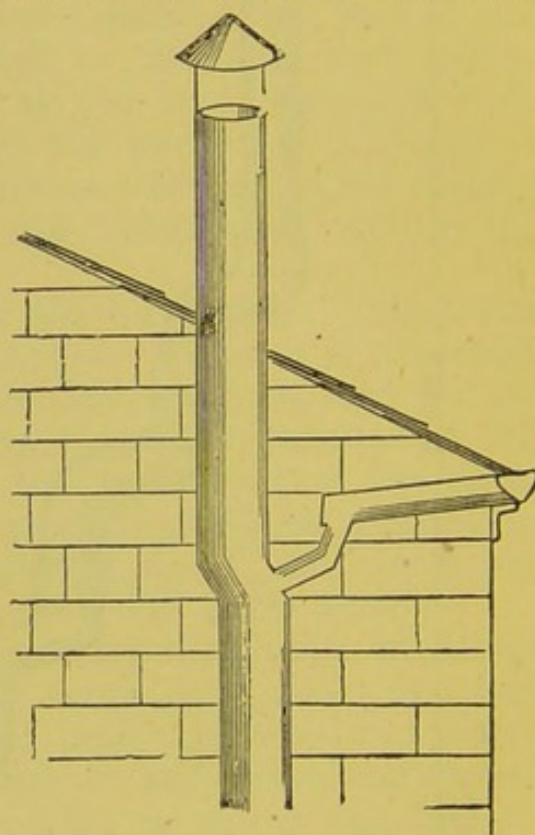
FIG. 66.

Fig. 66, from a correspondent, represents a soil-pipe ventilator into which the rain is conducted. The trapped bath waste and overflow, as well as the rain pipe, are connected with what is

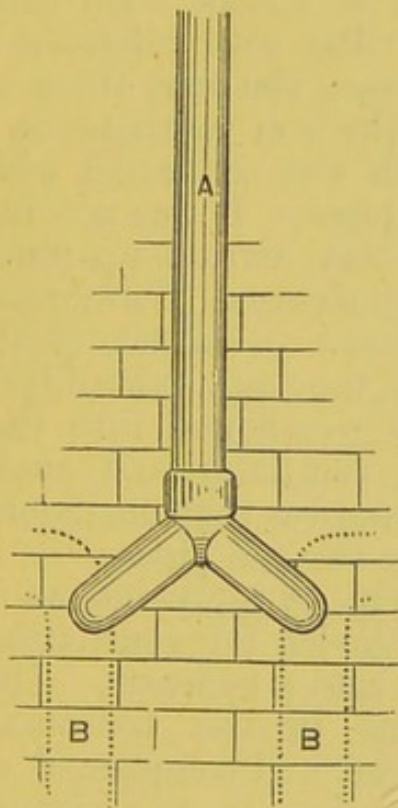
FIG. 67.

Fig. 67 represents two soil pipes built into the wall, and ventilated in a novel way. A pair of semi-detached villas had closets in the front, on the first floors over the lobbies. The soil pipes coming very near the surface of the wall on the inside were covered by about an inch of plaster; and in one villa the staining of this plaster and an effluvium nuisance gave indications of a leak. On calling at the villas with reference to this nuisance, the first thing noticed was the iron ventilator as shown which was connected with both soil pipes. It was not ill-fitted, and was carried up 9in. above the roof eaves. If a stoppage had occurred in either of the soil pipes, the contents would probably have overflowed into the common ventilator and choked it. A indicates the ventilator, B and B' the two soil pipes.

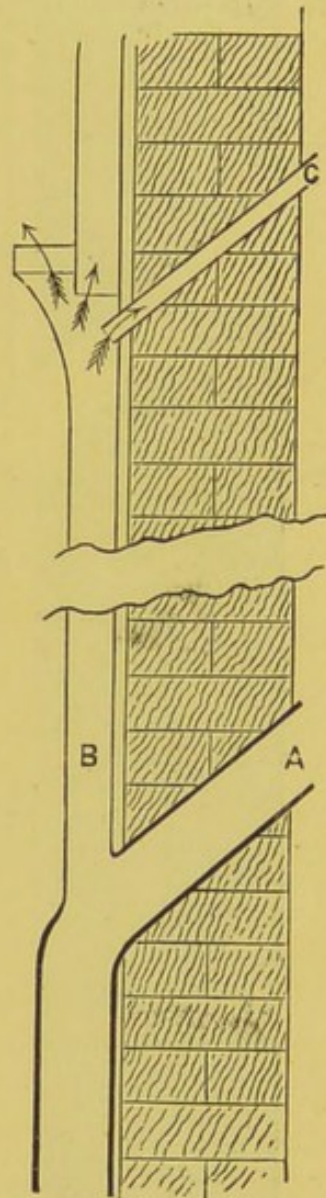
FIG. 68.

Fig. 68 represents an ingenious device for ventilating a soil pipe into a bedroom. Offensive smells in the bedroom were noticed and complained of. On inspection it was found that there was an open cistern in the bedroom, and that the overflow pipe from this was carried into the rain spout, which was made to act as a soil-pipe ventilator. A is a 4in. soil pipe taken out direct from a closet, B is a 2½in.

part of the foul air from the soil pipe was conveyed up the overflow pipe into the bedroom, part ascended the upper portion of the rain spout to the roof gutter, where a portion got in under the slates, and part was delivered externally to be drawn in at contiguous windows when open.

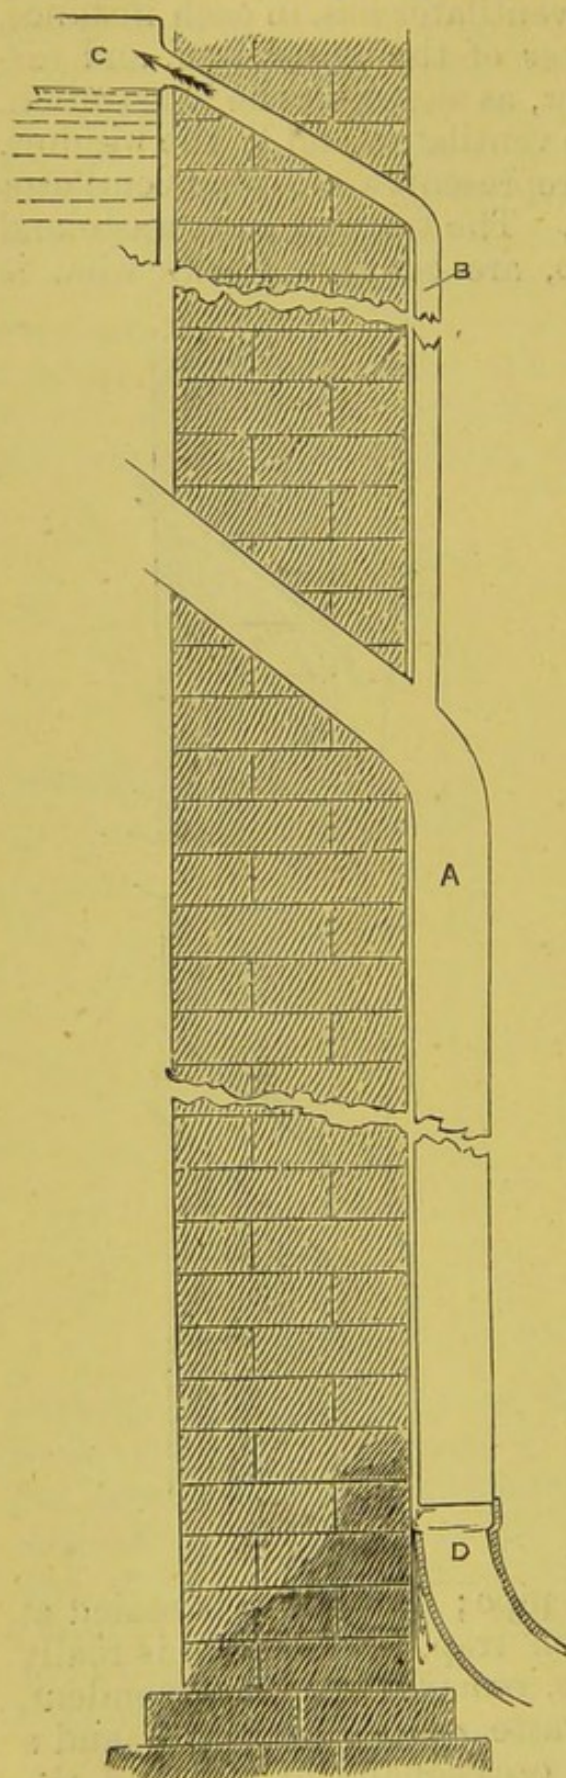
FIG. 69.

A correspondent sends me a sketch and description of a defect which he recently saw in an old house. (*Vide* Fig. 69.) Here is an unventilated soil pipe taken outside directly it leaves the watercloset, and as there is no proper connection between the soil pipe and house drain, filth is allowed to escape into the

basement. It will be seen also that the soil pipe receives the cistern overflow pipe, the effect being that the soil pipe is ventilated into the cistern room. A is the soil pipe, D the drain, C the cistern, and B the overflow. There is nothing very unusual about this arrangement, bad as it is, except that where a cistern overflow is carried into a soil pipe the connection is usually made inside the house, the plumber probably being conscious that he is doing something irregular. To bring a cistern overflow through an external wall, carry it down some distance, and deliberately connect it with an unventilated soil pipe, would

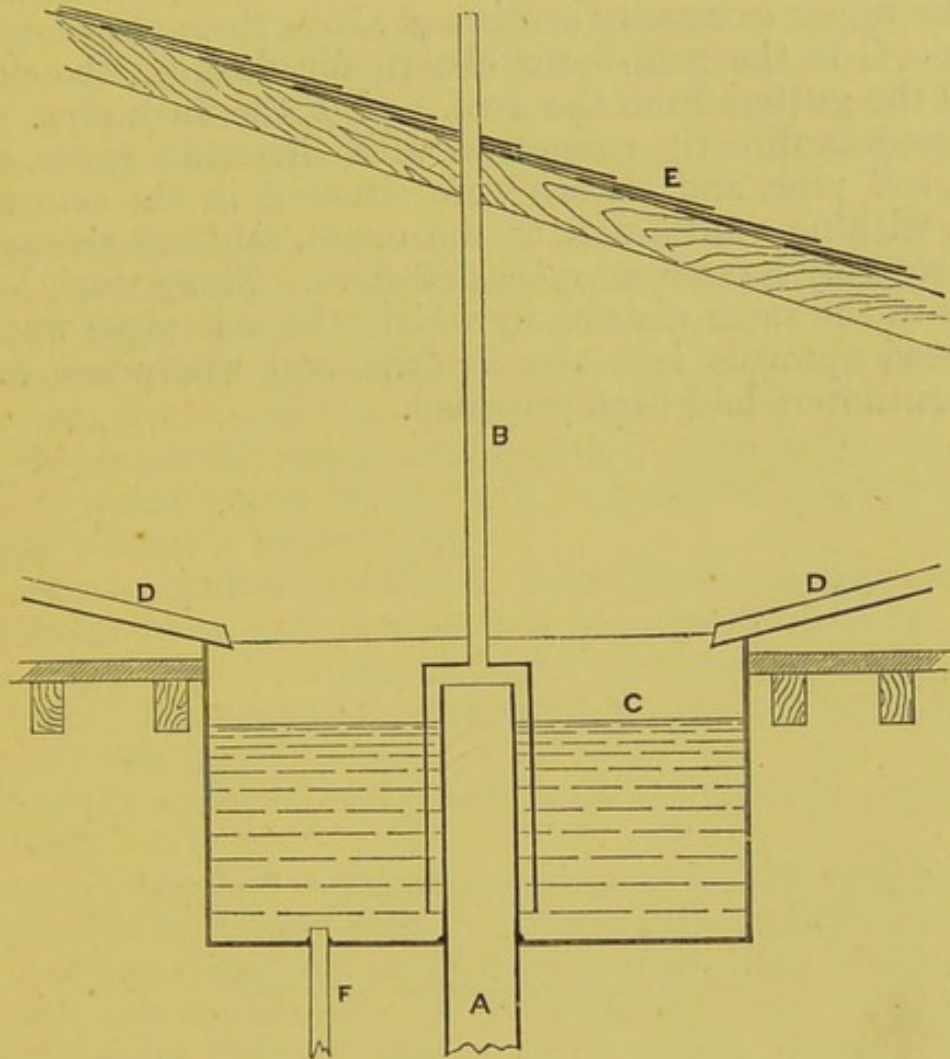
FIG. 70.

Fig. 70 represents part of a series of defects found in each of fifteen suburban residences, erected about twelve years ago. The soil pipe, of 4in. cast-iron pipes, was carried up through the bottom of the rain-water cistern to within two or three inches of the top, and made to act the part of overflow for the cistern. This is marked A in the cut. A zinc cap, in diameter two inches larger than the soil pipe, was placed in position over the end of this pipe, as a bell over a sink pipe. A zinc pipe B, an inch in diameter, was soldered round a hole at the top of the zinc cap, and the upper extremity continued above through the roof E, as shown. C is the rain-water cistern for flushing the closets, D and D the gutters from the roof, and F the flush pipe. As the soil pipe was directly connected with the main sewer, and the closet, soil pipe, and cistern were situated in the centre of the house, with no ventilation to the closet, sanitary arrangements could scarcely have been more defective. There were, however, houses in the same district in which the soil pipes were found continued upwards into the cisterns, and where not even one inch ventilators had been provided.

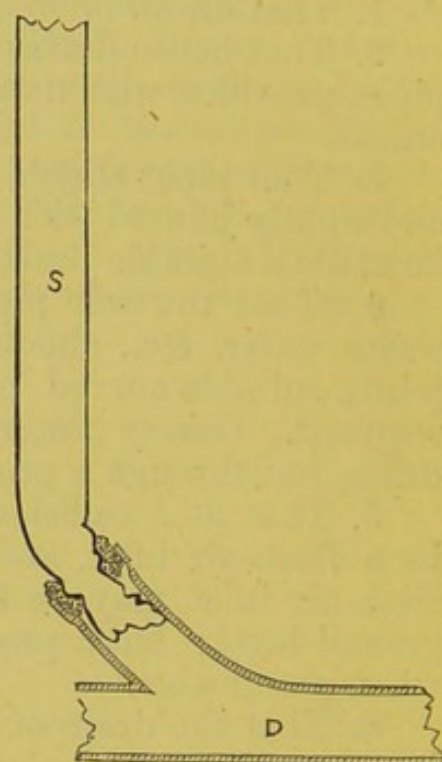
FIG. 72.

Fig. 72 shows a lead soil pipe S connected by a junction pipe D to the house drain. Instead of making a proper joint the workman had crumpled up the end of the soil pipe, and roughly thrust it into the pipe anyhow. It was cemented round, so that the joint did not actually leak, but at the joint the capacity of the soil pipe was reduced from being 4in. in diameter to being scarcely 2in., thus preparing the way for a stoppage sooner or later.

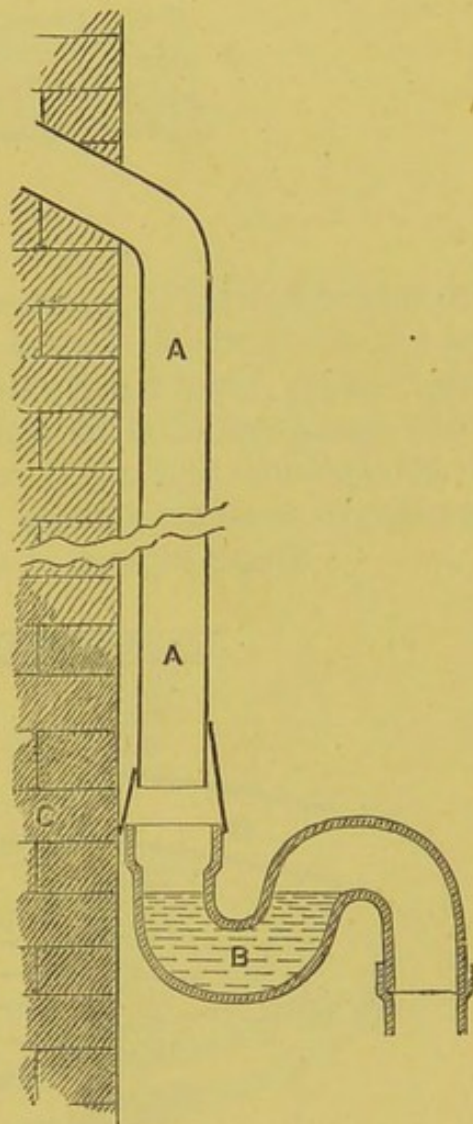
FIG 73.

Fig. 73 was sent by a correspondent in one of the largest towns in the kingdom. It represents an unventilated soil pipe, imperfectly connected with the trap at the foot. The connection consisted of four slates laid round the end of the soil pipe and trap. The result was that the contents of the soil pipe soaked into the ground and the contiguous portion of the wall, causing an effluvium nuisance inside the house. A indicates the soil pipe, B the trap, and C the saturated portion of the wall. Here

are three defects—the bad connection, the absence of a ventilator, and the trap at the foot of the soil pipe.

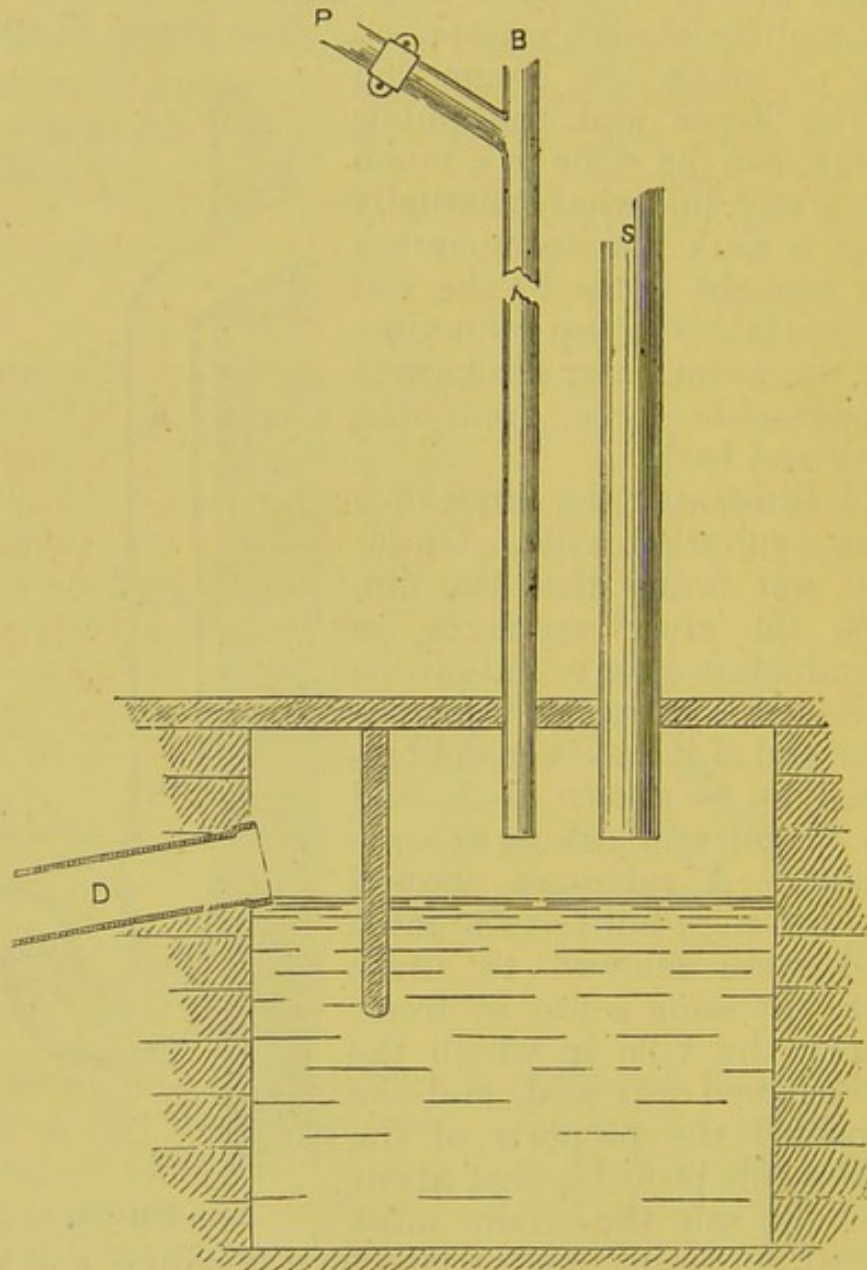
FIG. 74.

Fig. 74, received from a correspondent, is rightly described by him as a foul-gas generator. It represents a soil pipe S, and a waste pipe from pantry sink and bath, P and B, delivering into a covered pit measuring $2\frac{1}{2}$ ft. by $1\frac{1}{2}$ ft. and $2\frac{1}{2}$ ft. wide, and furnished with a mid-feather and outlet D, as shown. This arrangement was provided at a large house, and the workmanship was excellent though misapplied. The object of such a pit is merely to break the connection between the house and the public sewer, which can be done in a much more simple way, but what it actually becomes is a tank for intercepting the solids brought down by the soil pipe, and this is stirred up from time to time by the warm water discharged with considerable force from the pantry sink and bath.

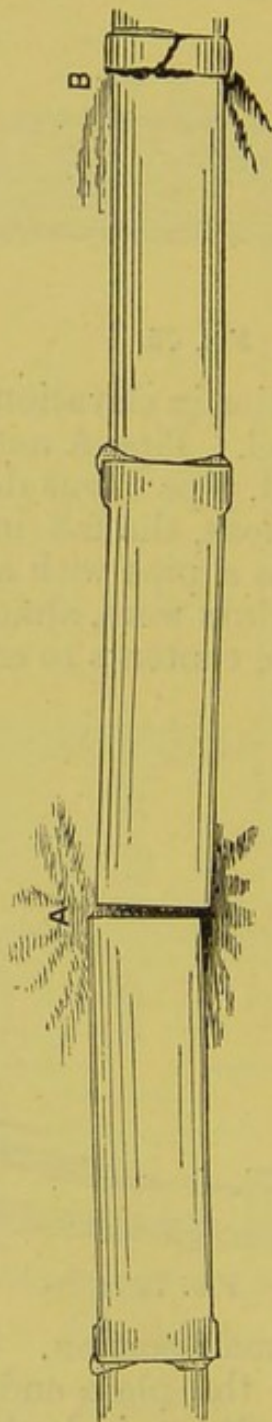
FIG. 78.

Fig. 78 shows another small portion. It will be noticed that two pipes are placed with the plain ends together, leaving an open joint at A, and the flange is broken off the pipe at B. Many of the flanges were found to be broken, and plain ends were placed together at two or three points.

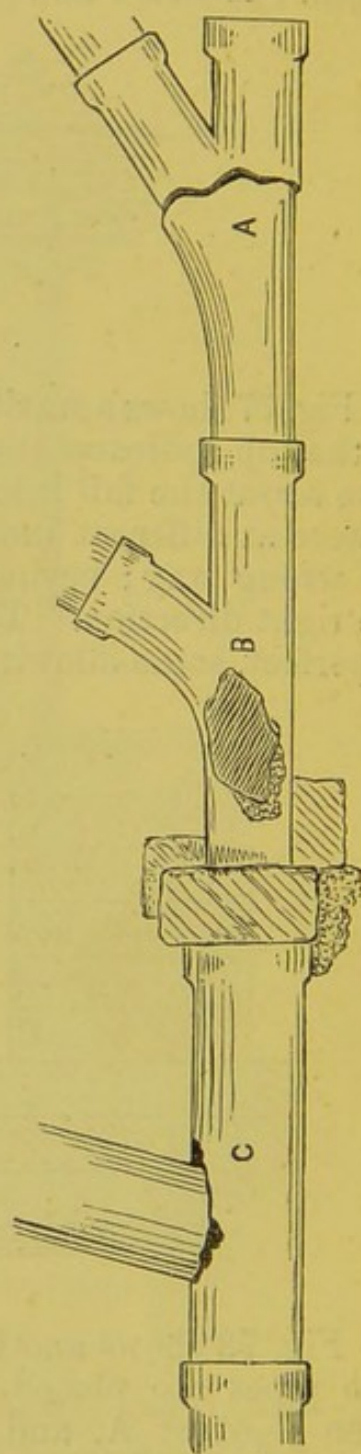
FIG. 79.

Fig. 79 represents the exact appearance of three pipes when the earth was removed from them. They are seen in plan, that is from above. At A is a 4in. junction, fractured right across, no proper bed having been made to support the pipe beneath.

the drain. Pipe B delivers into a 6in. pipe, there being a distance of fully 4in. between the pipes, the joint being roughly

made with brickbats and mortar. At C a hole had been knocked in this 6in. pipe, and another 6in. pipe from a gully trap roughly brought into it as shown. These three pipes are three consecutive pipes just as discovered. Of course the leakage from such a drain was enough to account for dampness in the neighbouring wall. However, the worst part of the drain is shown in section in

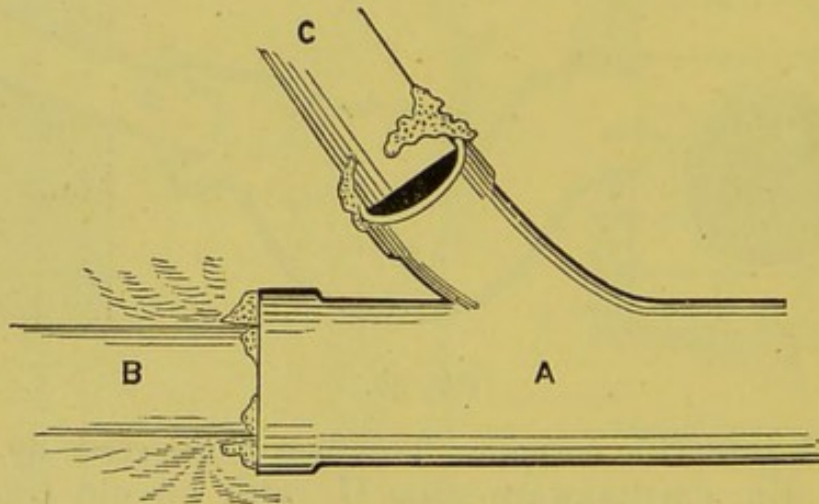
FIG. 82.

this house, and defects as shown were discovered. The pipe A was so tilted up that the end of pipe C did not fit into the socket meant to receive it, and B, which should have been a 9in. pipe, was a 6in. one. The joints were in part made of clay,

and were defective. At the joint between A and B the drain contents had leaked out, and at the joint between A and C the earth above had got into the drain.

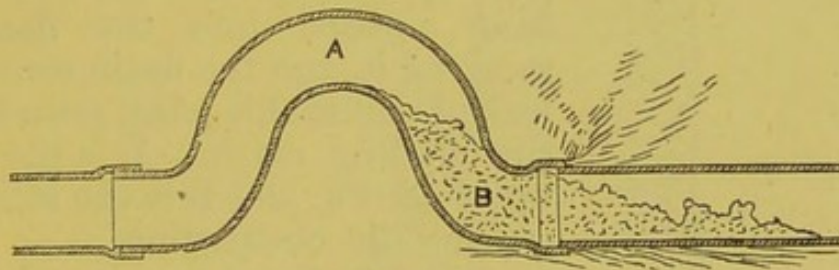
FIG. 84.

Fig. 84 illustrates an instance of remarkable stupidity that came under the observation of a correspondent from a small urban district. A 4in. earthenware pipe drain was not running, and it was exposed at the point where the stoppage appeared to be. The cause of the obstruction was at once brought to view. A trap had been introduced in the course of the drain, but it had been set *upside down*. None of the joints were properly made, and the pipe delivering into the trap had not been pressed into the flange that received it, and the drain contents had leaked out at this joint, saturating the surrounding earth. A is the trap set upside down, and B is the solid matter causing the obstruction.

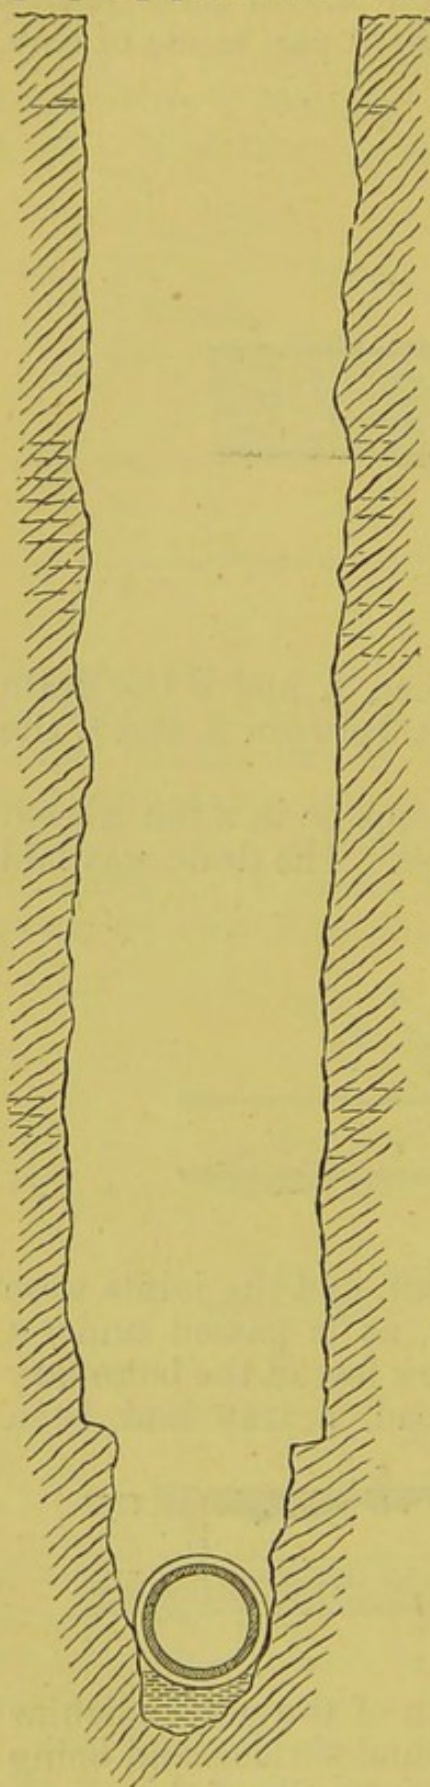
FIG. 86.

Fig. 86 indicates one of the causes of defective joints in drains. Defects were suspected in the drains of a good-class house built on the new red sandstone, and set back a little from the road. The main drain was exposed. It extended from the rear of the premises to the sewer, a distance of 75 feet, and was at the bottom of a very narrow cutting, as in the figure. It was a 6in. earthenware pipe drain; and considering the width of the cutting

in which it was laid it was not surprising to find all the joints imperfect. Of course, the object in taking out so little of the sandstone was to avoid expense; and it is not unlikely that the draining of the premises was a "contract job," tendered for at too low a figure. Near the pipe were two ledges, evidently designed to give the pipe layer a foothold; but it would have been quite impossible for any pipe layer to have laid a drain and made perfect joints in so narrow a trench. On taking up the pipes, it appeared that the main channel for the drainage from the house had been the bottom of the trench below the pipes—at all events much of the contents of the pipes had leaked into this channel. The figure explains itself.

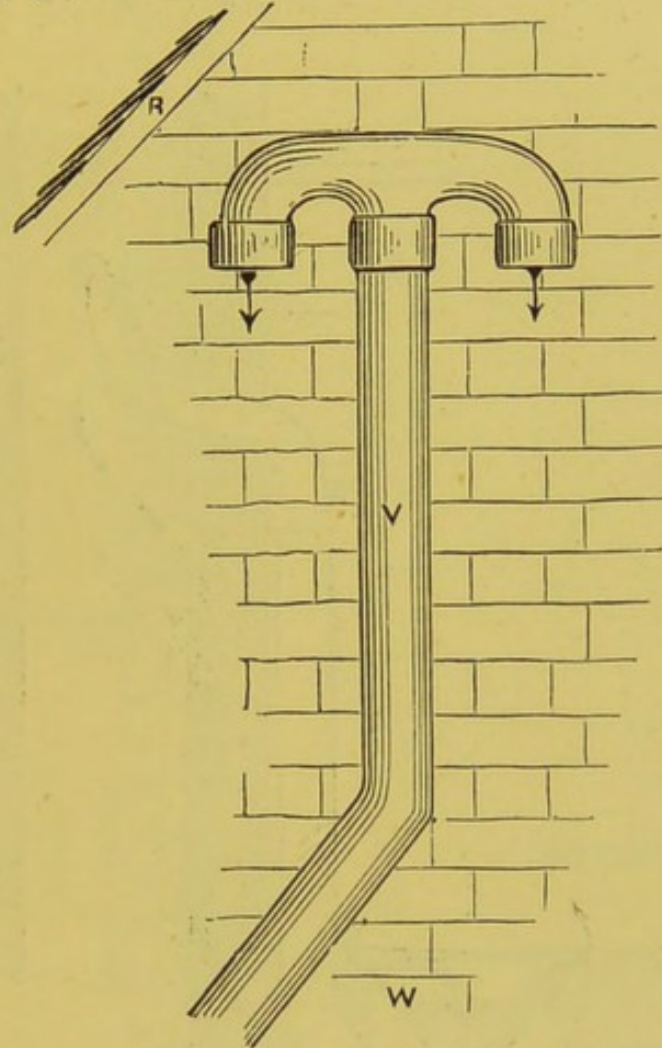
FIG. 87.

Fig. 87 shows the upper extremity of a drain ventilator. It was fixed to the gable wall of a large house, and instead of being carried up above the roof, in the usual way, it was turned obliquely to the right, apparently for no other purpose than to bring it over a window, and then it was capped with a terminal to direct any foul air it discharged downwards towards the window. V indicates the ventilator, which, with the terminal, was of 4in. cast-iron pipe. R shows a portion of the roof, and W indicates the position of the bricks just above the top of the window.

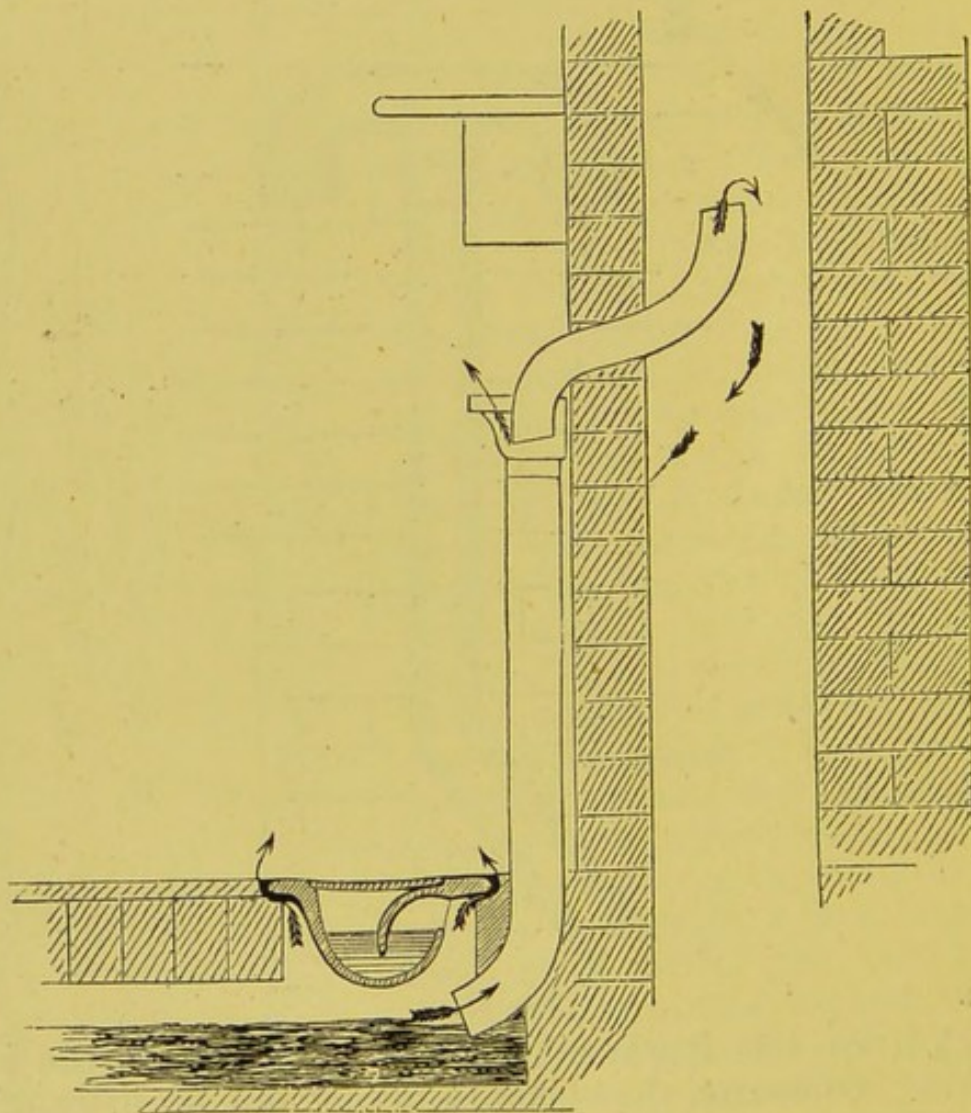
FIG. 88.

Fig. 88 represents a resident owner's attempt to remedy a defect in his house. In the basement of the premises was a rubble drain, laid without fall, the entrance to which was guarded by a loose D trap. Such a drain (it was continued from this house under three or four others) was necessarily a drain of deposit, and the effluvia arising therefrom had free access to the house, the traps notwithstanding. The owner thought he could remedy the nuisance by fixing a perpendicular pipe as shown, through which he could flush the drain and keep it clean.

The pipe was accordingly fixed, and buckets of water poured down, but the nuisance remained. Having an idea (not an uncommon one) that the current of air is always upwards in a chimney, the

owner next carried a pipe, from the head of the flushing pipe, for about a foot up the chimney. The result of the owner's remedial measures was that the effluvia, instead of coming up merely at the edges of the loose trap, had free exit at the flushing

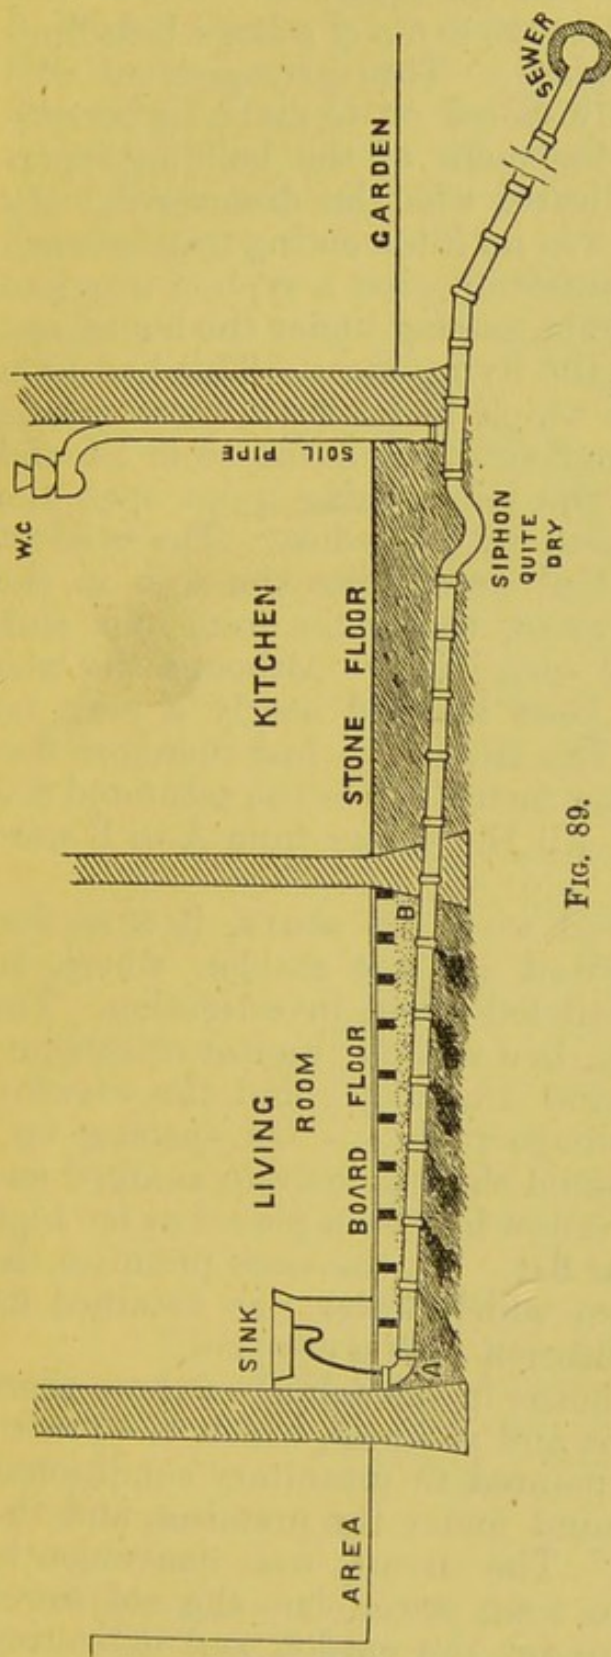
FIG. 89.

Fig. 89 shows the sanitary arrangements of a large boarding-house at an inland watering-place. The correspondent who supplied the sketch was recently called on to make an investigation, and the section of the basement of the building represented in the cut correctly indicates what he discovered. My correspondent writes: "There was no intercepting trap between the public sewer and house connections, but a syphon trap had recently been inserted in the drain passing under the house, and new pipes had been laid under the living room. This had been done to get rid of a bad smell which had been noticed in the living room. On pulling up the floor of the living room I found the pipes laid on the ground, the joints being quite open, the pipes loose, and partially covered with sawdust. The sawdust and soil were saturated with foul water from the sink in the pantry adjoining the living room, the water from this sink having all escaped through the open joints. Although the trap under the kitchen floor had been inserted nearly a year, no water had ever reached it. The sewer gas had therefore free access to the house by the living room." A is the saturated soil and B the saturated sawdust. All the joints from A to B were open.

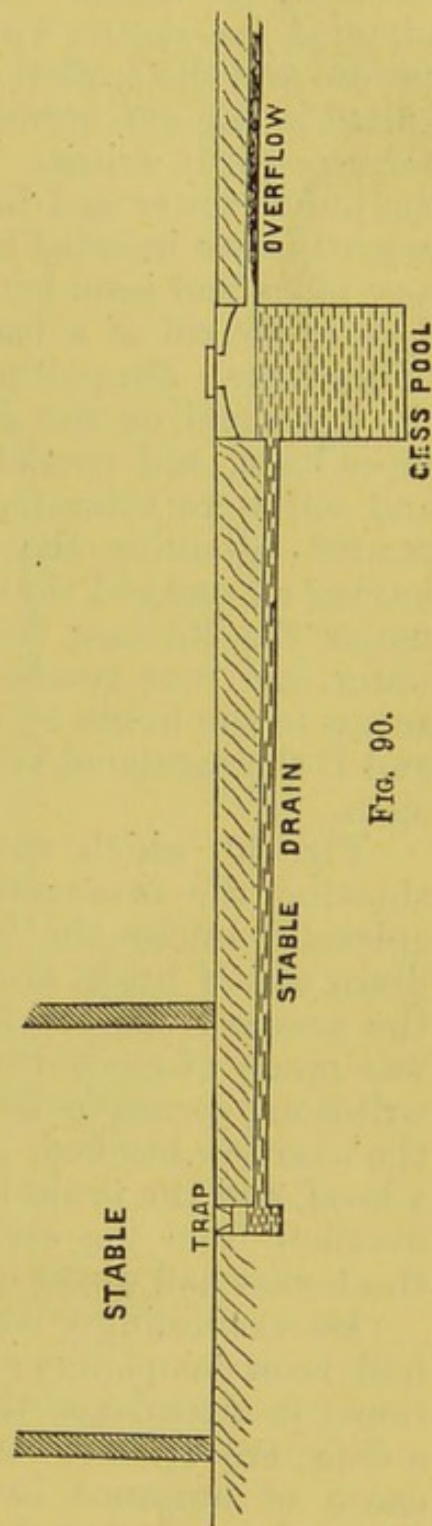
FIG. 90.

Fig. 90, which was received with the above, is a section showing the arrangements found at large stables, where, an epizootic among the horses had led to an investigation. The drain was of brick, 6in. by 6in., laid without mortar or cement; the cesspool was 7ft. by 4ft., and 5ft. deep; and the overflow was made of agricultural drainage pipes. "On opening up," writes my correspondent, "I found the stable drain charged and the overflow blocked. The overflow had been placed at too high a level, and the drain itself was flat. On the same premises the overflow from the cistern from which water was obtained for the horses had direct communication with a cesspool."
