Defects in plumbing & drainage work... Illustrated by upwards of a hundred woodcuts. / described by Francis Vacher.

London : John Heywood, 1889.

Defects in Plumbing and Drainage Work

described by **Francis Vacher**
upwards of 100 illustrations

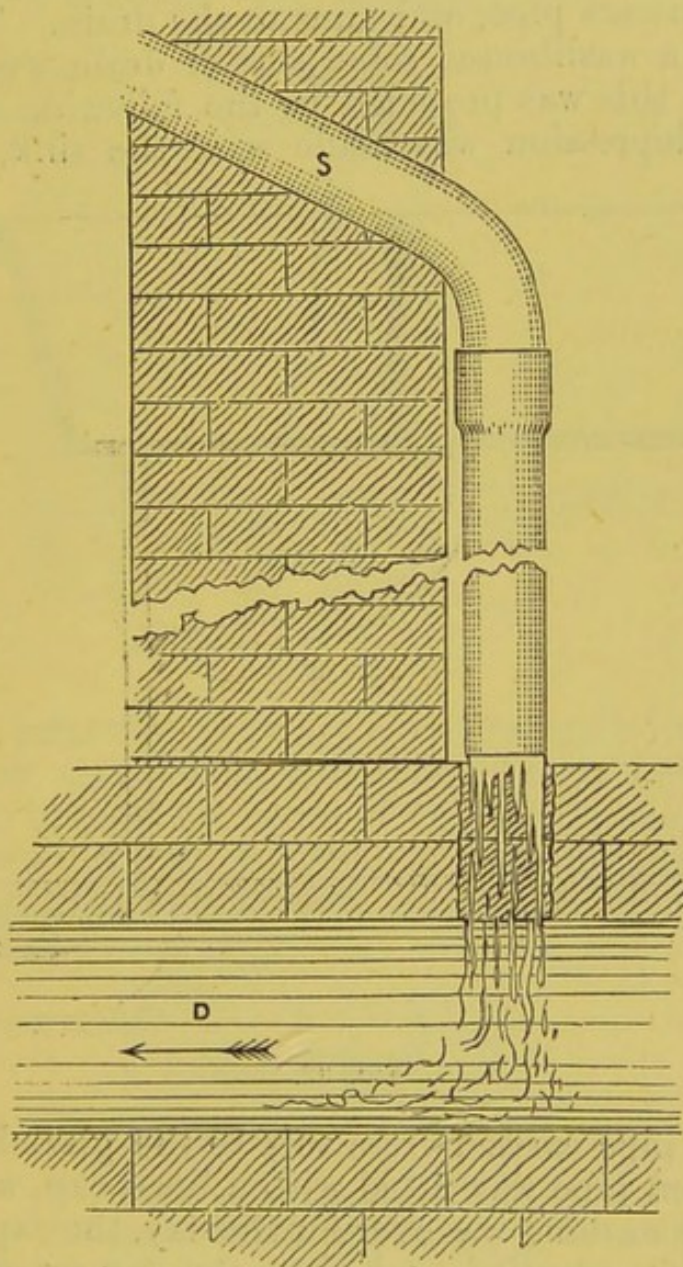
FIG. 91.

On examining a large old house in the suburbs (where there had been complaints of effluvia and sickness, which the practitioner in attendance thought pointed to insanitary conditions), a defective brick sewer was found under the premises, and the cause of nuisance indicated. The house was conveniently situated for draining into the town sewer, but the old sewer originally provided, running under the garden and delivering into the river, had not been interfered with. The tenant had been induced to think that the drains were properly arranged, and external to the house, *as the soil pipe was carried down outside*. I pointed out that it was not ventilated, and on removing the earth at the foot brought to light the old sewer

running under the house. The length of iron soil pipe ($4\frac{1}{2}$ in. pipe) had not been quite long enough to reach to the sewer, so a hole had been roughly cut in the sewer and the soil pipe delivered over it, no joint having been attempted. In Fig. 91, S is the lead soil pipe properly jointed to an iron soil pipe. The way this delivered into the drain D is shown.

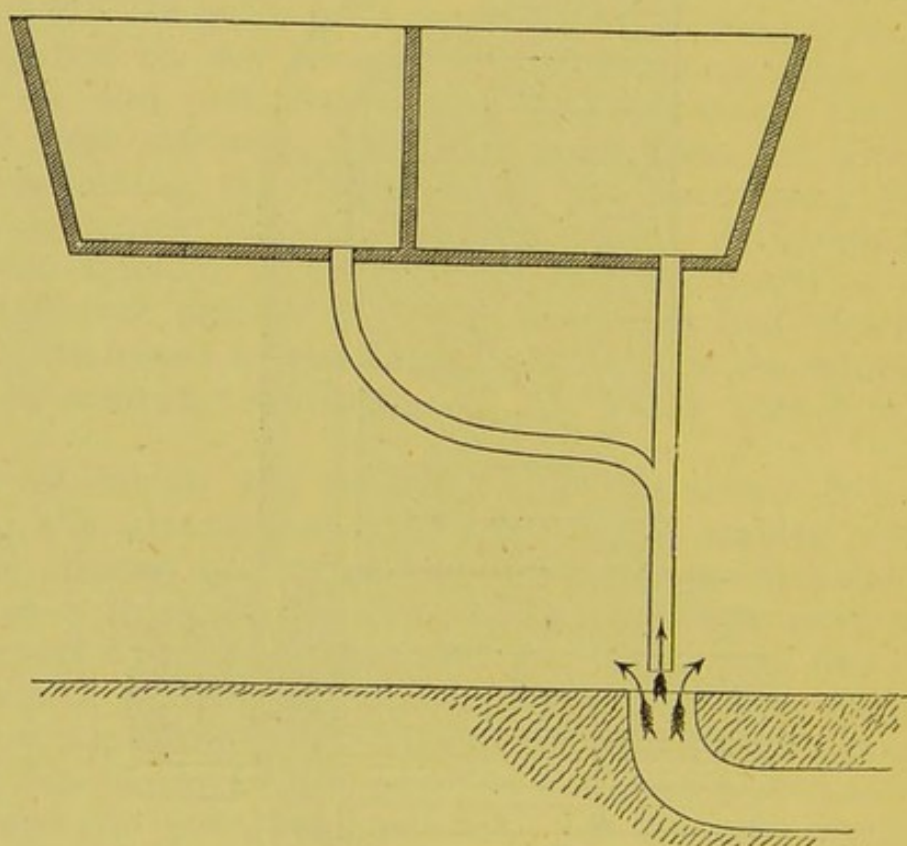
FIG. 92.

Fig. 92 represents an untrapped drain in a washhouse adjoining a kitchen. Complaint was received from the occupant

of the premises of an effluvium nuisance. Two fixed washtubs discharged over a grating in the floor, and on the grating being removed it was found that the washhouse drain was without a trap of any kind, and delivered into the sewer direct. The arrangement is shown in the illustration. The owner of the house was a builder, and yet when communicated with and directed to abate the nuisance he at first insisted on connecting

the waste pipes from the washtubs with the washhouse drain. It was pointed out to him that this could not check the ingress of sewer gas, but would merely deliver it at a higher level, and that whether the waste pipes from the tubs were connected with the washhouse drain or not, the latter would have to be severed from the sewer by a gully trap, or in some other efficient manner.

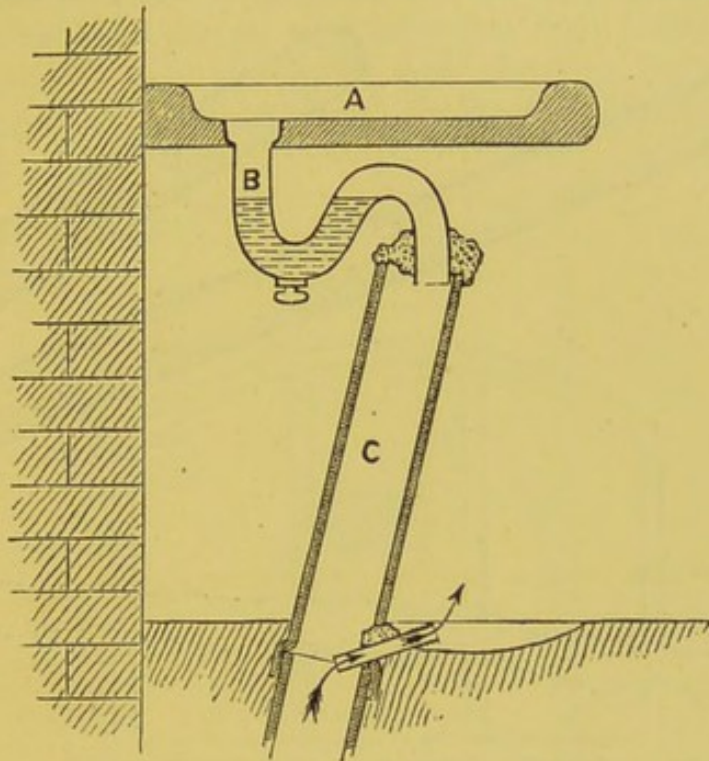
FIG. 93.

Fig. 93 shows in section a sink as fitted in the basement of a small house let at about 8s. a week. The sink waste pipe was trapped with a large iron (S) trap, and delivered into a 4in. glazed earthenware pipe, and thus to the drain. The basement being used as a washhouse, some sort of drain was required for the floor, and this was provided in the following way: A small dish-shaped depression was made near the sink, and a short

length of iron pipe carried from this to the glazed earthenware pipe. This iron pipe was fitted with a brass cap, which screwed on. After the washing was over for the day, the cap was screwed off and the tubs emptied, and then the cap screwed on again. Of course, in practice, the cap was not always screwed on at once; and one night that it chanced to be left off, the effluvium nuisance was so bad as to cause the woman of the house to get up and search for the cap and put it on. A is the sink, B the iron trap, and C the glazed earthenware pipe. The whole arrangement was unworkmanlike, but B was jointed to C quite securely with cement, and the floor near the sink was finished off with cement, so that the only direct communication between

the inside of the house and the drain was through the short iron pipe described.

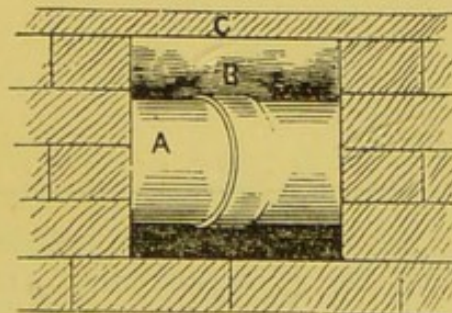
FIG. 94.

Fig. 94 represents a curious case of obstruction which I discovered in making an examination of a very large house. It was ascertained that the obstruction was in an old drain under

the area. On removing the flags a square brick-lined drain was brought to view, and crossing this obliquely was a 6in. pipe drain, which was the immediate cause of the obstruction. The pipe drain had been laid in connection with additional sanitary accommodation recently provided, and those responsible for the work seem to have been indifferent as to the effect it must have

on the old drain. A is the pipe drain, B the old brick drain shown in section, and C the area flagging.

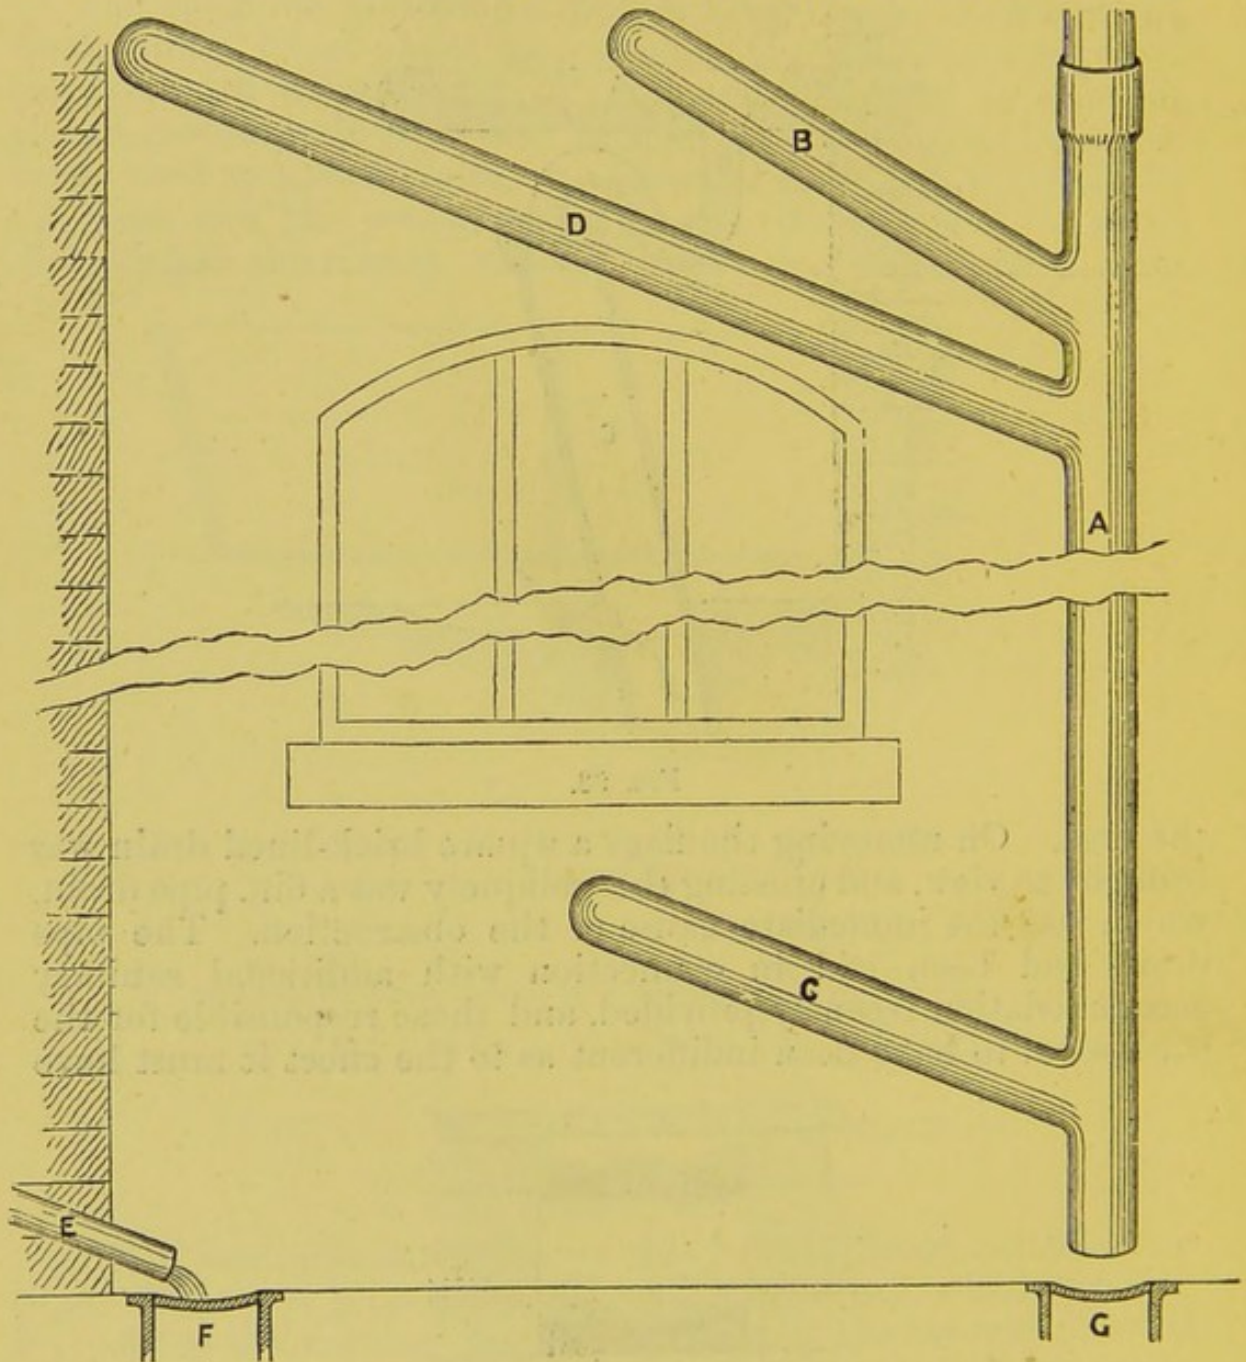
FIG. 95.

Fig. 95 is a specimen of ill-planned work in connection with a hospital. One of the peculiar features of the hospital is that there are two distinct drainage systems—one for so-called "sewage," which is specially treated, and one for surface water,

which passes into a pond. It was arranged that all bath and lavatory waste water was to pass into the foul water, or "sewage" system. As the work was carried out, it seems to have been left to chance as to which system of drains the waste pipes delivered into. A is a rain spout from the roof, delivering on a gully trap G, connected with the surface water drain; B and C are dis-

charge pipes from the first floor and ground floor lavatories; D is the discharge pipe from the first floor bath—all these being connected with the rain spout A. E is the discharge pipe from the ground floor bath, delivering on a gully trap F, connected with the foul water drain. The 4in. earthenware pipe drain leading from F crossed over the 4in. earthenware pipe drain from G, the one lying almost close to the other. A, B, C, and

D are 4in. iron pipes. E is a small lead pipe, as shown. "The object of this blundering," writes the correspondent who furnishes me with these particulars, "is difficult to see, as it would have been far simpler to discharge all the bath and lavatory water on a grid in F." The most economical way of remedying the mistake appeared to be to connect the gully G with the foul-water system, and this has now been done.

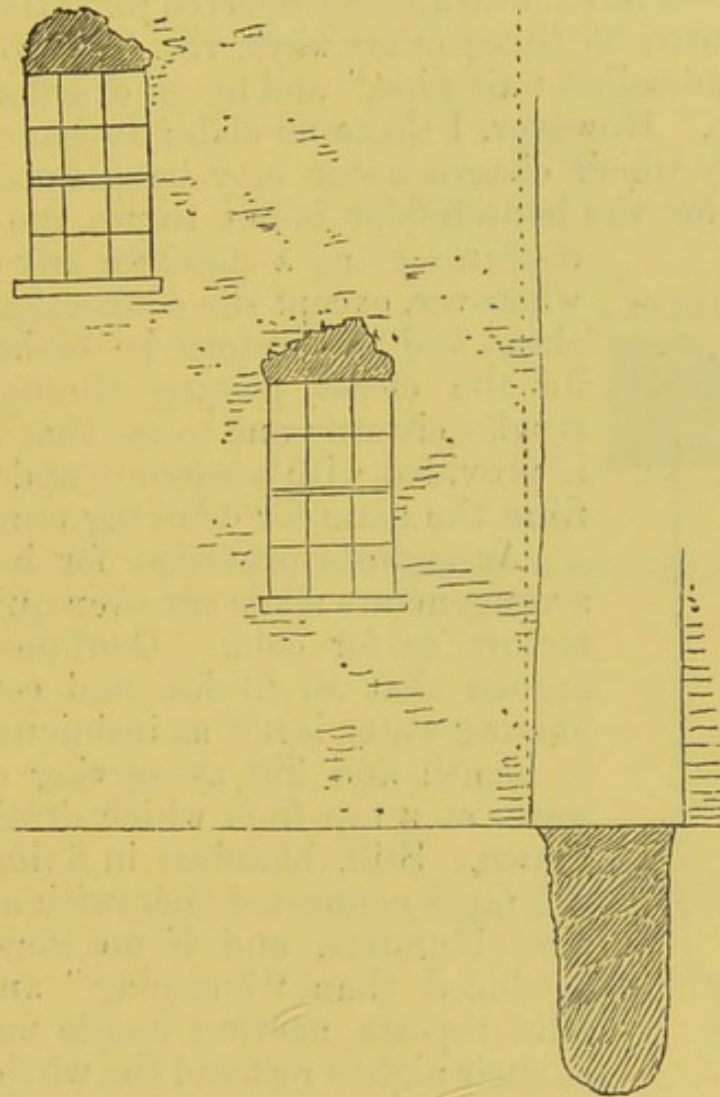
FIG. 96.

Fig. 96 shows the effects of not shoring up a wall before digging a trench close to the wall footings. Earth was removed

from a back passage, to the depth of about 9ft., in order to reconstruct a drain, and as a result the wall parallel to the trench got out of the perpendicular, as shown in the dotted lines in the sketch. Some time after the ground had been filled in, the brick arches over the windows fell out as indicated. Workmen often appear to think that shoring up the sides of the trench in such a case is sufficient. The house on the opposite side of the passage was much larger and higher, and thus not so liable to be affected.

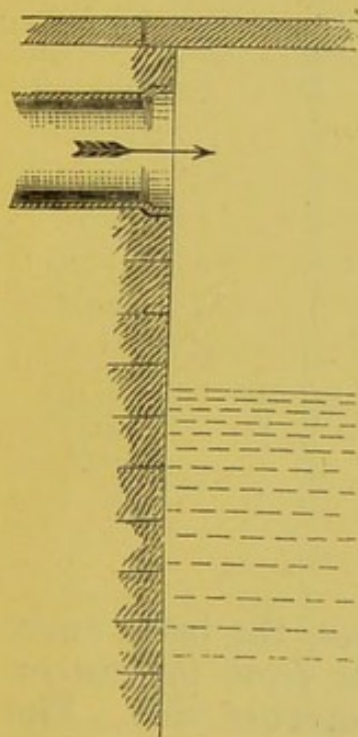
FIG. 97.

Fig. 97 represents a portion of the interior of a terra cistern, the overflow pipe from which is carried directly into the drain. Connecting the cistern overflow to a drain is, I regret to say, a

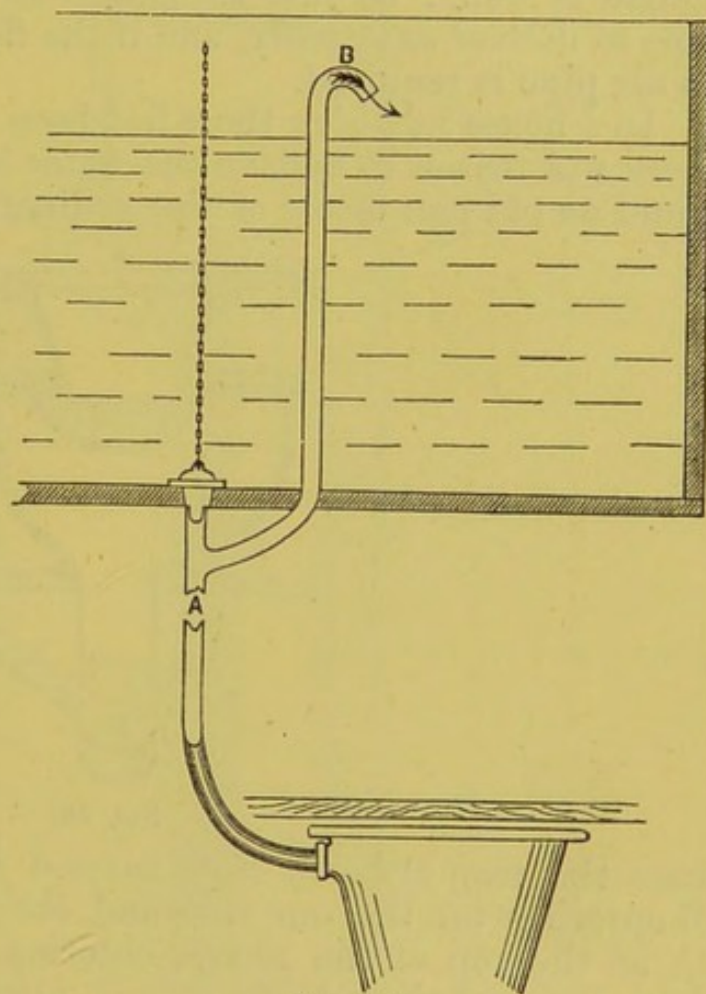
FIG. 98.

Fig. 98 represents a portion of the interior of a domestic store cistern, used for flushing a closet, and for other purposes. A is the flushing pipe brought down to the closet basin, and B is a so-called air pipe, which discharges foul air out of the flushing pipe on the surface of the water in the cistern. Of course it would be just as simple an arrangement for the air pipe to deliver externally, and if the flushing pipe is big enough no air pipe is required.

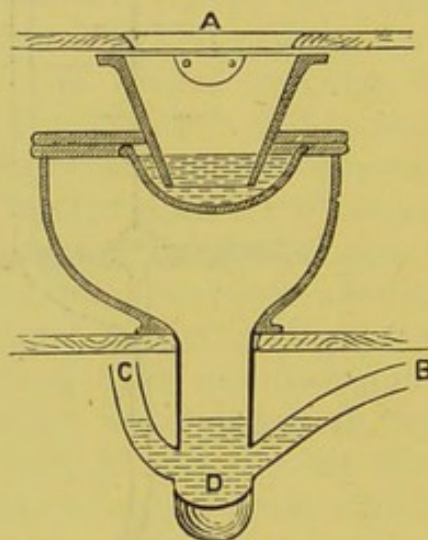
FIG. 99.

In a house in which there had been much sickness, and where there was reason to believe the water had become polluted, was found an old pan closet of the ordinary form—*vide* Fig. 99, A.

Into the trap D below were carried two pipes, the bath waste B entering on the one side and the *overflow from the cistern* C, at the top of the house, entering on the other side. The trap was continued as a soil pipe (inside the house and unventilated), delivering into an ill-jointed drain under the basement.

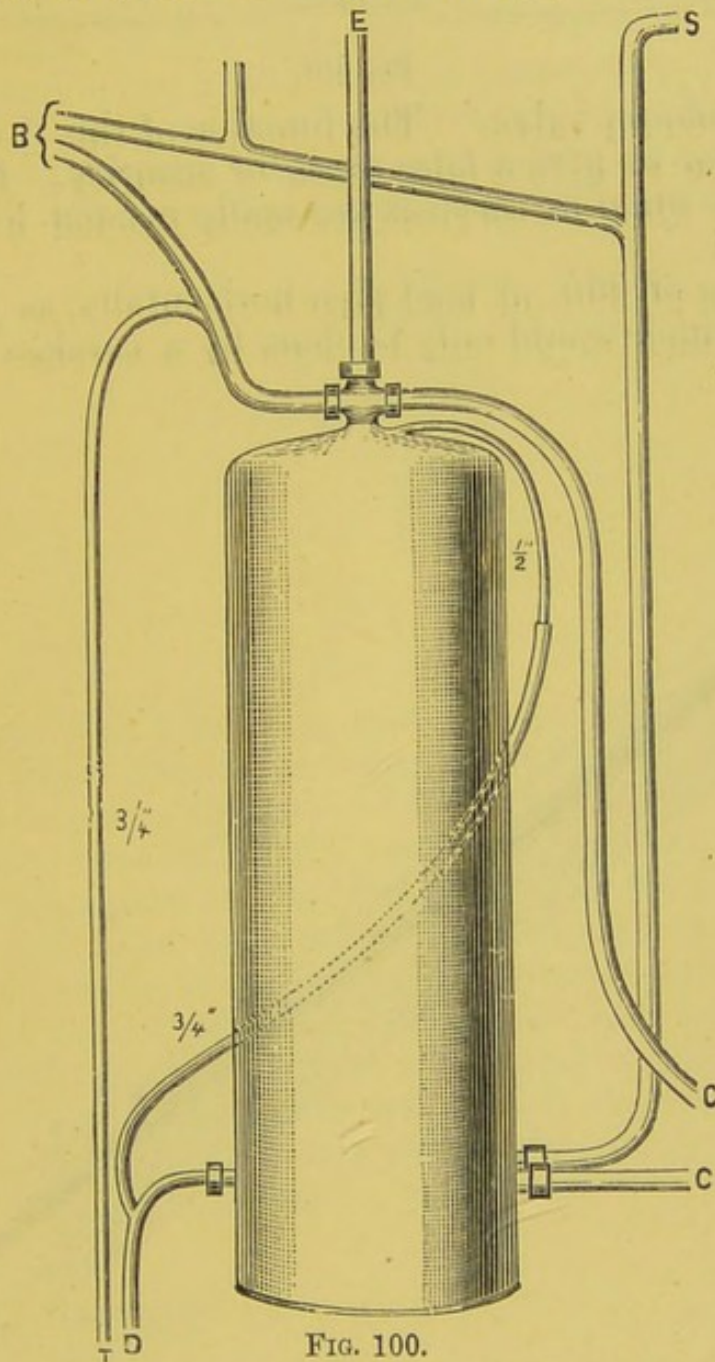
FIG. 100.

Fig. 100 illustrates an instance of defective plumbing which was made manifest owing to frost. I was informed that a copper cylinder, which had been fixed ten years since, and had hitherto given no trouble, had suddenly collapsed, the copper being rent in two places. On arriving at the premises I found the cylinder a hopeless wreck, and water still spurting from one of the rents. The cylinder measured 4ft. by 1½ft., and was fitted as shown. C and C are the circulating pipes, E the expansion pipe, S the cold supply, T a hot water tap for the kitchen, D the draw-off pipe for emptying the cylinder, which

was also used to supply a bath on the kitchen floor, and B a hot and cold pipe leading to a bath on an upper floor. I traced the supply pipe, and found that from the point S it was horizontal for 39ft., out of which 30ft. ran along an external wall, then it ascended along an external wall to a cistern, at the top of the house. It was not surprising that this pipe had frozen. The next thing was to trace the expansion pipe, which was led up

and made to pierce the roof, where the end had become choked with snow and ice. The bath had been in use once or twice since the frost, and as the cylinder cooled, the collapse had taken place. All the pipes were $1\frac{1}{4}$ in. except those marked. It is not easy to understand the intention of the $\frac{3}{4}$ in. extending from the pipe D, and continued as a $\frac{1}{2}$ in. to the top of the cylinder. It appears to have been put in as an afterthought. Probably the water in the bath supplied from D was not found to be hot enough, as

The fixing of 39ft. of lead pipe horizontally, as just referred to, is work which would only be done by a careless or ignorant

plumber. A pipe should always be given a sufficient fall to enable it to be emptied if required, and when nearly horizontal should be laid on a piece of wood.

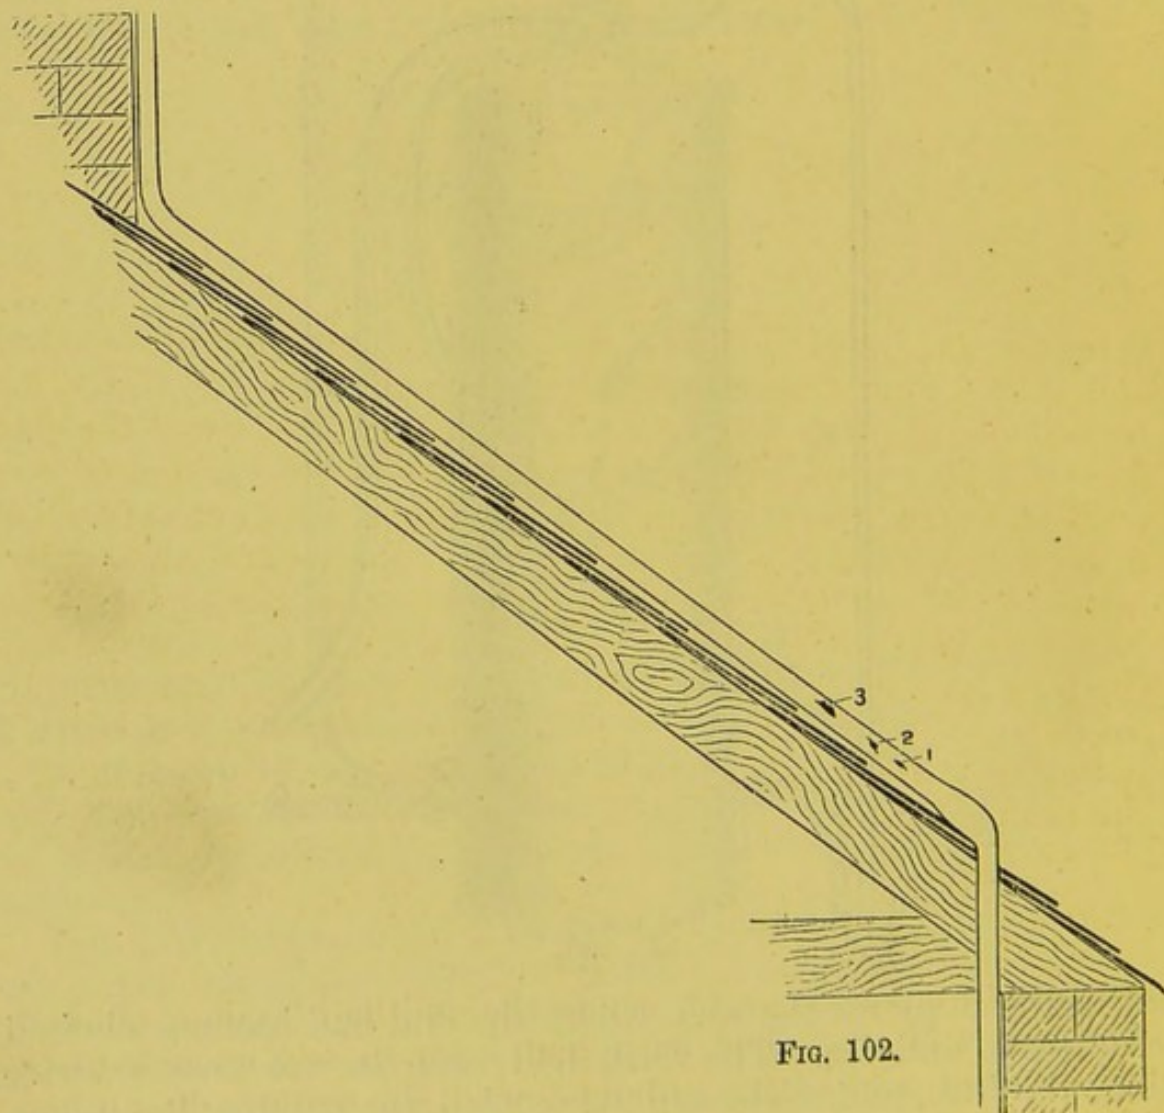
FIG. 102.

The next illustration, Fig. 102, shows the expansion pipe from a hot water cylinder, which was ruptured by frost three times between Christmas and the middle of January. Every plumber knows that an expansion pipe should not be exposed to the action of frost, yet the pipe shown was carried along the roof, unprotected for five feet, and then up a chimney for four feet. Just beyond the point where it pierced the roof there was a joint, and the first rupture occurred close to this at 1. After it was mended, a second rupture occurred at 2; and after this was mended, the pipe burst for the third time at 3. The

chimney was from a kitchen, and was practically always warm, and if the pipe, instead of being carried along the slates, had been made to pierce the roof where the chimney came through, it would have been efficiently protected from the action of frost.

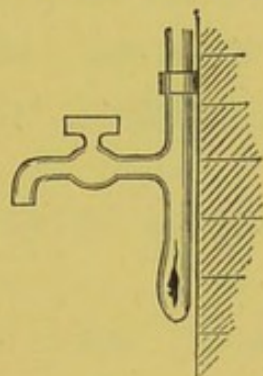
FIG. 103.

The defect shown in Fig. 103 was noted by a correspondent. A service had been provided for the garden, and the tap not being placed at the lowest part of the branch a portion remained which could not be emptied. The water had been run off from the pipes and cistern, as a frost was expected, but, of course, the *cul de sac* remained full, and froze, and the lead was burst, as indicated in the cut. As soon as the water was turned on again the rent was made manifest.
